Comments on the PennDOT Determination of Effects Report on the Headquarters Road Bridge

A report prepared for the Delaware Riverkeeper by:

Mark L. Stout, PhD
Mark L. Stout Consulting

14 December 2015

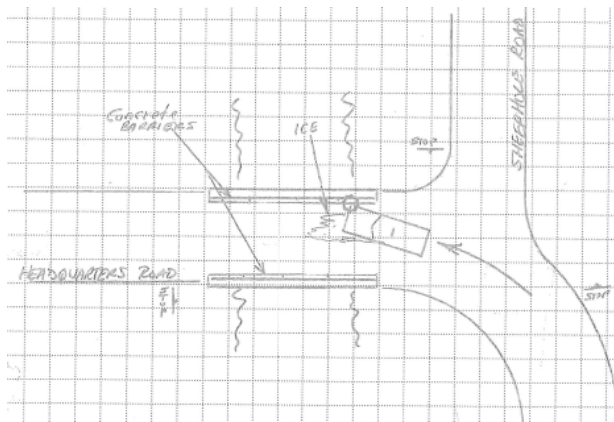
- 24 October 2003 – A vehicle driving westbound on Headquarters Road attempted a left turn onto the bridge and slid on an icy road surface on the bridge, resulting in contact with the bridge wall (see figures 1 and 2).
- 1 April 2006 – An unregistered, uninsured vehicle left the scene of the crash while the driver and passengers were out for a “joyride.” Details of the crash are minimal but do indicate that contact was made with the Jersey barrier on the bridge.
- 7 May 2006 – A motorcyclist reported losing control of his eastbound motorcycle on loose gravel as he entered the bridge (see figures 3 and 4).

Figure 1
Police sketch of 24 October 2003 crash, vehicle skidding
on icy surface into Jersey barrier

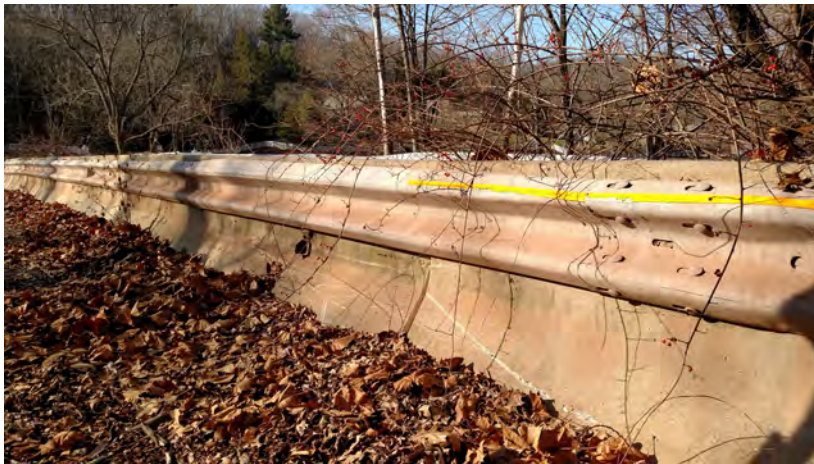
Figure 2
Jersey barrier on Headquarters Road Bridge, showing impact scrapes,
possibly resulting from the 24 October 2003 crash

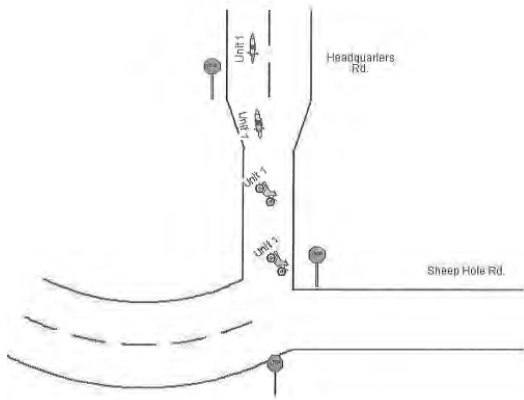
Figure 3
Police sketch of 7 May 2006 crash, motorcyclist losing control on loose gravel

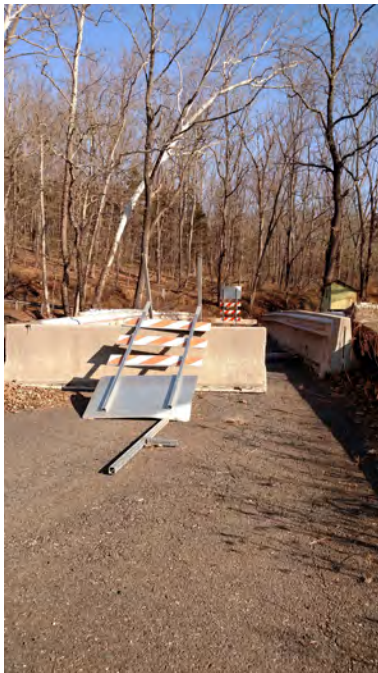
Figure 4
Eastbound view of Headquarters Road Bridge in the area in which the motorcyclist lost control in the 7 May 2006 crash

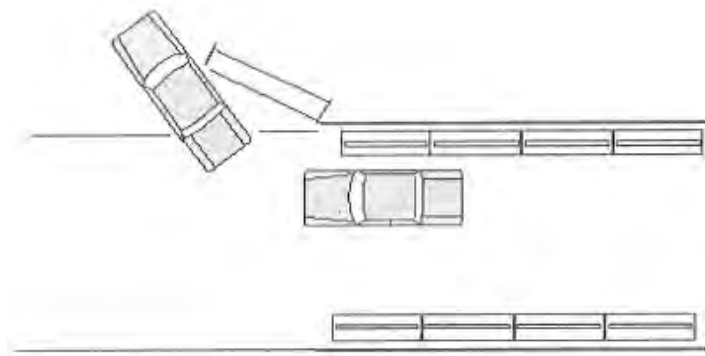
A fourth crash, on 6 July 2007, appears to have been near the bridge. A vehicle driving westbound was reported as having made contact with a fence or wall near the bridge. Based on the limited description and the police sketch (figure 5), the

Figure 5
Police sketch of 6 July 2007 crash, impact on the fence
to the west of the bridge

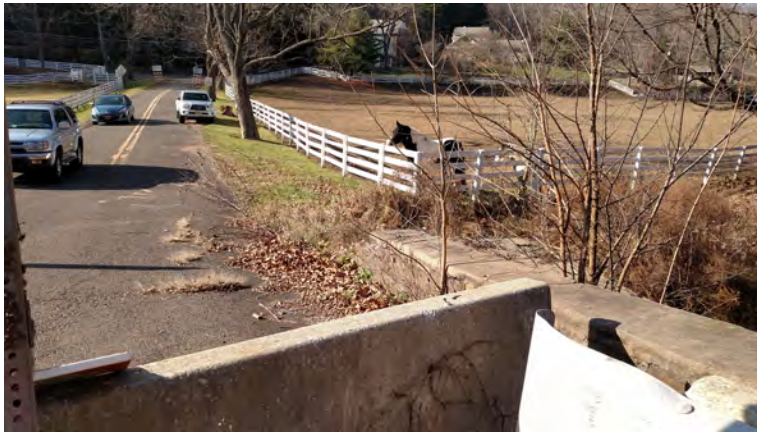
vehicle probably made contact with the fence on the western end of the bridge (figure 6).

Figure 6
The fence to the west of the bridge, the apparent site of
impact in the 6 July 2007 crash

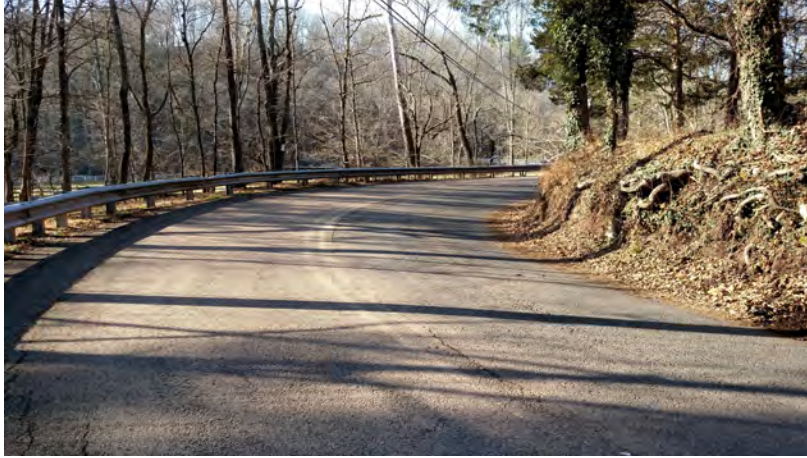
Of the crashes at the curve, 3 occurred when the road surface was wet and all 5 involved a westbound vehicle crossing the centerline (see figures 7 and 8). These crashes are all well beyond the influence of Headquarters Road Bridge, but do indicate a “hotspot” where PennDOT should consider upgrading such safety measures as signing and striping.

Figure 7
Westbound view of the curve on Headquarters Road located 250 feet east of the intersection with Sheephole Road, the site of 5 crashes within the reporting period

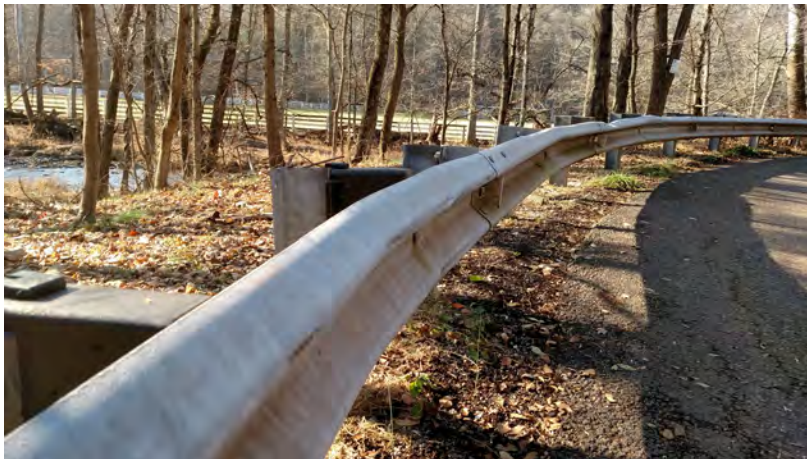
Figure 8
Guardrail along the Headquarters Road curve, showing signs of multiple impacts
