# Lower Crabby Creek Restoration

Learning the Art and the Science

This slide presentation is the first part of an on-going account of the restoration of Crabby Creek, a small cold water feeder stream to Little Valley Creek, just north of Paoli, Pennsylvania, in suburban Philadelphia. The stream is part of the Valley Creek Watershed that includes Valley Forge National Historical Park. Crabby, a well wooded brown trout nursery stream, suffers the ravages of storm water run-off from the impervious surfaces of the development in its headwaters. By 2008 the erosion of about 3500 cubic feet of streambed had undercut a sanitary sewer line that carries a million gallons of waste per day, creating a potential environmental disaster.

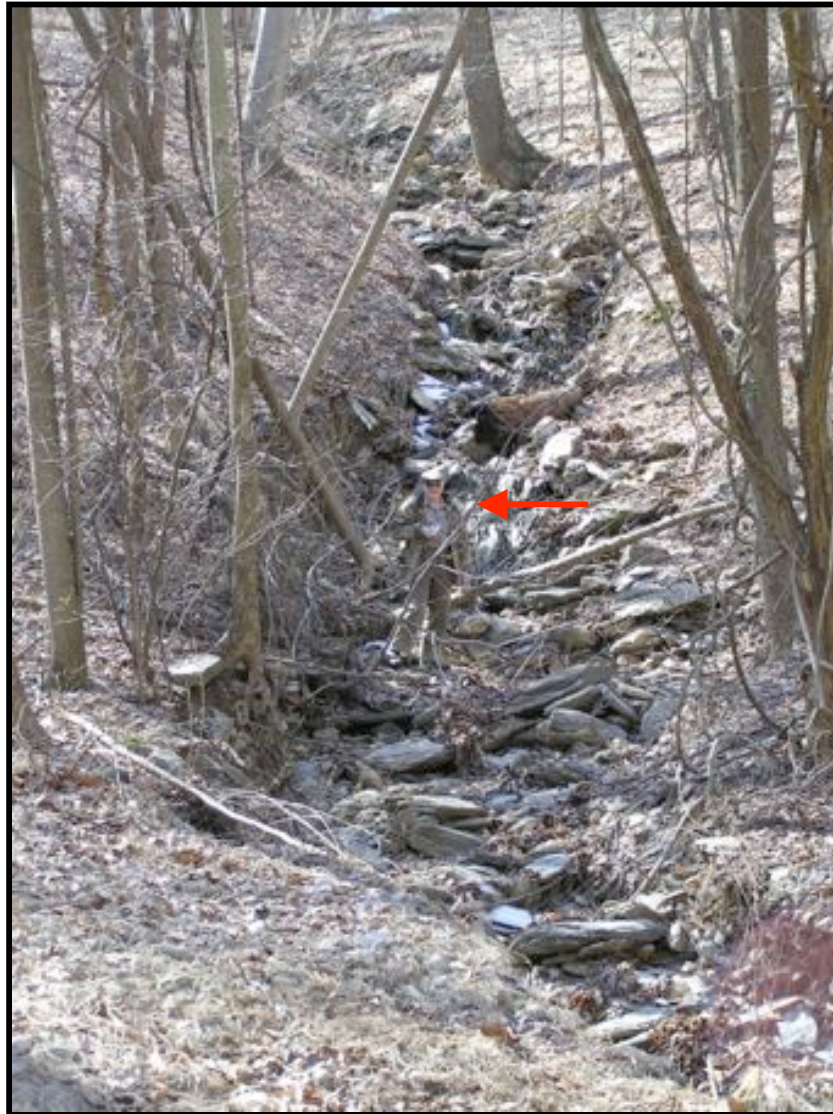
# Erosion below outfall

For scale,  
note the person  
standing in the  
eroded swale.

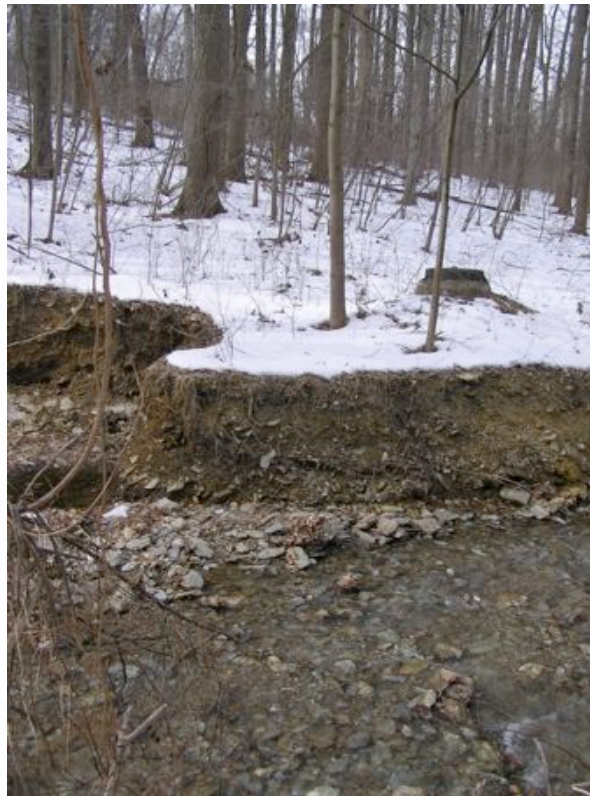
↑  
Erosion of sewer line fill  
in stretch upstream  
from tunnel under railroad

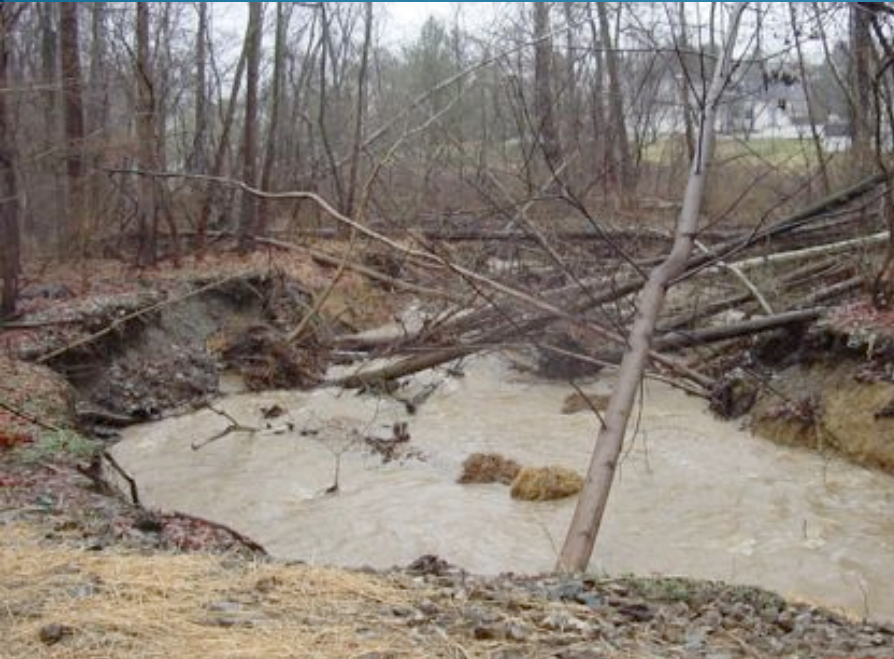
2005 2"+ storm

The powerful flows caused incision of the silt below the roots of the trees along the stream bank in the eroded reach below the elbow in the sewer line, causing them to be ineffective at holding the banks because of undercutting below the roots. This is a common problem in streams located in areas with legacy silt.

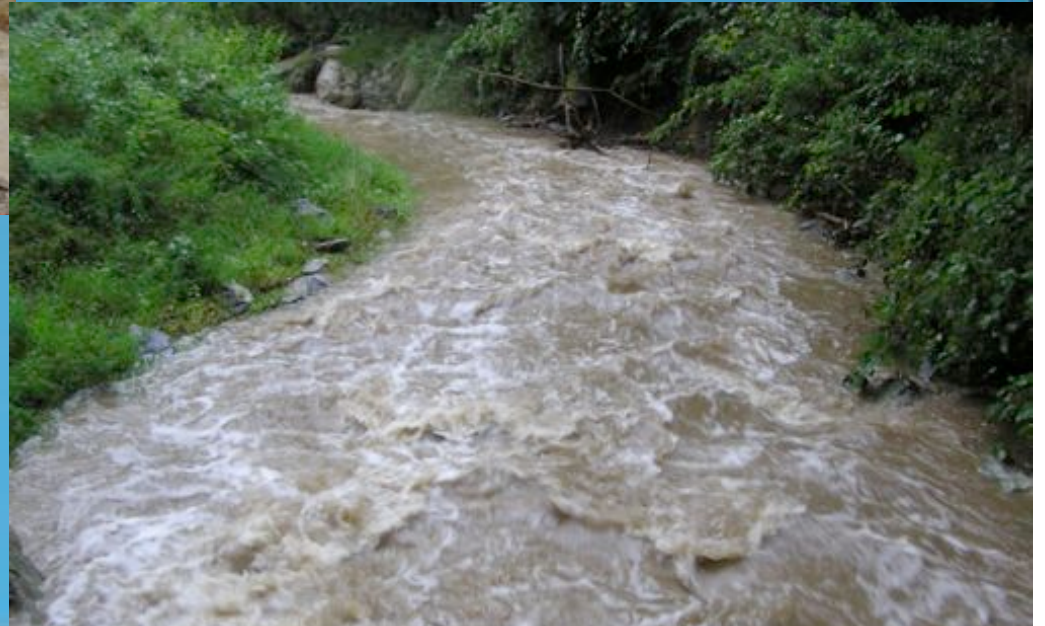
2008 2"+ storm

Eroded stretch along upper part of elbow in sewer line

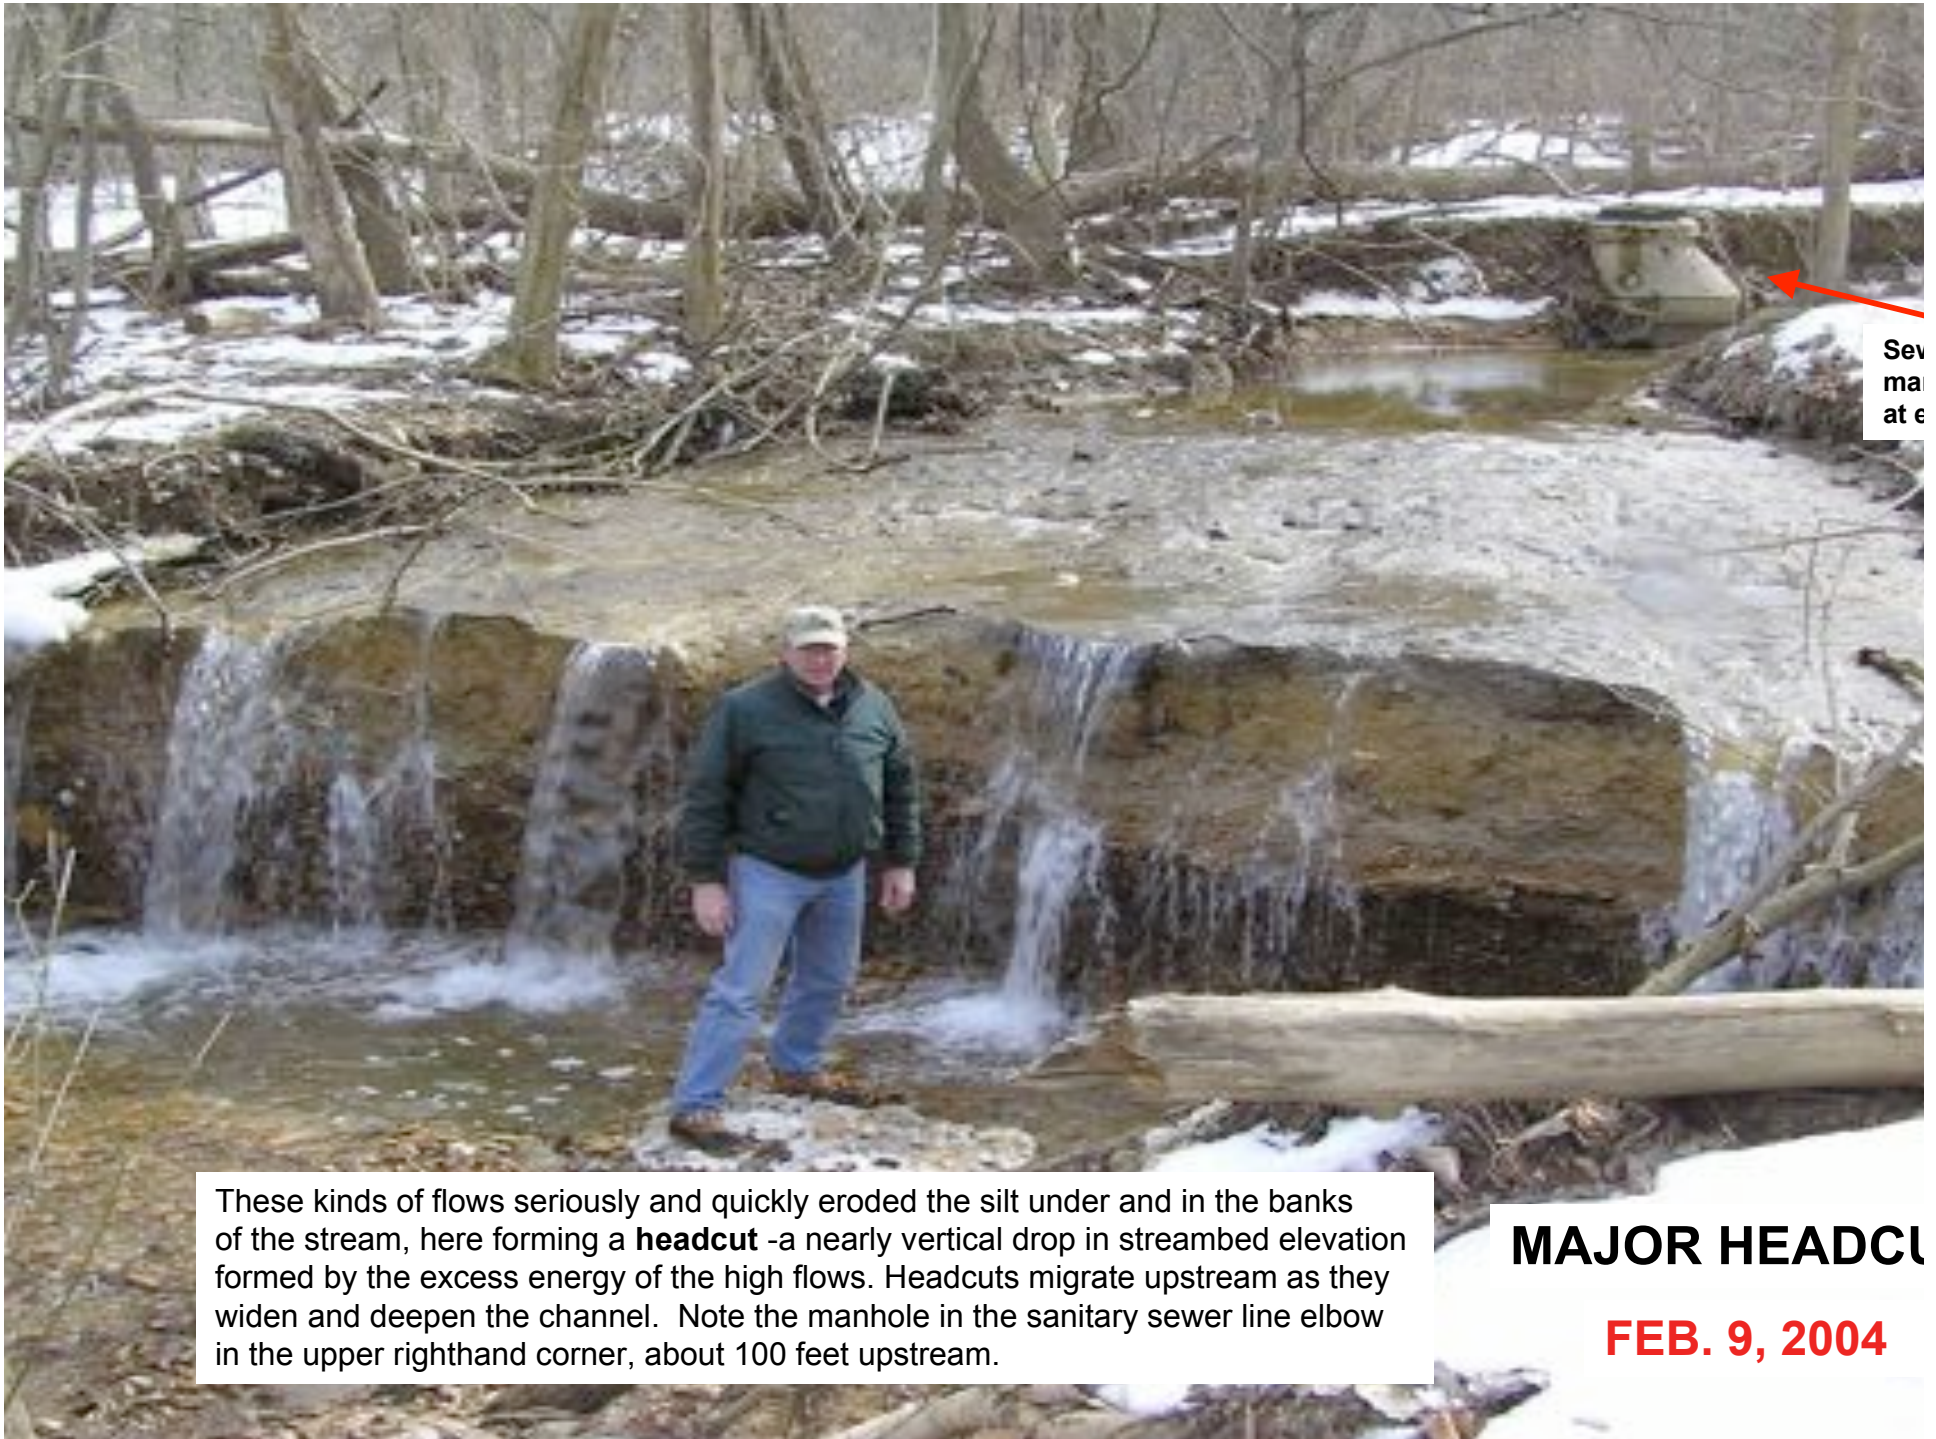
**FEB. 9, 2004**

These kinds of flows seriously and quickly eroded the silt under and in the banks of the stream, here forming a **headcut** -a nearly vertical drop in streambed elevation formed by the excess energy of the high flows. Headcuts migrate upstream as they widen and deepen the channel. Note the manhole in the sanitary sewer line elbow in the upper righthand corner, about 100 feet upstream.

**MAJOR HEADCU**

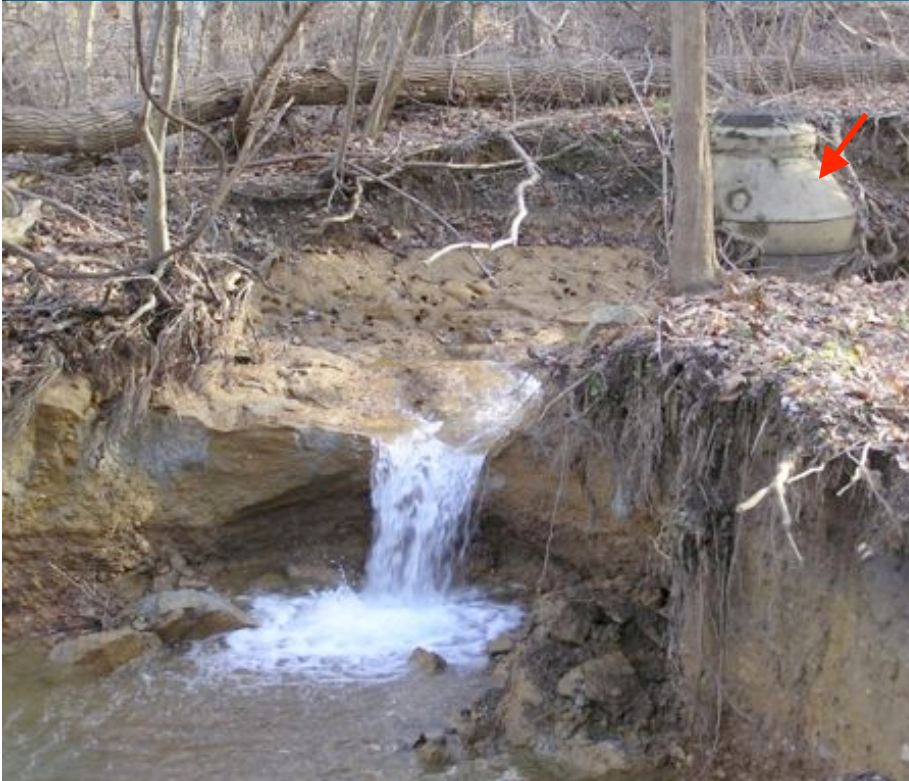
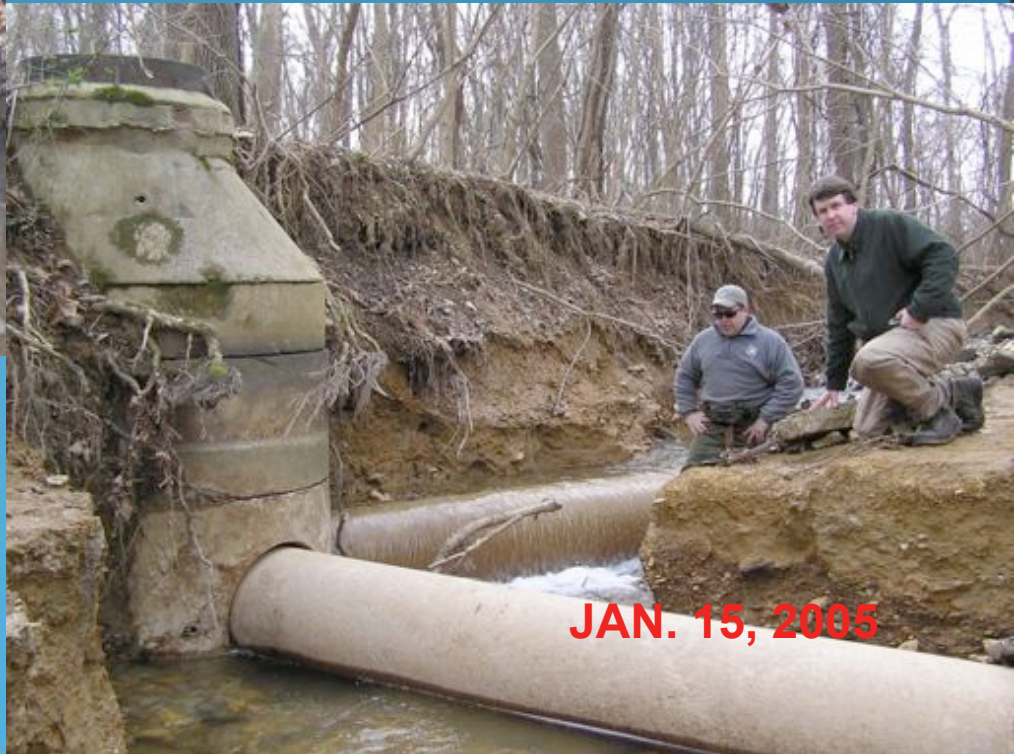
# UPSTREAM MOVEMENT OF HEADCUT

Within a year, this head cut had moved quickly upstream and started to undercut the 1 million gallon per day sanitary sewer line.

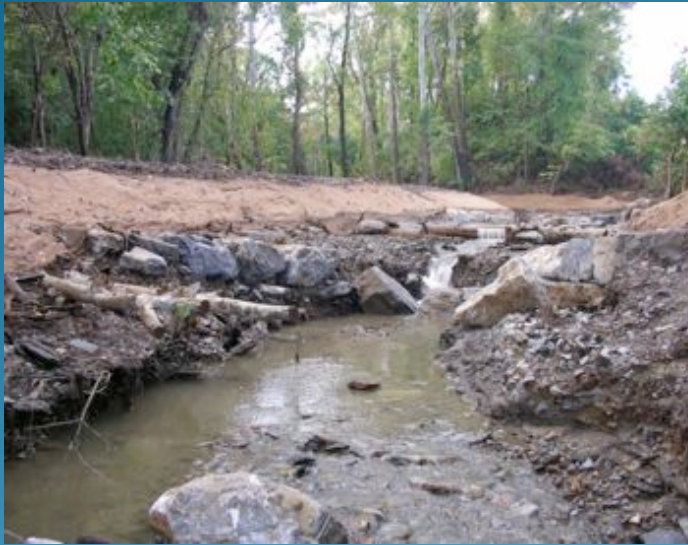
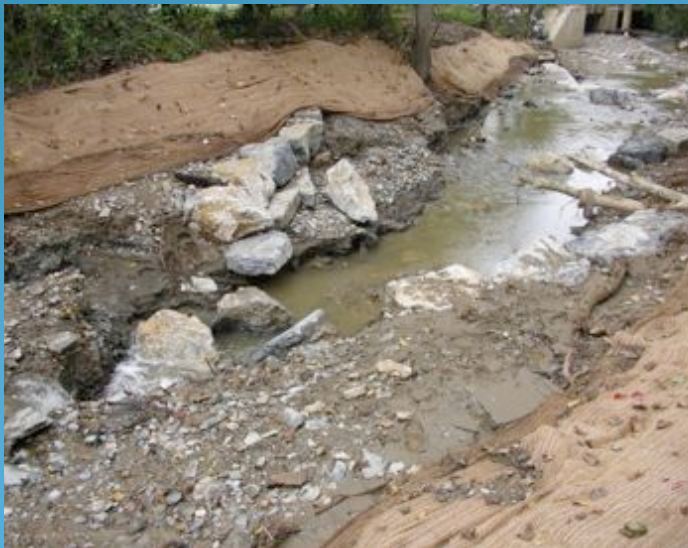
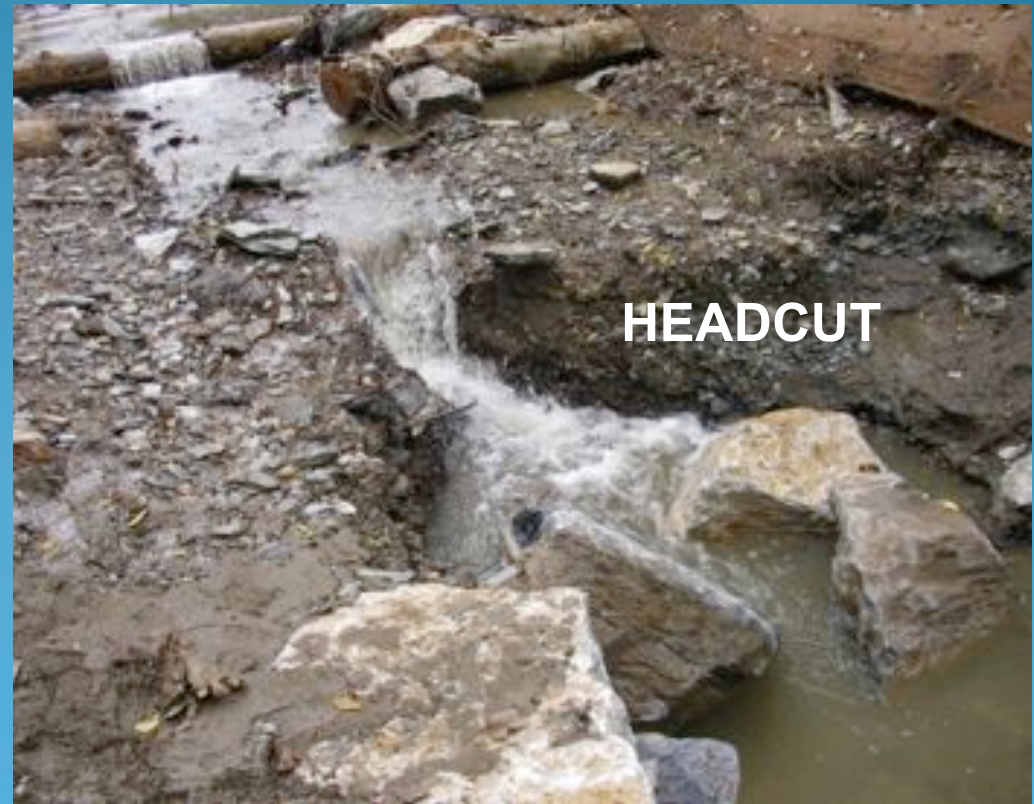
# Heavy Storm Damage to CROSS VANE #9

9/25/2008 before  
construction completion

**HEADCUT**

An above average number of significant rainstorms in the 16 months following the completion of the restoration quickly formed the stream channel; problems started to be revealed within 6-9 months. There were 12 storms in the 1"-2" category and 8 in the 2"-3" category; half of the latter were 2½" or more causing 160+ cfs flows. We photographically monitored the structures after heavy storms to document the outcomes. The first of these rainstorms occurred on 9/25 of 2008 and washed out several structures at the lower end of the reach above Rt 252, as illustrated on the next slide. The photos illustrate the depth of silt below the footings of these lower structures, and the nascent headcut that started to move upstream. The structures had to be rebuilt with deeper footers.

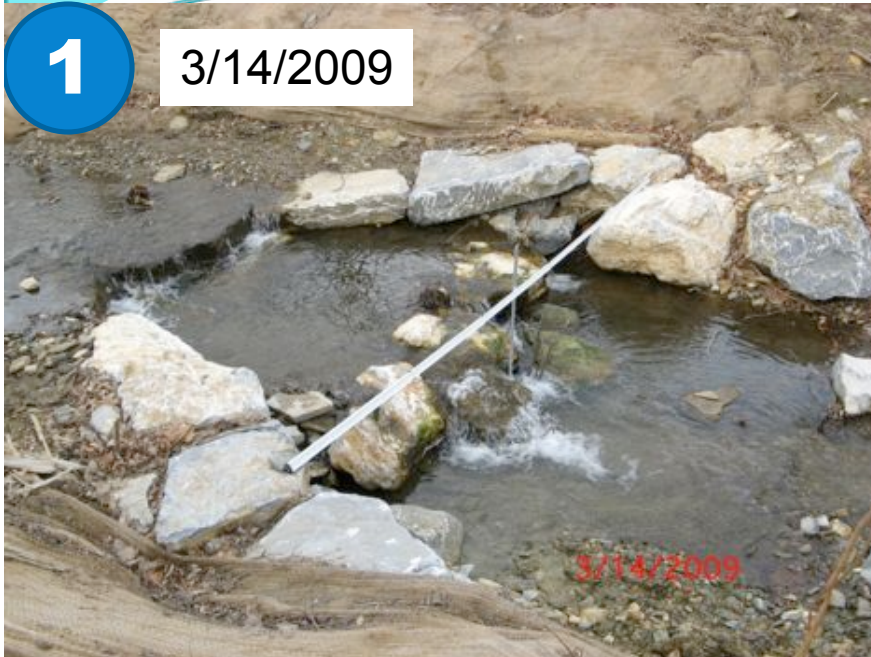
1

On the following slide, in Photo #1 Cross Vane #10, a throated cross vane, the last structure in the restored reach, is shown on 3/14/2009 to be intact and holding grade. By 8/2, the throat, which had been built without any footer rocks, nor keyed in to the arms, and without any backing or underlying geo-textile, had washed out, dropping the level of water in the throat and most likely making it impassable for trout, except perhaps at high water. The arrows in Photo#2 point to areas behind the right (facing downstream) wall of the structure which are beginning to be back cut. By 9/14/2009 two boulders in the right wall were washed out of the structure and by 12/9 three boulders had been moved, and a forming head cut at that point is poised to move upstream.

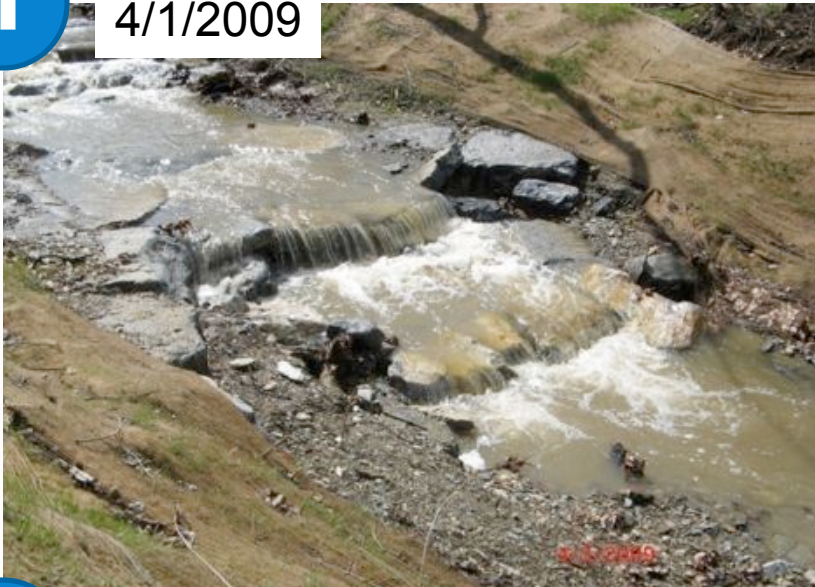
1

On the next slide in Photo #1, Cross Vane 9a (a **double** throated vane ) is shown intact on April, 2009. This was one of the structures that had been washed out in September of 2008, and rebuilt with deeper footers, but without any underlying or backing geo-textile. By 6/19 the lowest throat had washed out and by 7/29 the center throat followed. The level of the water below the backbone dropped substantially, and high water continued to move rock as shown in photo #4.

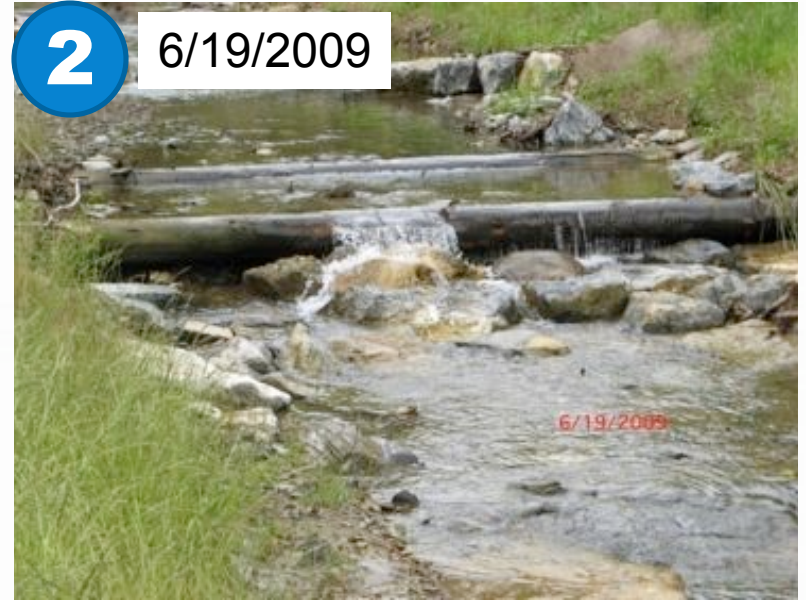
2

The last log bump on the restored reach, positioned near the top of the final 6% drop, shown in Photo #1 on the next slide, was functioning as of 4/3/2009. Note the heavy bedsill that had been lain on the stream bottom below the log. However, by 6/19 some of the boulders at the foot of the log had washed out and water had begun moving under the the log. By 10/28 the log had been completely undercut and was no longer functioning as a grade control. Several things were wrong with our log bumps. First, the diameter of the logs used were less than the proposed average depth of the stream. Usually, where logs are used in this fashion, they are stacked two deep and pinned with rebar. Second, they should be backed with geotextile to hold the upstream fines in place. It is also important that the log (s) be deep enough into the streambed to that they are continually wet, otherwise the wood will rot prematurely.

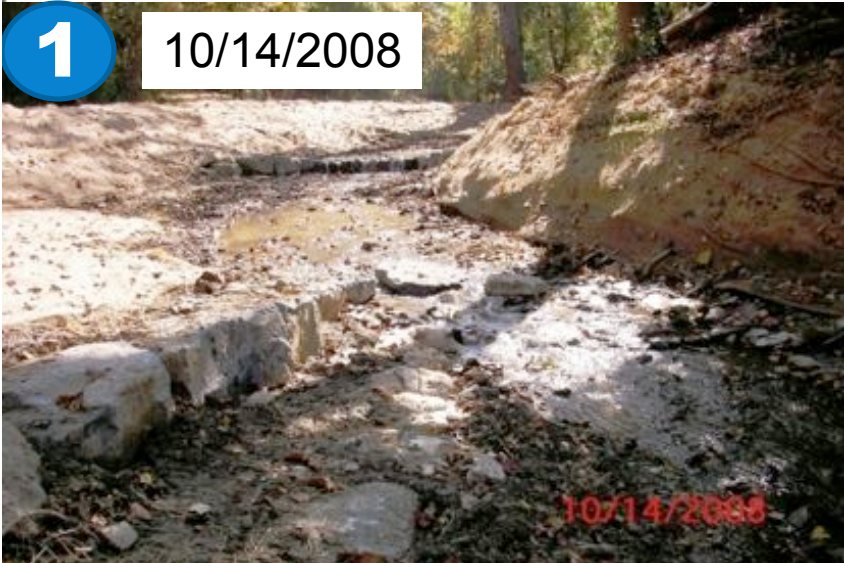
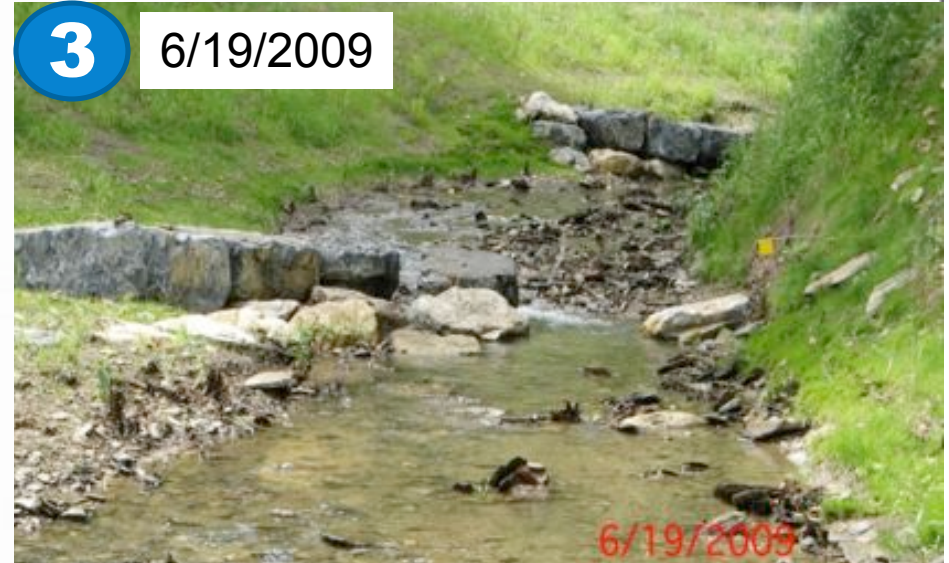
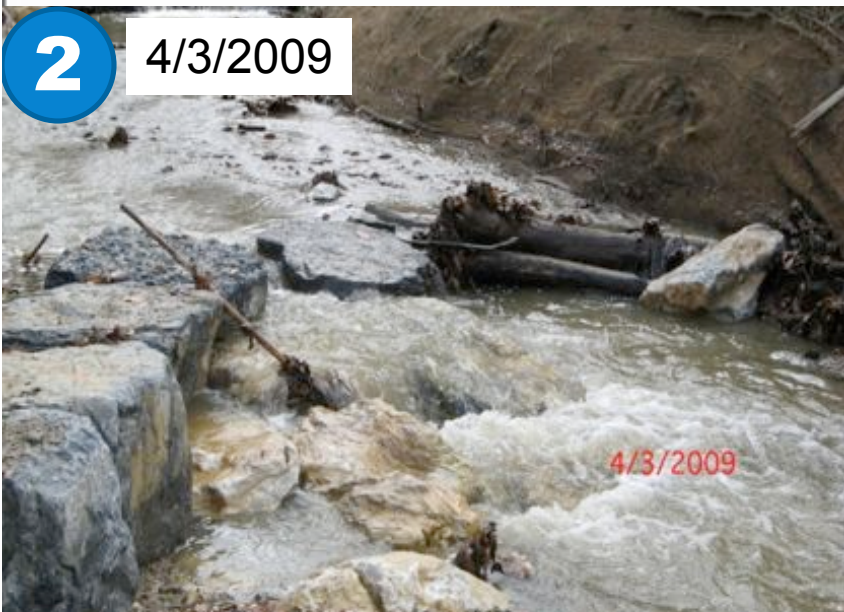
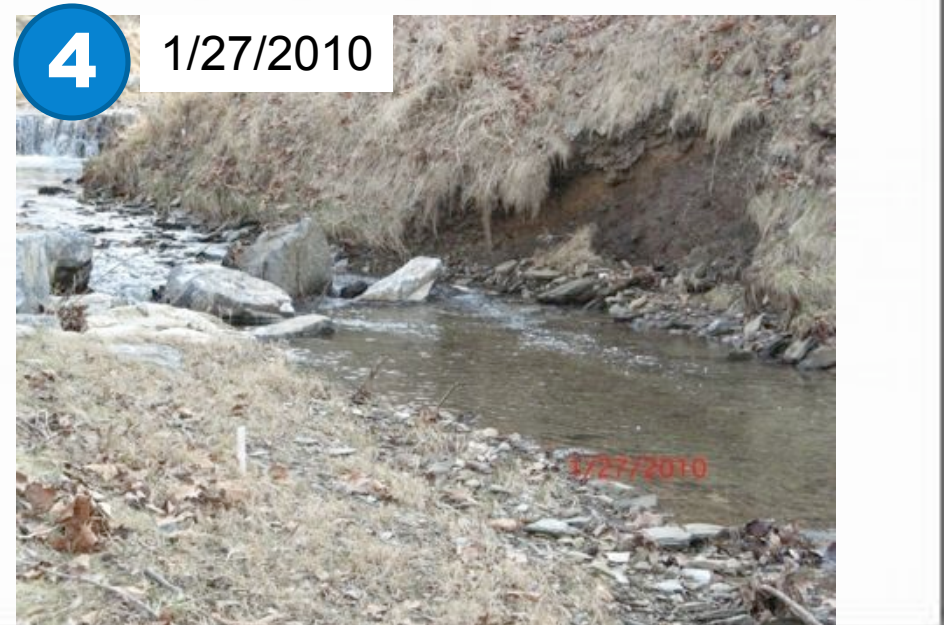
# J-Hook #3

J-Hook #3, near the top of the canyon, is shown in Photo #1 on the next slide on 10/14/2008, shortly after it was built. The stream bed had not yet really formed. By 4/3 of 2009 it is clear that the water was trying to move to the outside of the hook. We found that this was the tendency of most of our J-Hooks, probably because the banks could not withstand the high shear stress when the water was moved to the outside of the hook prior to vegetation establishing itself. We tried to move a log into the opening that had been created by the high flow, but it was soon washed out. A deep scour hole was formed in the slot, and sometime after 6/19 the large rock on the end of the hook was rolled into it by high water. This created even more pressure on the opposite bank which became significantly eroded. Eventually we removed the large rock so that water was no longer being forced to outside and the erosion was diminished.

In retrospect, this J-Hook probably should have been placed to force water toward the right bank, away from the high bank on the left. As we found out later, J-Hooks are probably not appropriate structures for a stream reach with this kind of slope.

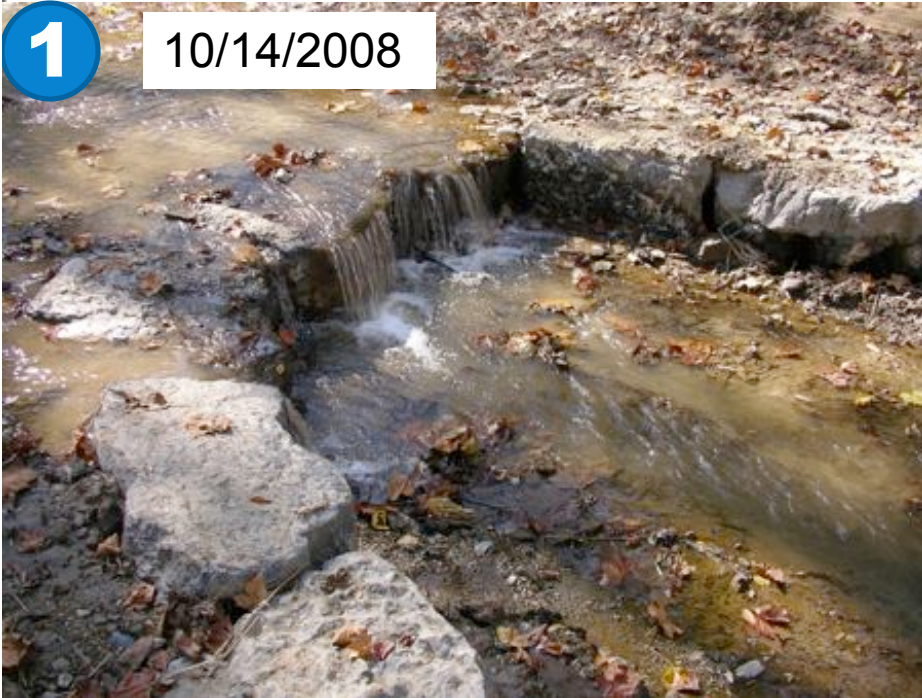
1

Cross Vane #4, at the top of the canyon, is shown on 10/14/2008 shortly after the restoration was completed. The stream channel had not really yet been formed. In an earlier slide we showed that the silt just below Cross Vane #4 was very deep. ←

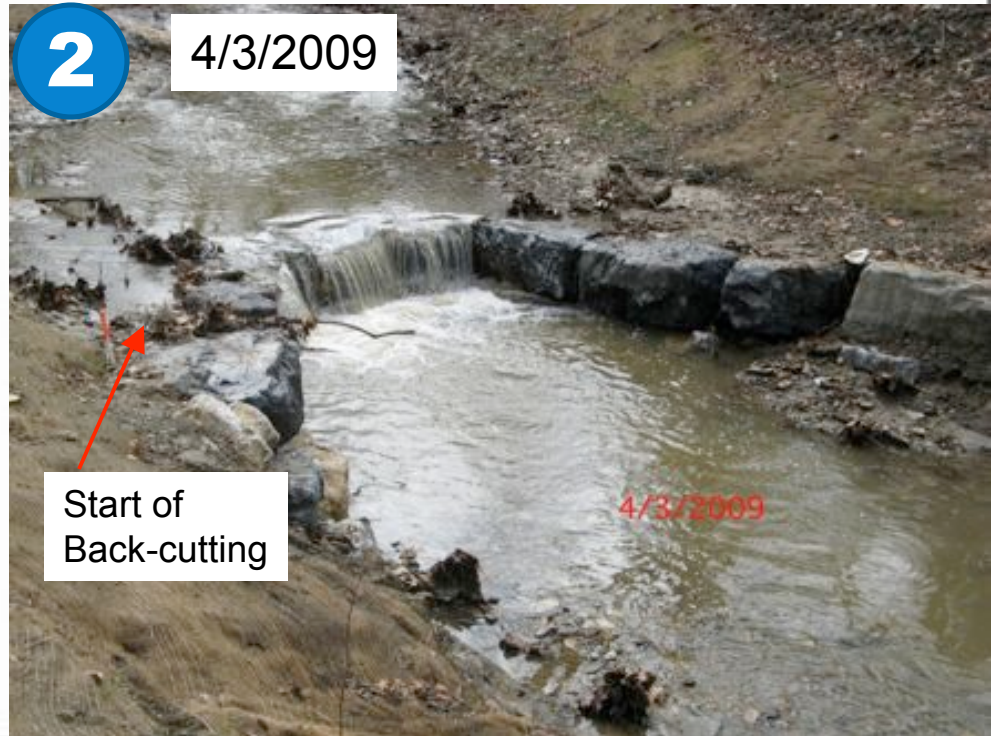
2

By 4/3/2009, a deep plunge pool had formed within the vane and the water drop had become significant. Note that there was already some evidence of back-cutting on the right side of the vane (looking downstream). →

Start of Back-cutting

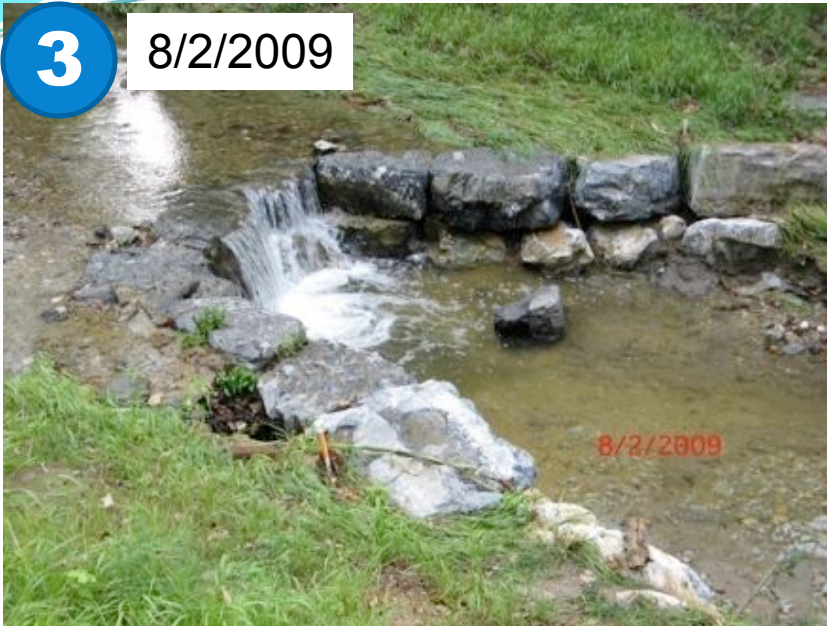
3

On Photo #3 on the next slide we see that by 8/2 the plunge pool had gotten so deep it was well below the footers of the vane and the back-cutting on the right side was all the way down to the water level in the scour hole. By 10/29 part of the right side of the vane had been collapsed into the scour hole.

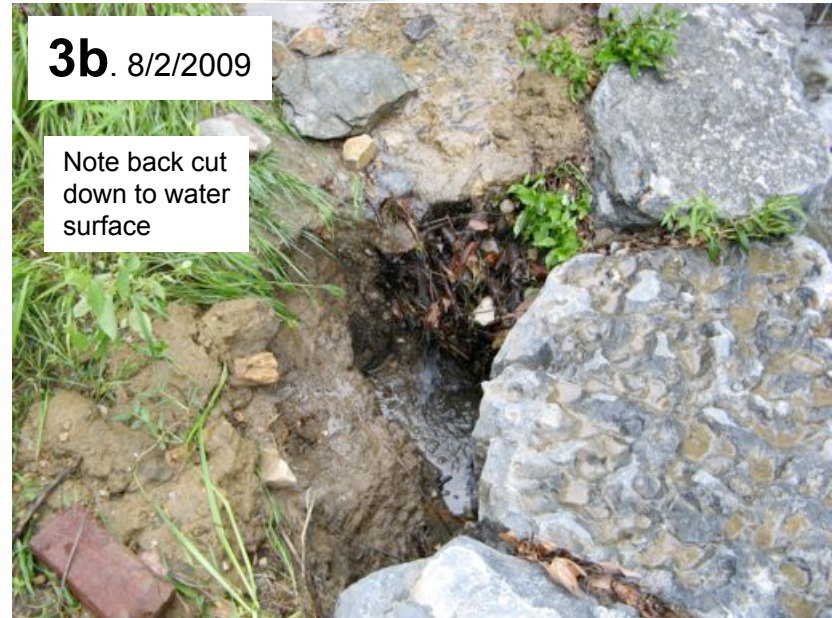
3b. 8/2/2009

Note back cut down to water surface

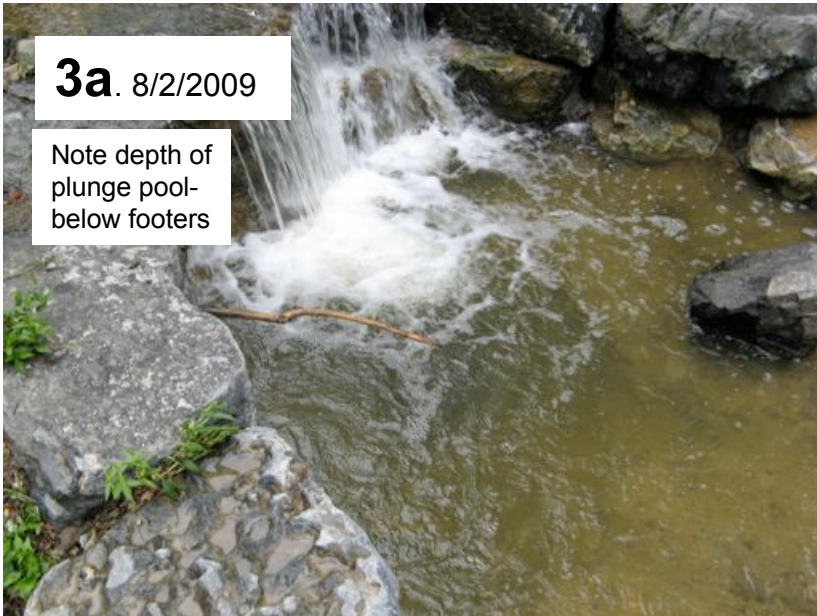
3a. 8/2/2009

Note depth of plunge pool below footers

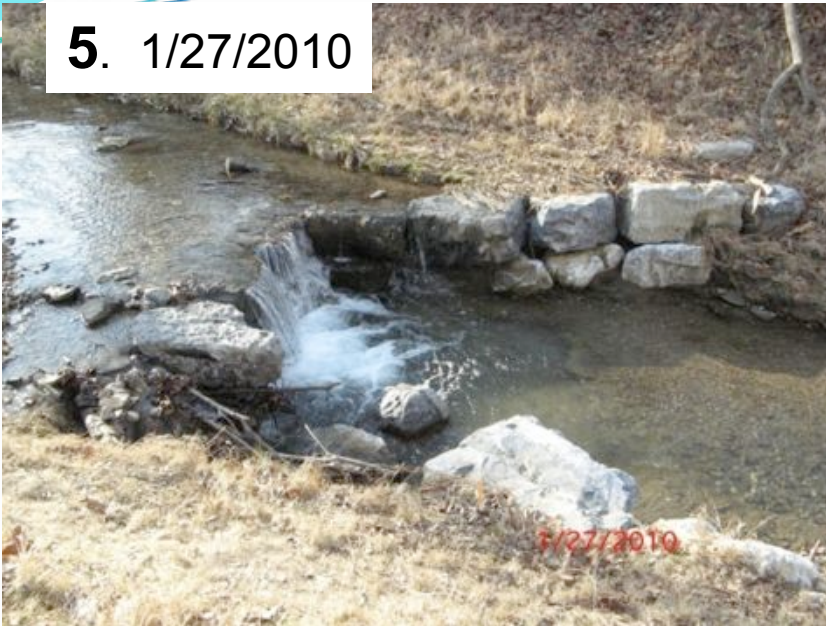
**5.** 1/27/2010

The wall has continued to collapse and a head-cut has formed and started upstream. The debris from the collapse and head cut has nearly filled the deep scour hole.

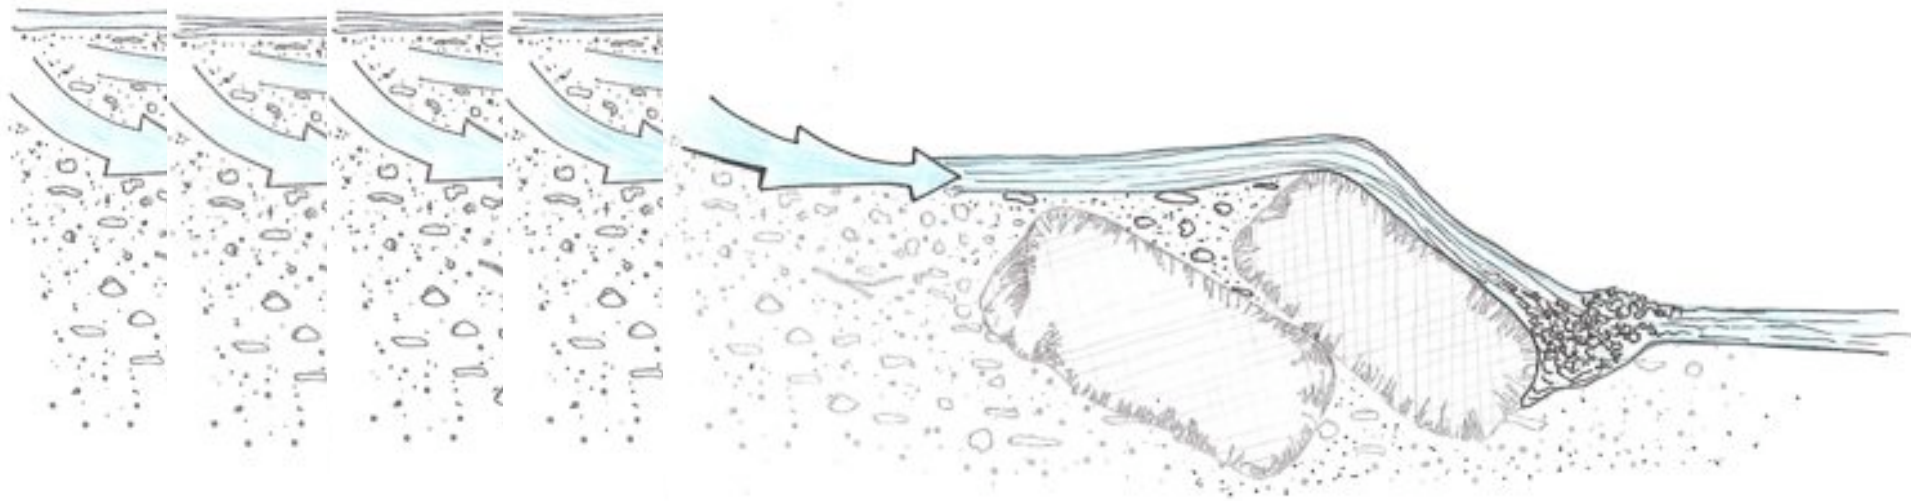
On the following slide series, we illustrated what we believe is the mechanism of failure. As high water pours over the vane, the scour hole deepens. Similarly, water can erode behind the rocks in the vane and can jet through the openings in the boulders. There was no geo-textile or chinking of these openings with smaller rocks to prevent this jetting. It is standard practice to do at least one or both of these backings on this kind of structure, especially on silt based streams, to prevent just what happened. As the the scour hole gets deeper (there was not rock bottom in the scour hole underlain with geo textile to limit the scour depth), and the back-cutting worsens, heavy water rolls the large rocks into the scour hole and the structure ceases to hold grade and becomes the source of a head cut.

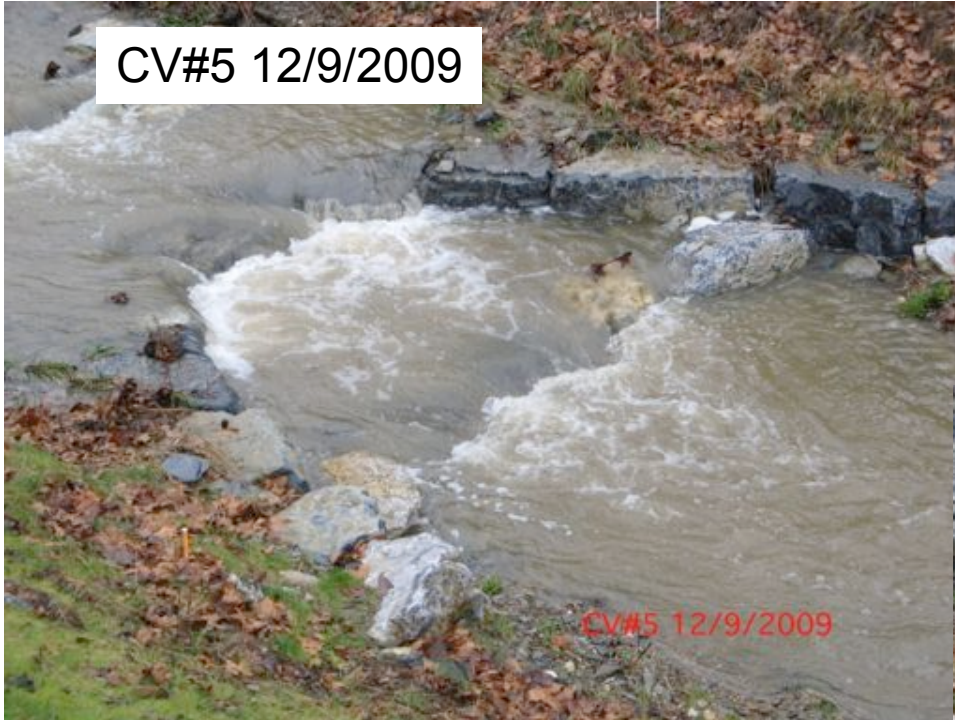
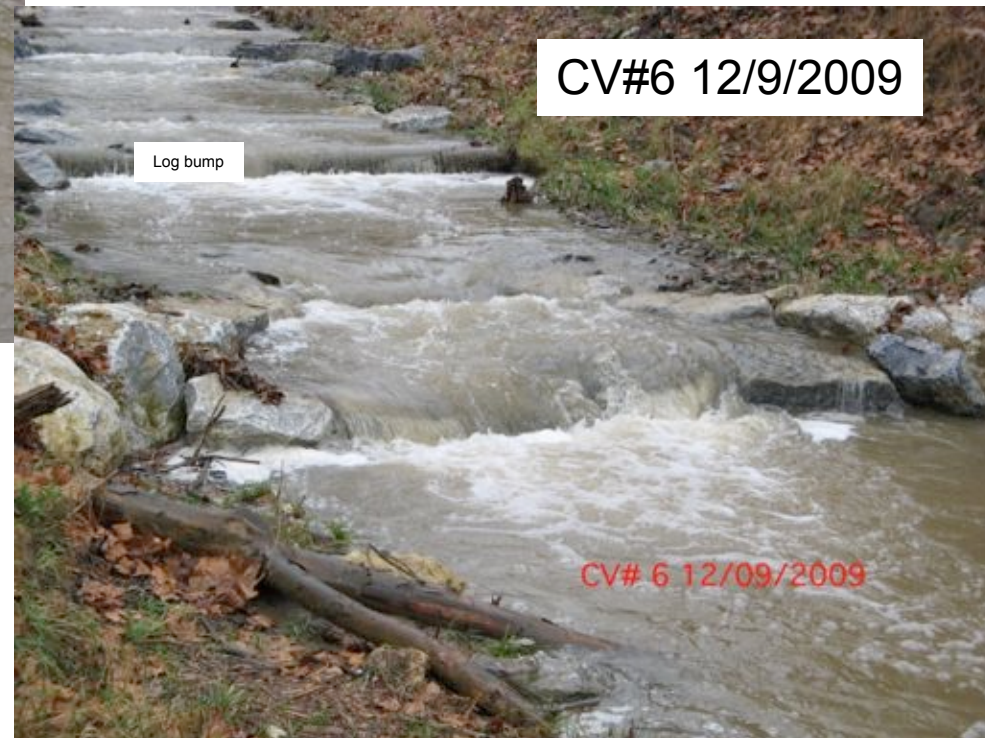
# Some Cross Vanes and Log Bumps in the canyon area survived

These structures in the canyon survived into 2010 undamaged, although the log bumps shown on the right below did partially undercut and needed a repair fill on the upstream side. We wonder how long these structures will survive given the inadequate construction.

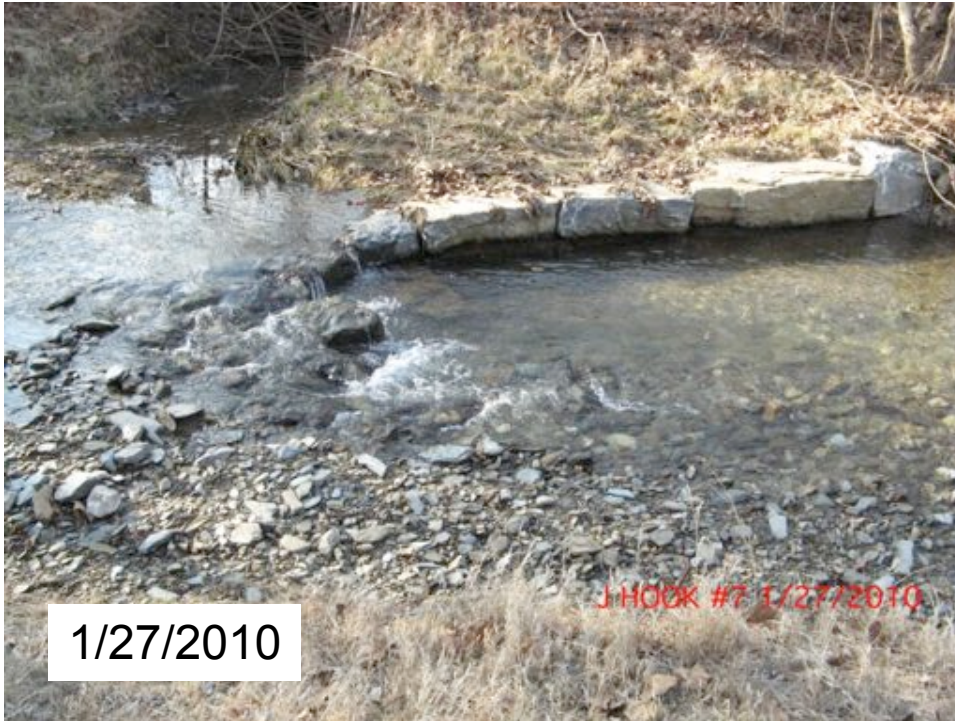
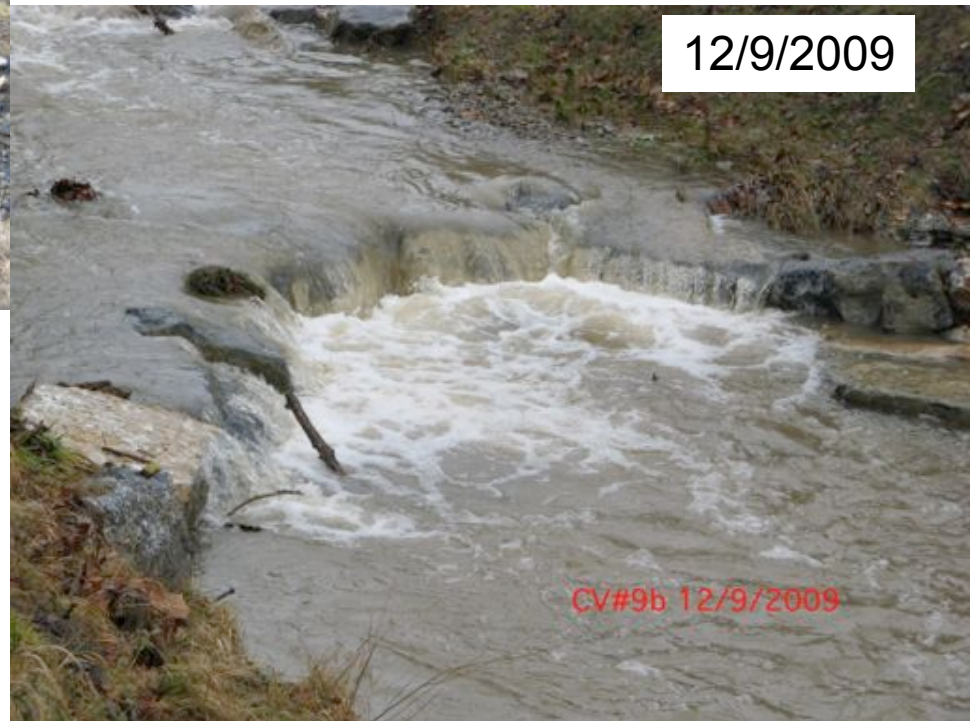
J-Hook #7 and Cross Vane # 9b also survived intact into 2010

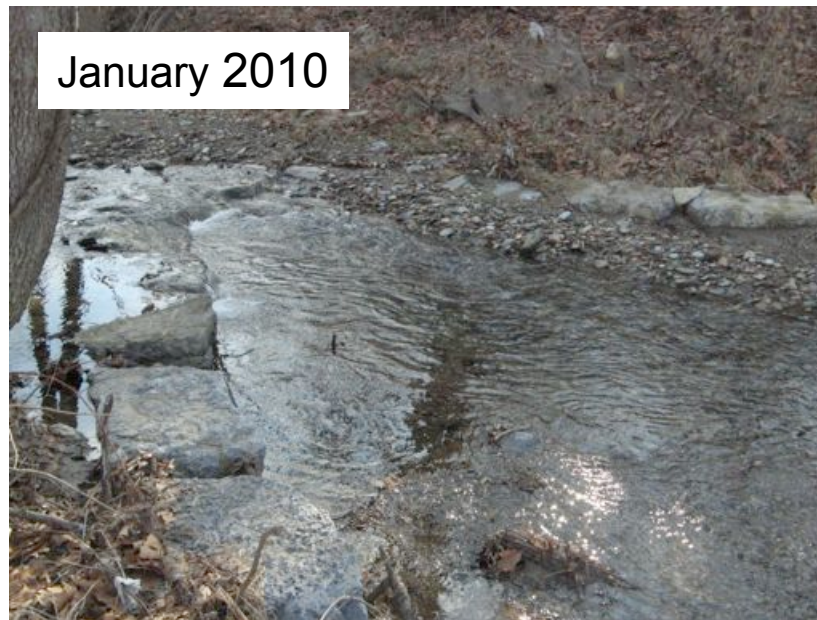
Cross Vane #7, at the bottom of the canyon where the slope abruptly levels and the flood plane widens, is starting to fill in.

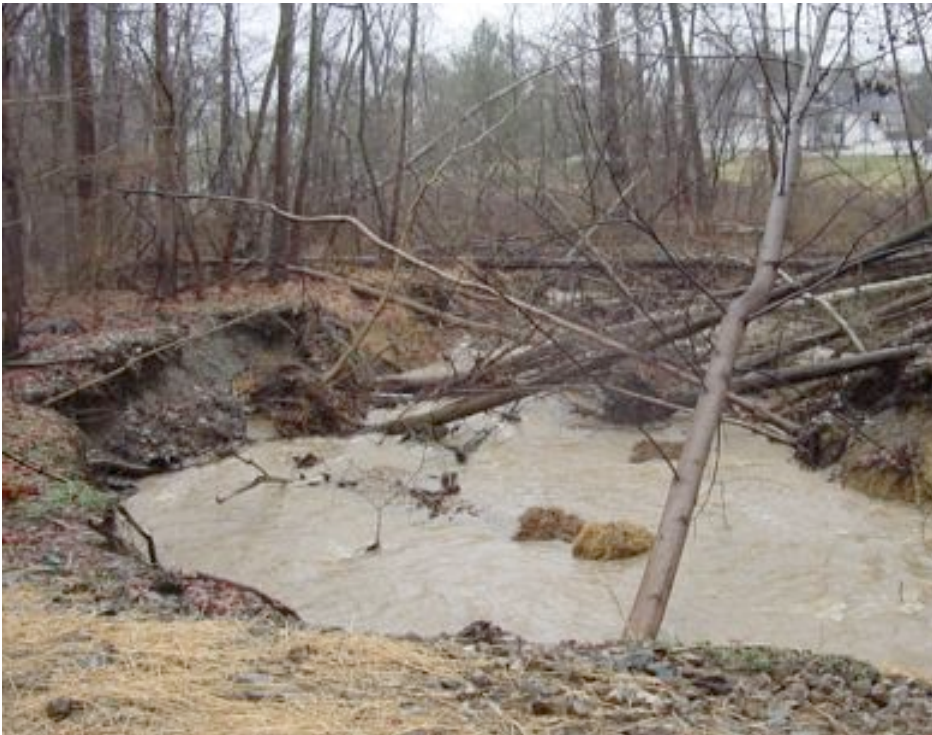
### OLD CHANNEL

In spite of the problems, we have progressed from the disaster of the old channel on the left, and the potential for an environmental catastrophe if the sewer line had collapsed, to a more controlled high flow through the new channel away from the sewer line, shown on the right. The problem is to now fix the channel with an appropriate design so that the control can be sustained until streamside vegetation can grow and the biological habitat continues to improve.
