# Lower Crabby Creek Restoration

Learning the Art and the Science

This slide presentation is the first part of an on-going account of the restoration of Crabby Creek, a small cold water feeder stream to Little Valley Creek, just north of Paoli, Pennsylvania, in suburban Philadelphia. The stream is part of the Valley Creek Watershed that includes Valley Forge National Historical Park. Crabby, a well wooded brown trout nursery stream, suffers the ravages of storm water run-off from the impervious surfaces of the development in its headwaters. By 2008 the erosion of about 3500 cubic feet of streambed had undercut a sanitary sewer line that carries a million gallons of waste per day, creating a potential environmental disaster.

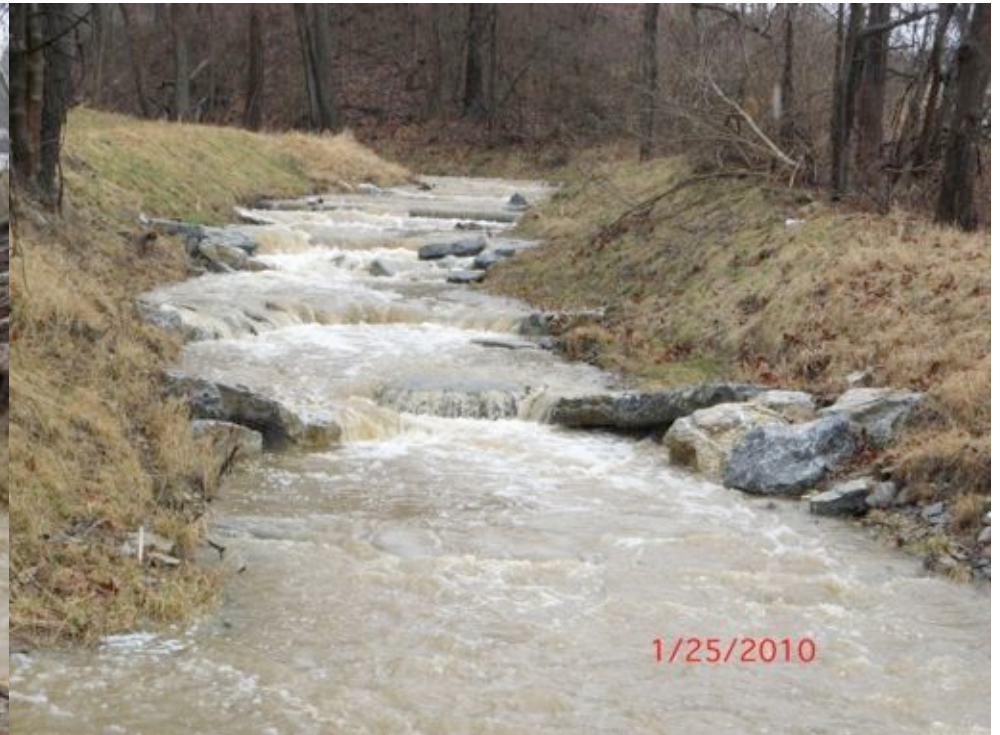
### NEW CHANNEL

In spite of the problems, we have progressed from the disaster of the old channel on the left, and the potential for an environmental catastrophe if the sewer line had collapsed, to a more controlled high flow through the new channel away from the sewer line, shown on the right. The problem is to now fix the channel with an appropriate design so that the control can be sustained until streamside vegetation can grow and the biological habitat continues to improve.
