## MEMORANDUM

**SUBJECT:** VALLEY RUN RESTORATION OPPORTUNITIES DURING UNIVERSITY CONSTRUCTION

**DATE:** MAY 11, 2016

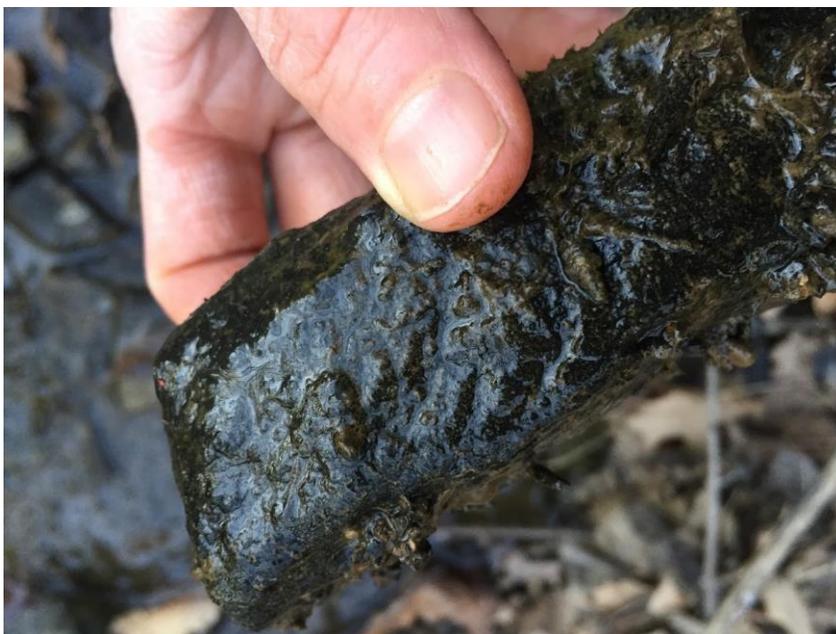
Photo 1. Benthic invertebrates (caddisflies) observed in South forested headwater tributary in “the Triangle”

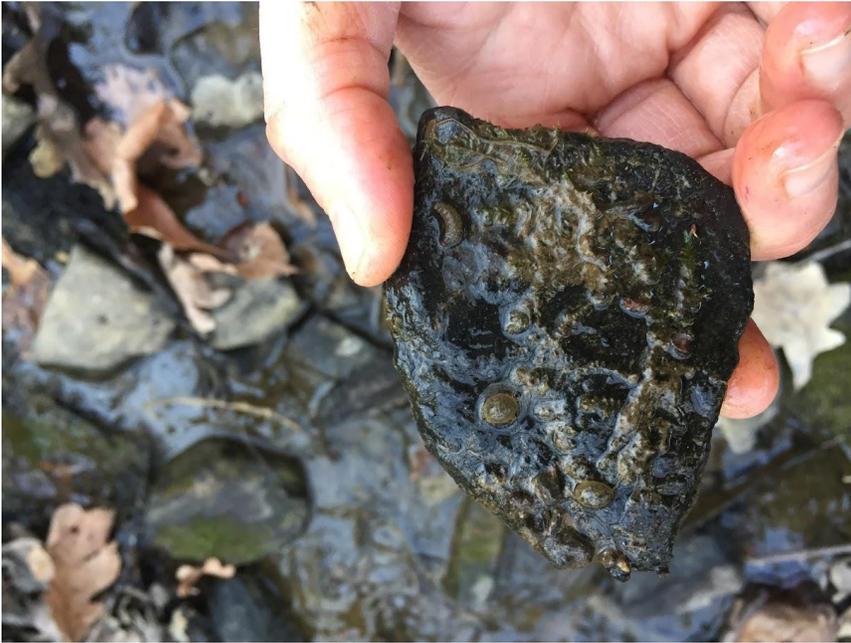
*Photo 2. Water snipe larvae and snail eggs observed in South forested headwater tributary located in "the Triangle"*

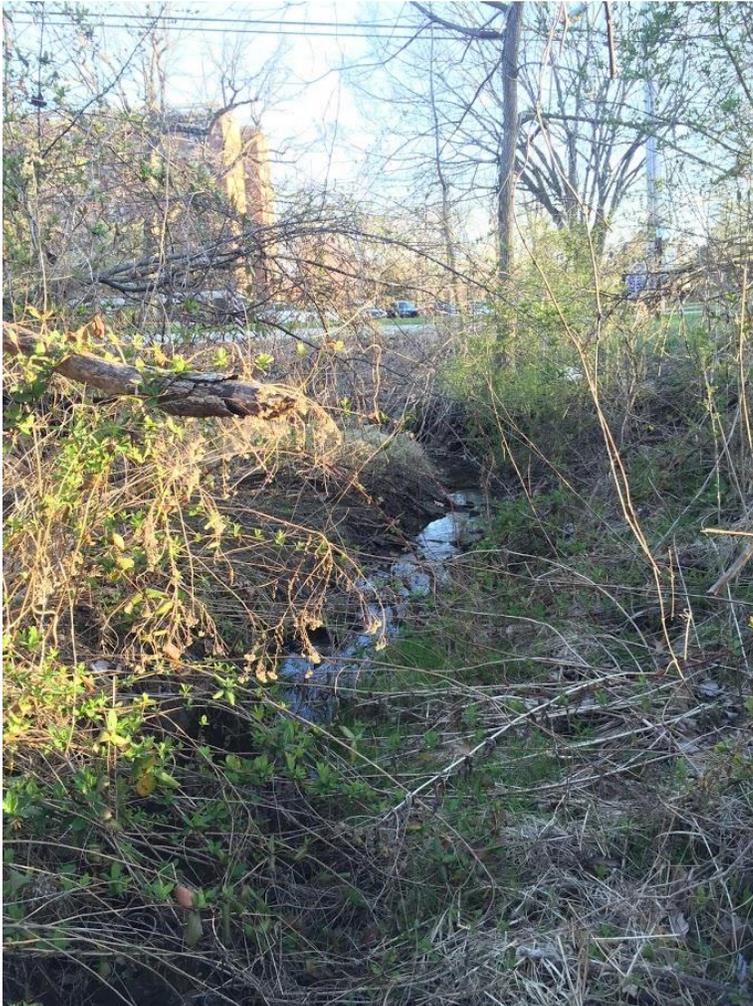
*Photo 3. Taken along bank of small forested headwater tributary facing DS toward South Ithan Avenue. This tributary is located within "the Triangle"*

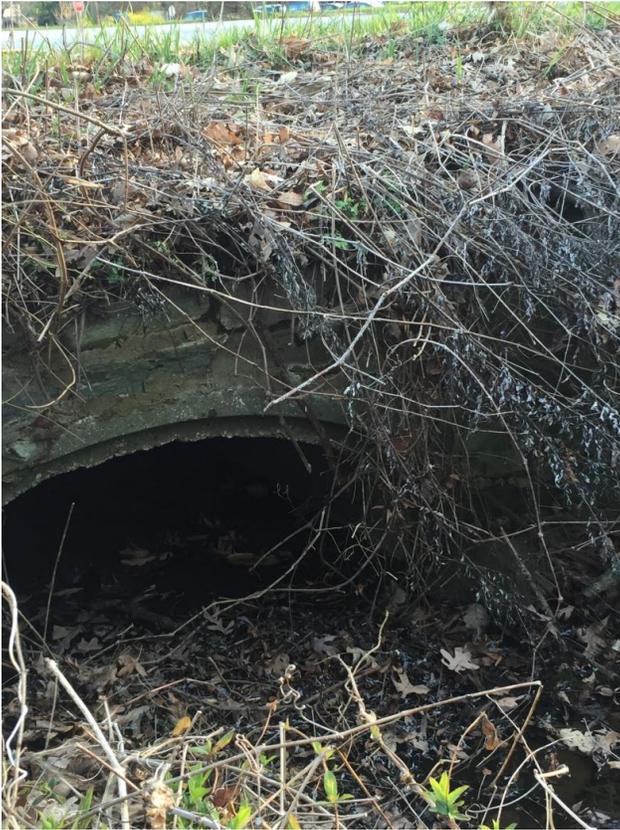
*Photo 4. Culvert under South Ithan Avenue which the forested headwater tributary flows through*

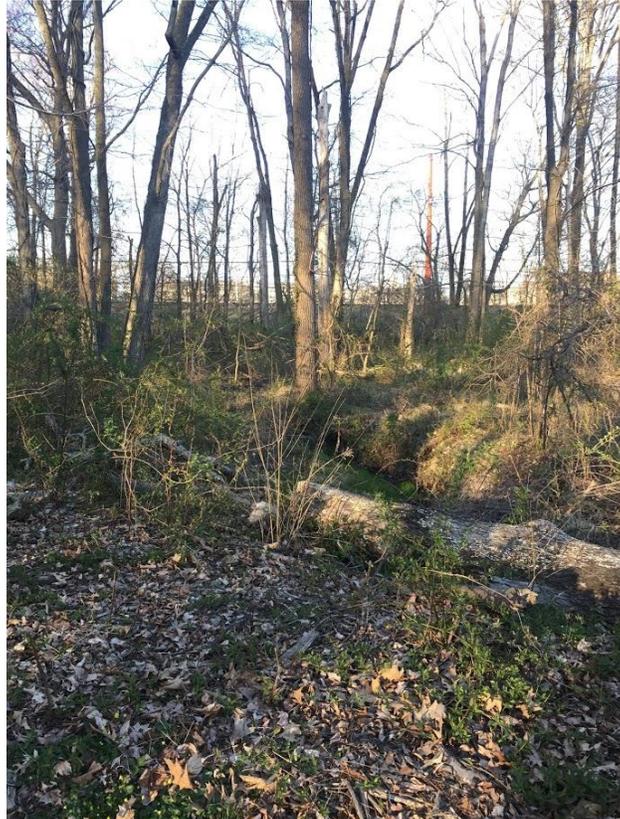
*Photo 5. Forested South tributary facing upstream towards the Septa ROW and utility corridor (looking back towards the Villanova parking lots)*

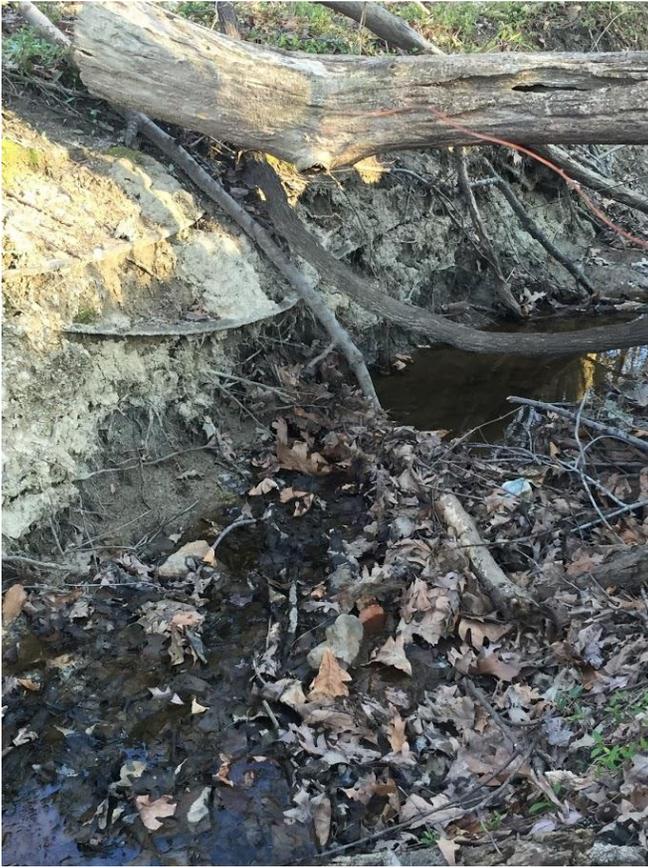
*Photo 6. Erosion in forested South tributary and evidence of high stormwater inputs from Rte 30 runoff and the northern Villanova parking lot.*

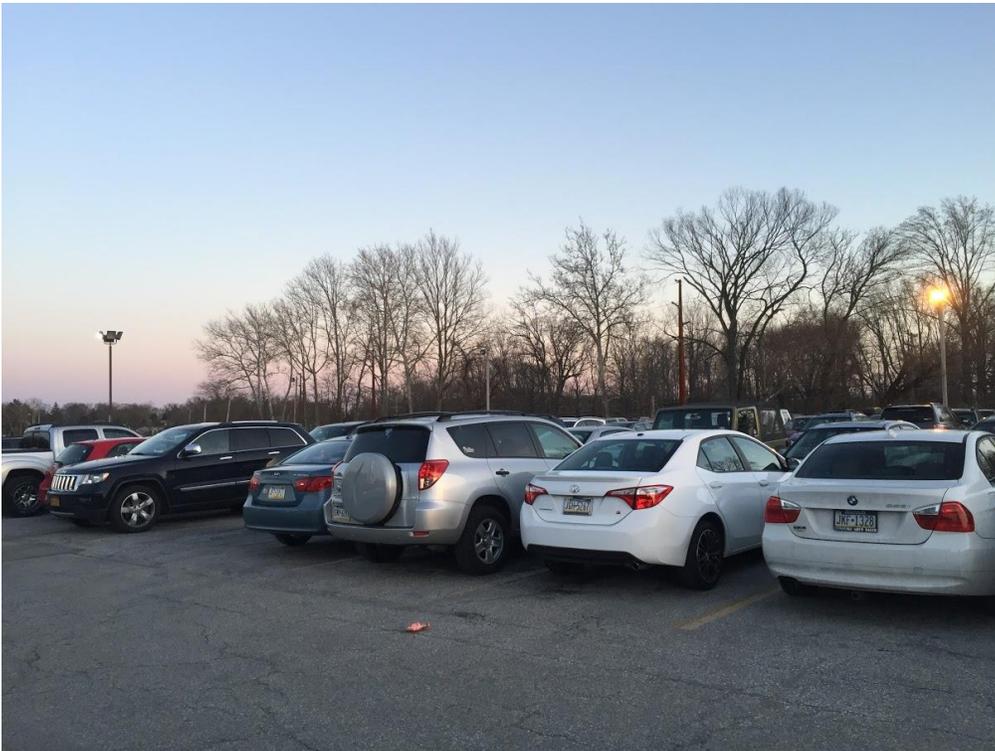
*Photo 7. Villanova parking lot located just south of Rte 30 where buried stream is located that feeds into the tributary in "the Triangle" South of Septa ROW (facing South towards the Septa ROW and utility ROW)*

With renovations of the parking lot being planned, we strongly encourage Villanova to explore the daylighting and restoration of this headwater stream within the footprint of the Villanova parking lot which would have tremendous benefit to the watershed and which also may prove more cost effective than the maintenance of a very old culvert and replacement by a new culvert. American Rivers provides an excellent overview on daylighting that is available at this link: <http://www.americanrivers.org/wp-content/uploads/2014/04/daylighting-streams-report-2.pdf>.

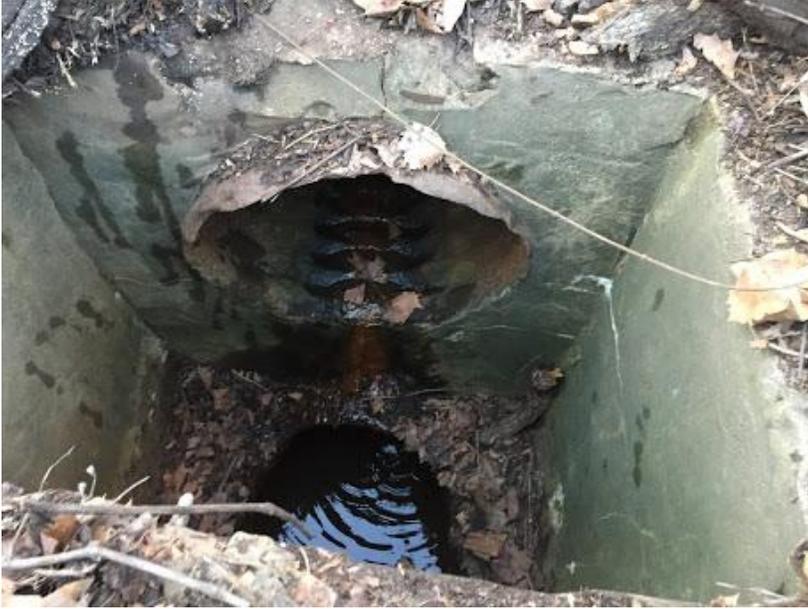
DRN documented Outlet A has a junction from a pipe that we believe runs under the Villanova parking and then flows under the Septa ROW flowing directly into the forested tributary in “the Triangle”.

*Outlet A flow originating from under Villanova parking lot with trickling water that we believe flows under the Septa ROW (via a pipe) and directly into the South forested tributary in “the Triangle”. The pool of water in photo was approx. 13 inches deep.*

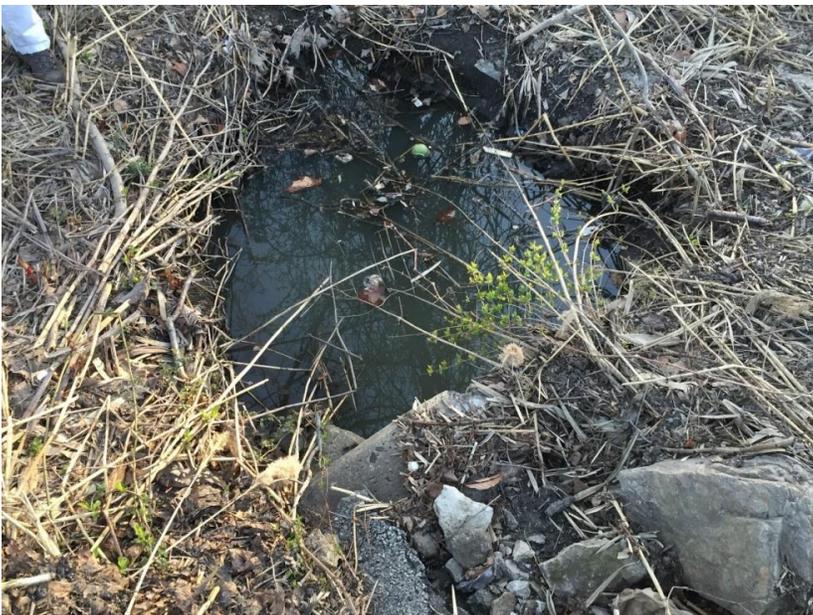
Outlet B, which also appears to collect and flow under the parking lot is located east of Outlet A and had a very low baseflow running adjacent and in an eastward direction along the the Septa ROW to South Ithan Ave. This above ground tributary is dominated by *Phragmites*, has evidence of trash and debris dumping within it, has very little riffle habitat, is eutrophic, and is confined between the Septa ROW and parking lot – conditions are poor. However, there was evidence of limited stream benthic life on the few cobble sized rocks that were examined along it. This tributary with erosion noted along the banks also has severe inputs from stormwater likely flowing off Rte 30 and the parking lot – see the location of highway storm drain grate maps on map below. Outlet B is likely another headwater spring/tributary that originates from under the parking lot.

*Photo 8. Outlet B that has low flow running parallel the Septa ROW (railroad) in easterly direction*

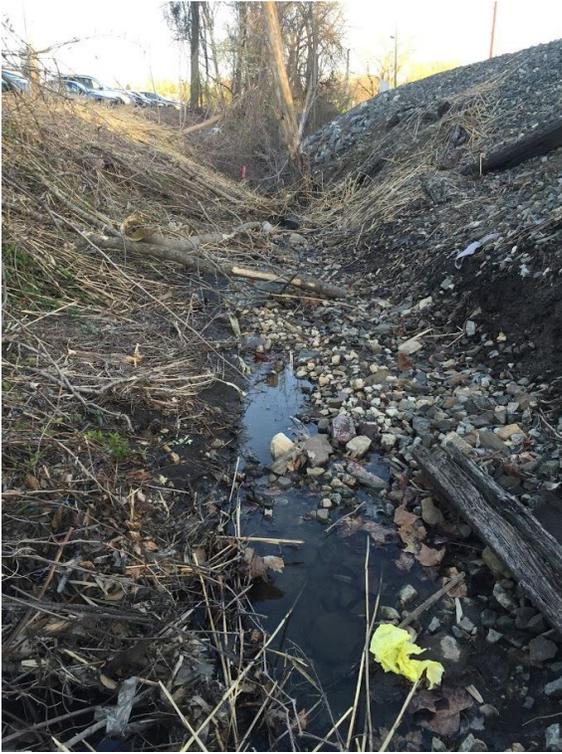
*Photo 9. Outlet B seep or tributary that flows easterly along the Septa ROW*

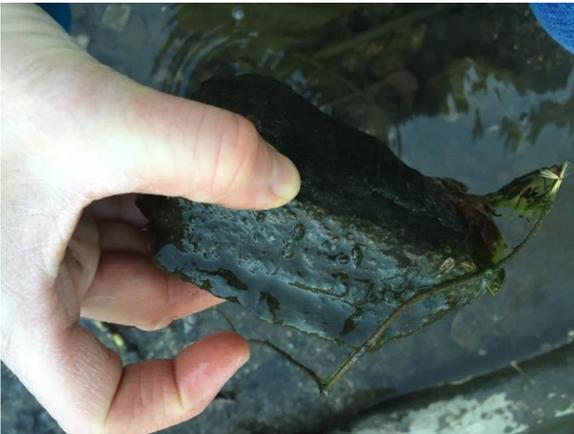
*Photo 10. Stream macroinvertebrates and algae in Outlet B tributary running parallel the Septa ROW*

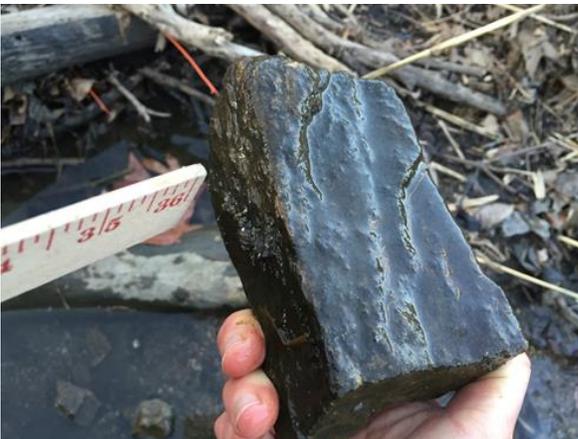
*Photo 11. Evidence of net spinner caddisflies – in tributary originating from Outlet B*
