Bishopville Pond

Restoration of Aquatic Life Movement

Joe Berg, Biohabitats
Keith Underwood, U&A Associates
Kevin Smith, Md DNR
Roman Jessian, Md Coastal Bays

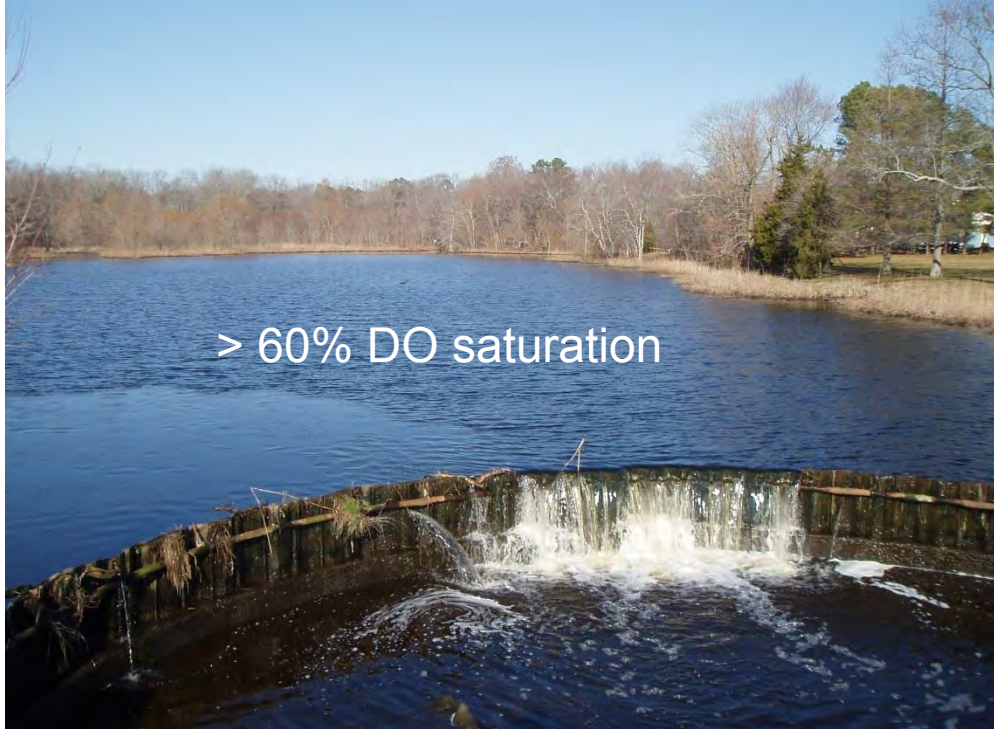
> 60% DO saturation

Water Quality issues, i.e.,
Dissolved Oxygen
Problems in Summer

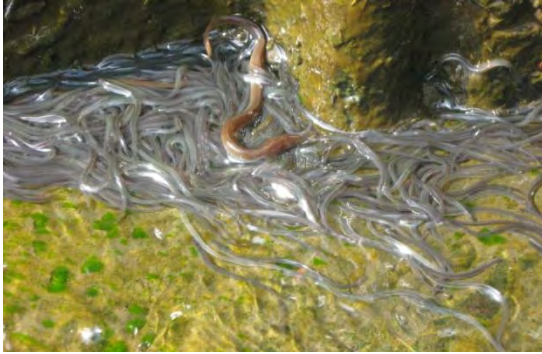
Elvers attempting to climb dam wall

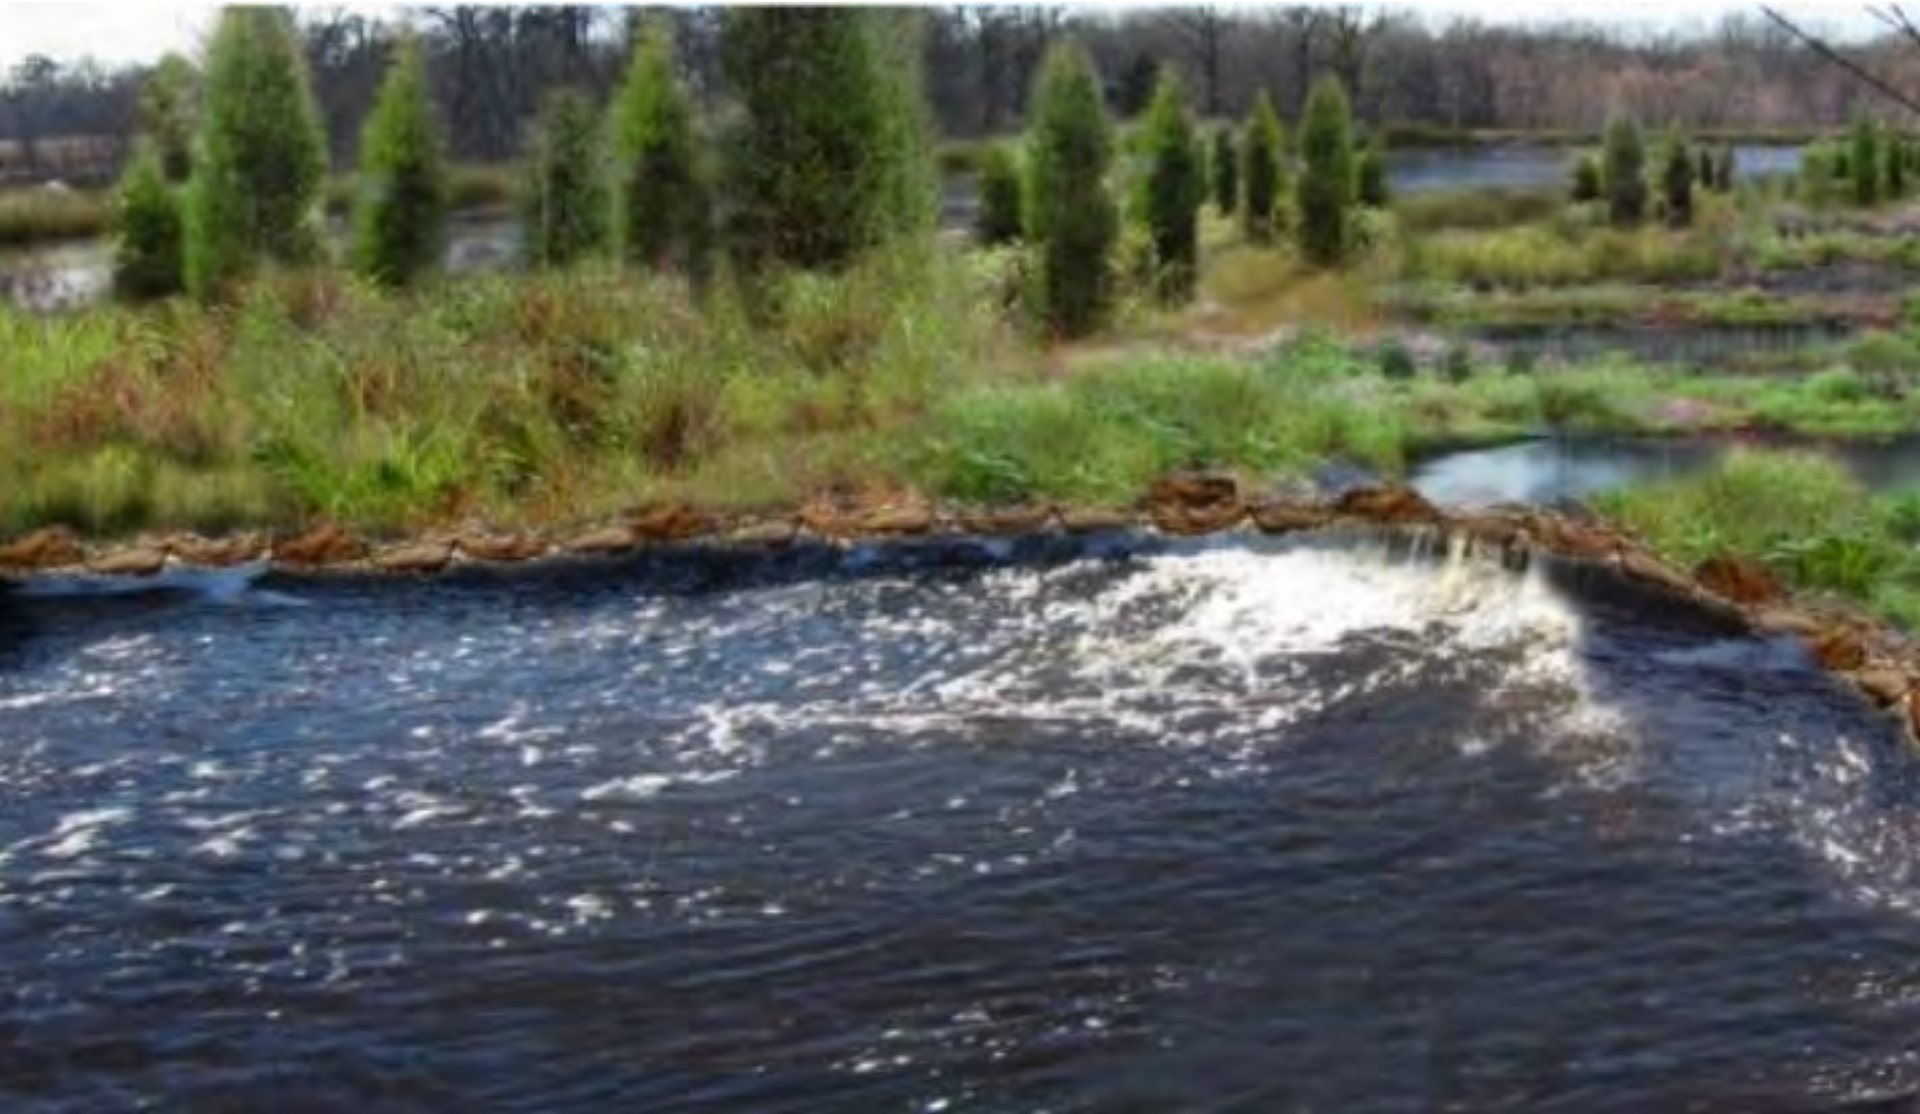
Simulation for Adjacent Property Owners

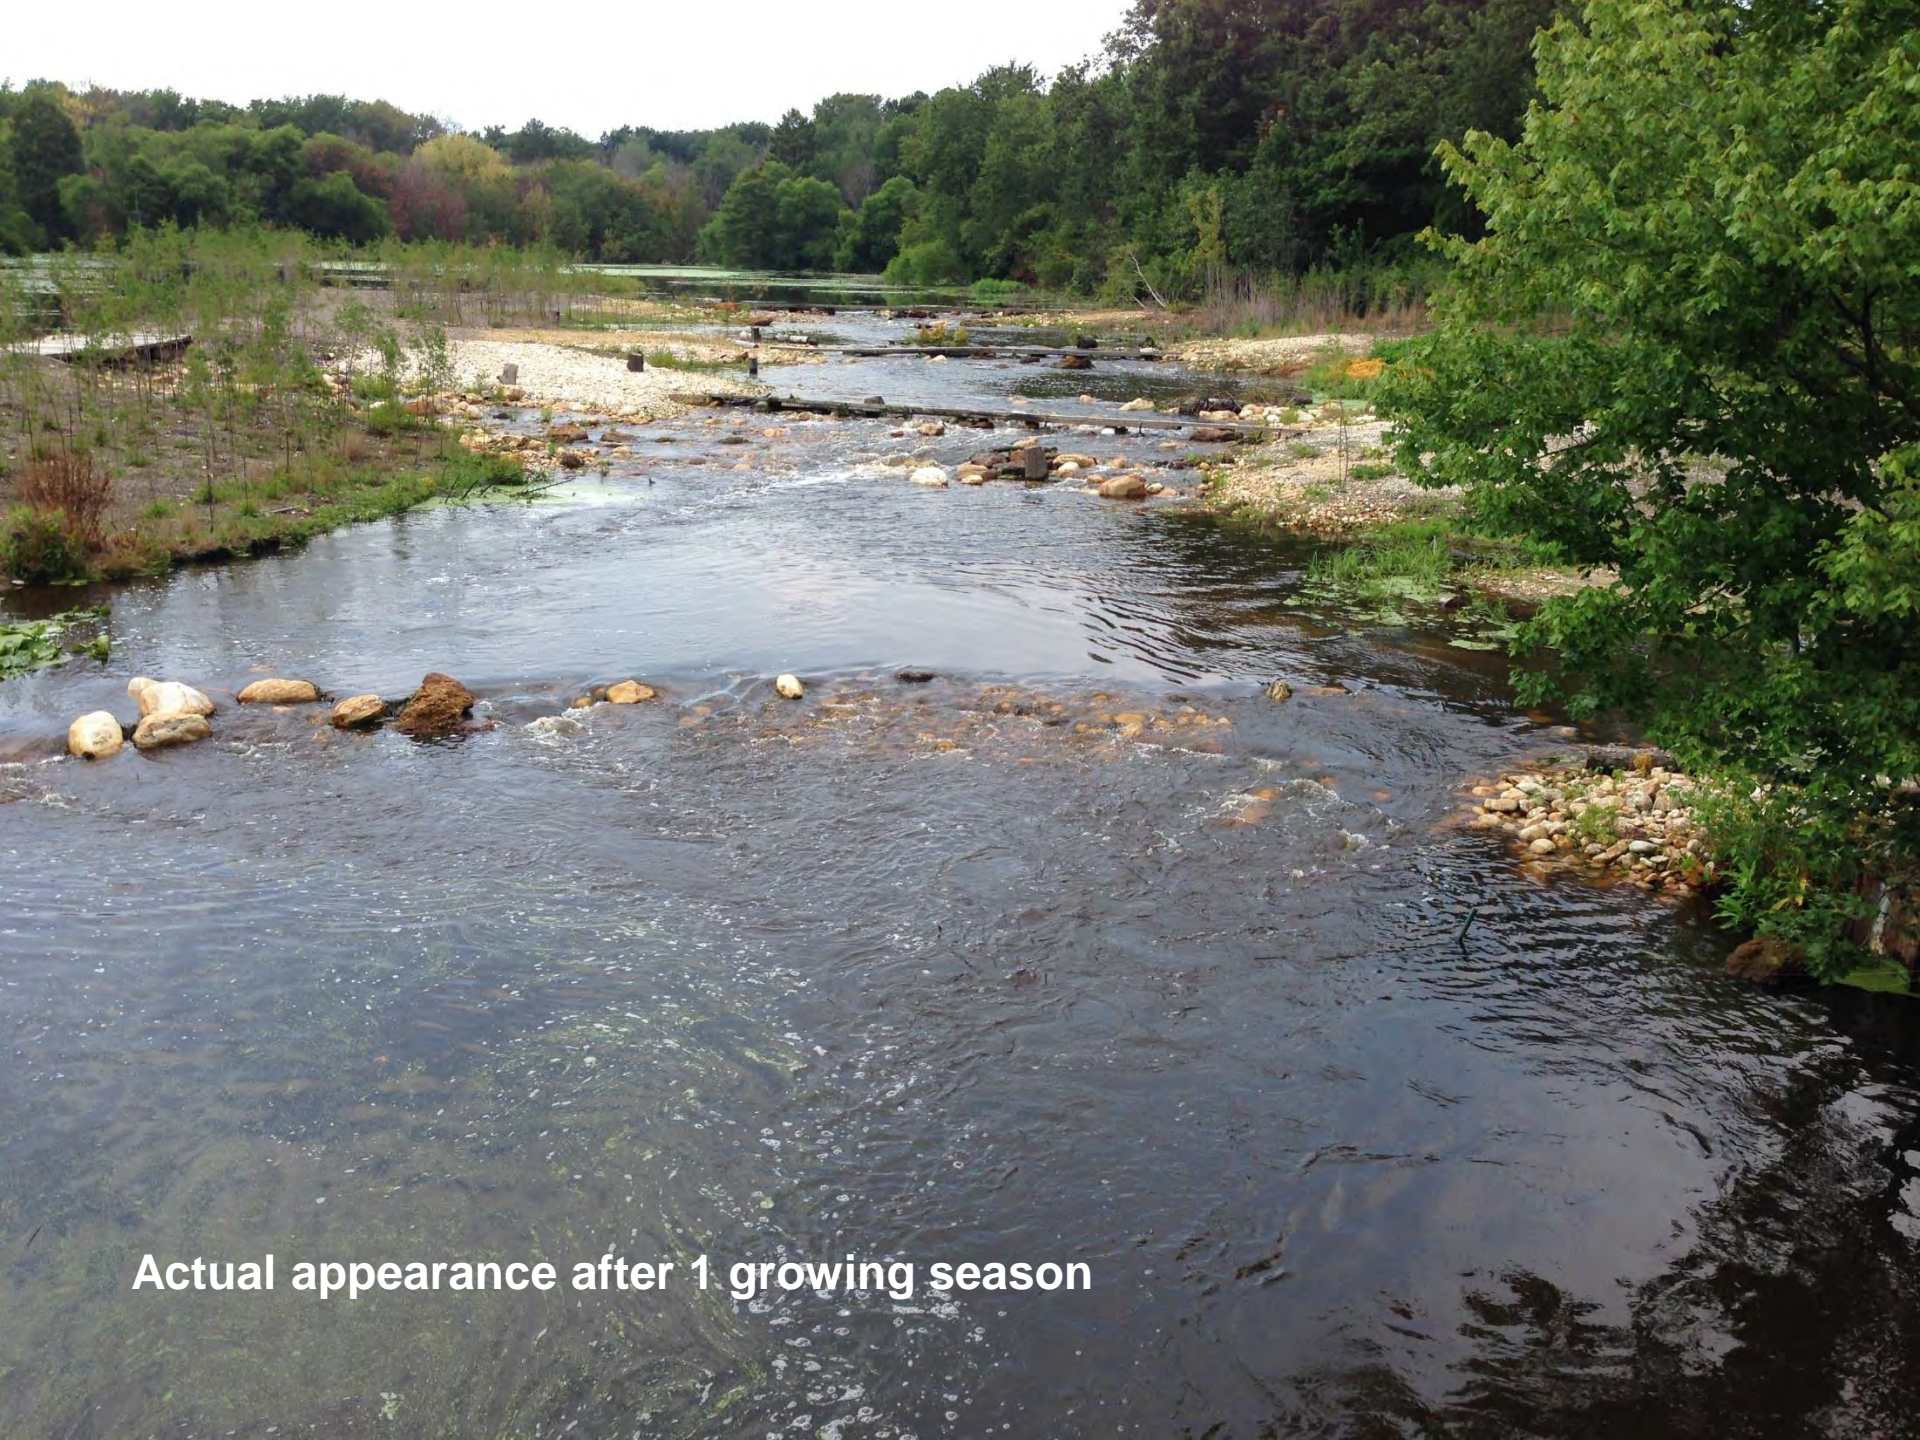
Actual appearance after 1 growing season

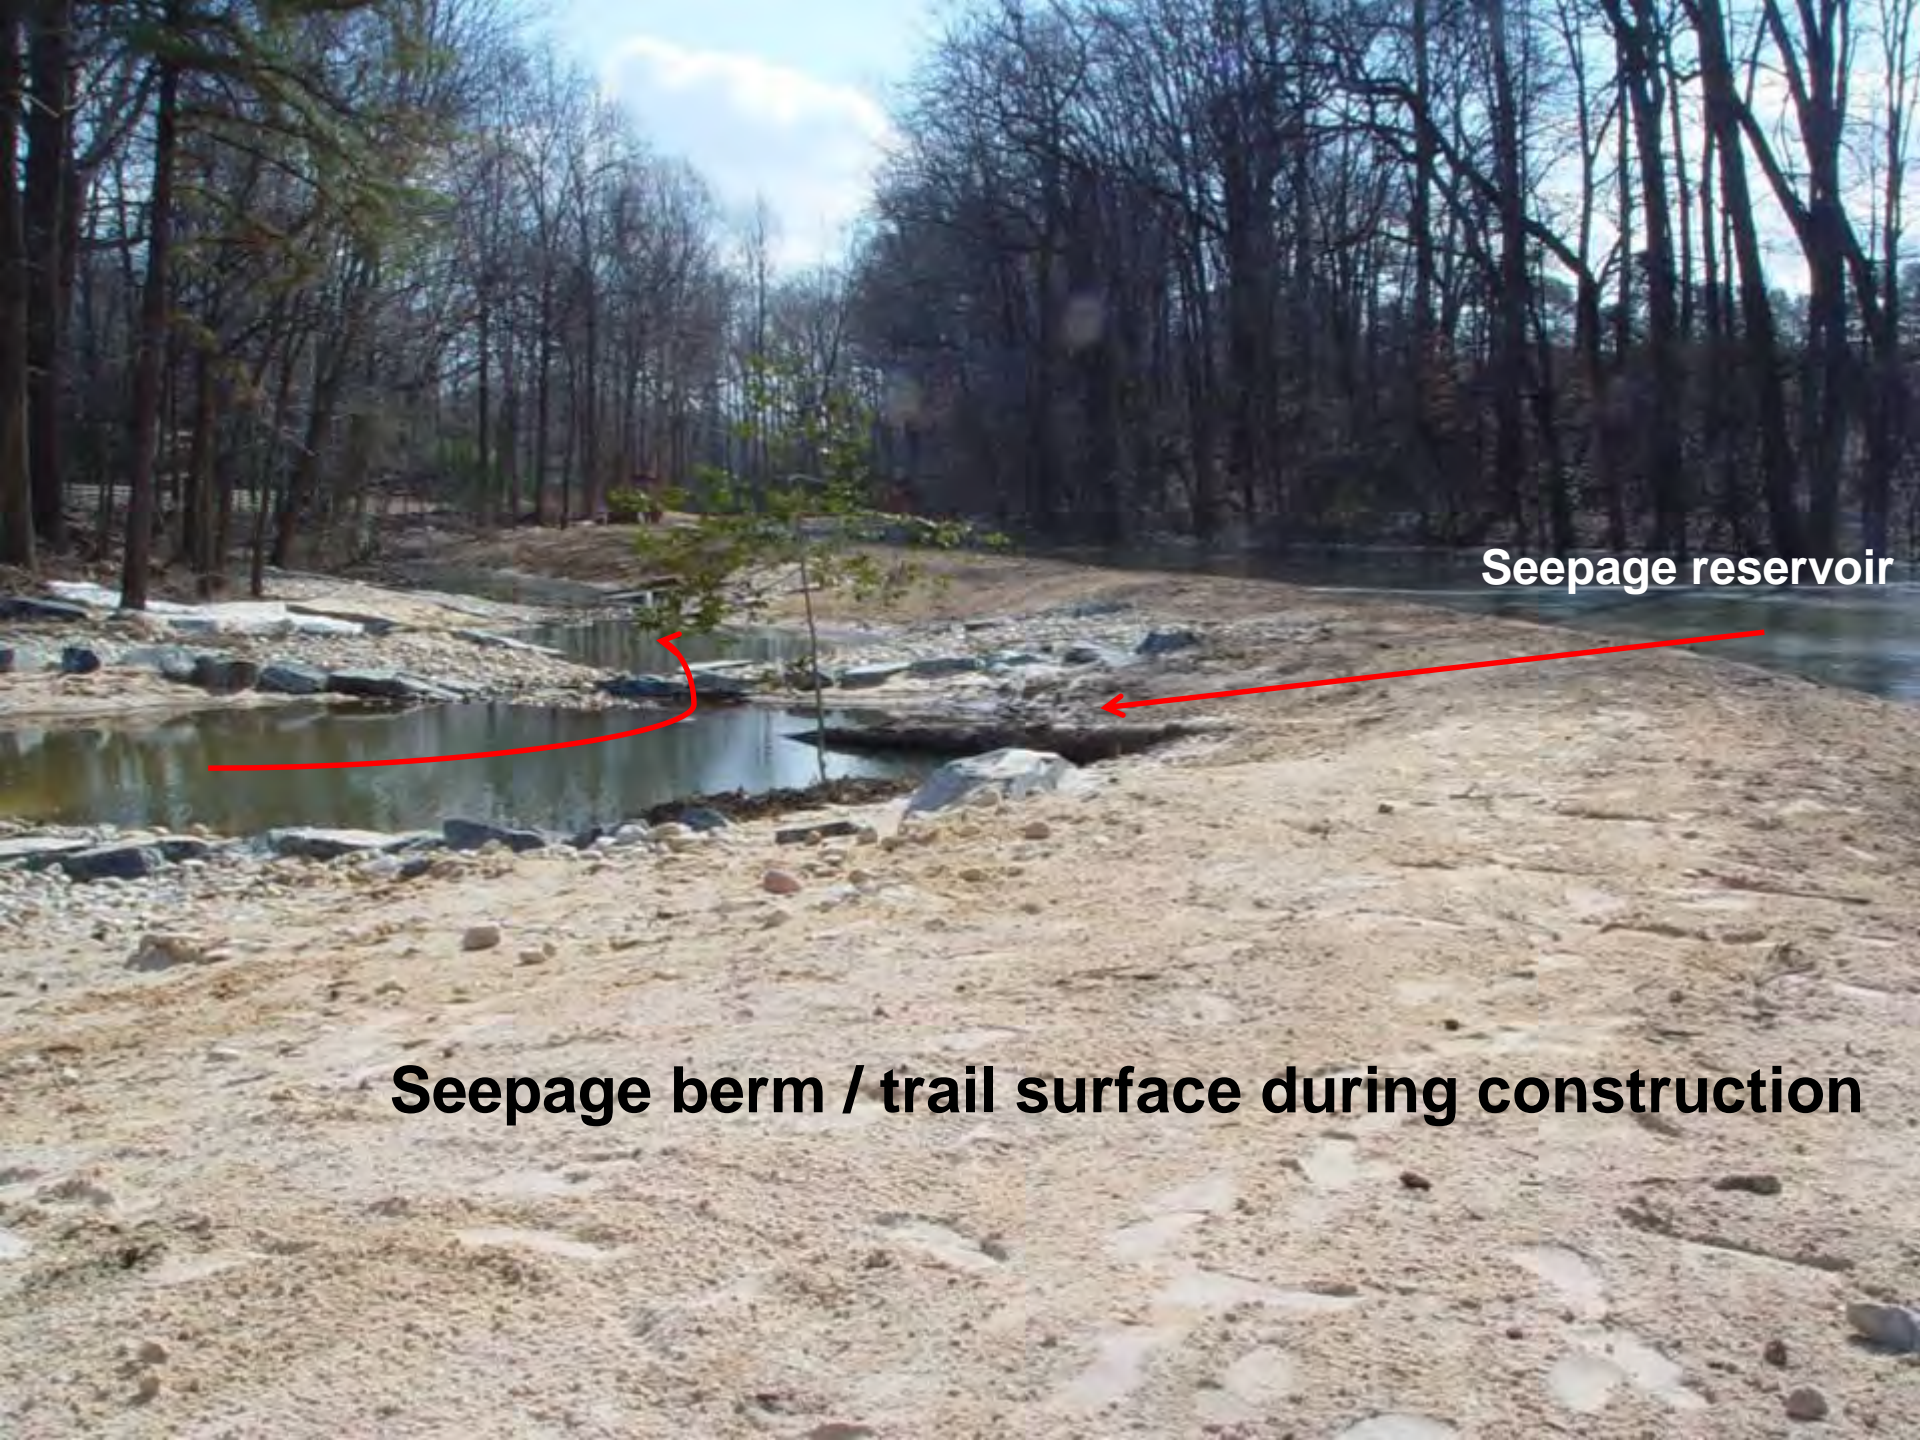
Seepage reservoir

Seepage berm / trail surface during construction

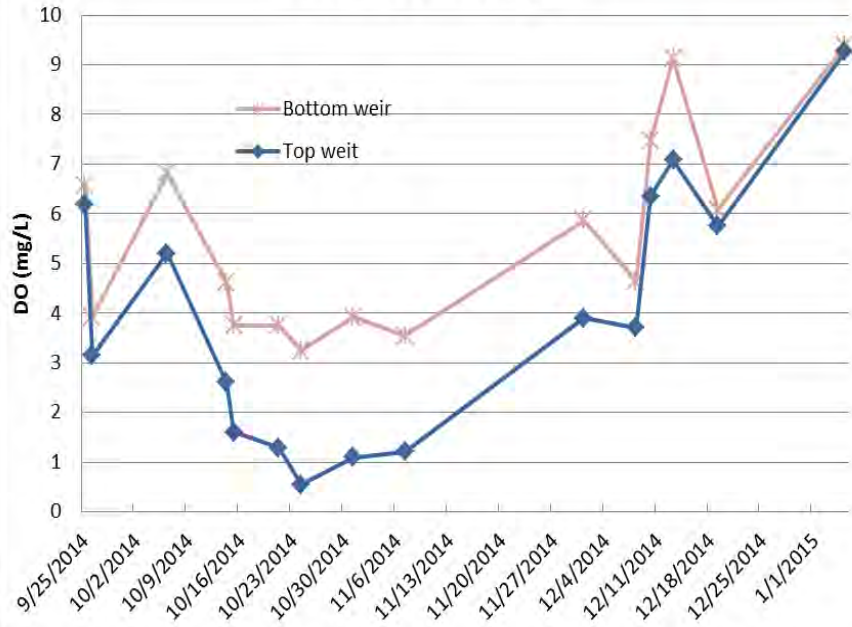
Dissolved Oxygen

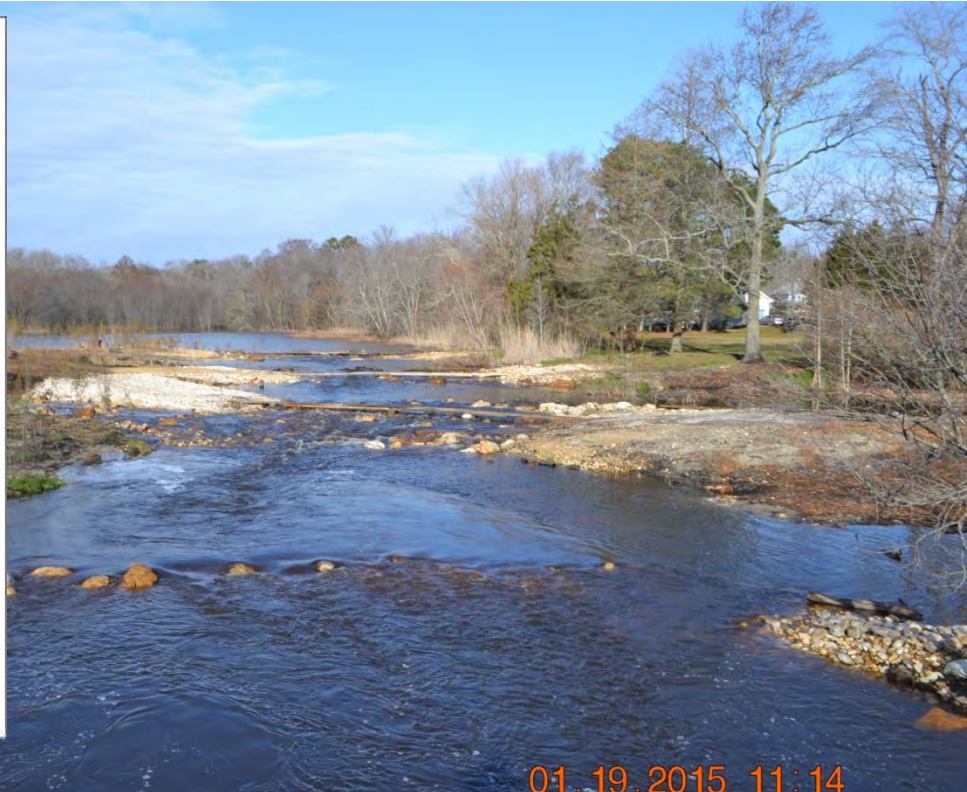
Water Temperature
