What's Good for the Tap is Good for the Creek!

*Reading Area Water Authority
marks five years of
Source Water Protection*

Reading Area Water Authority

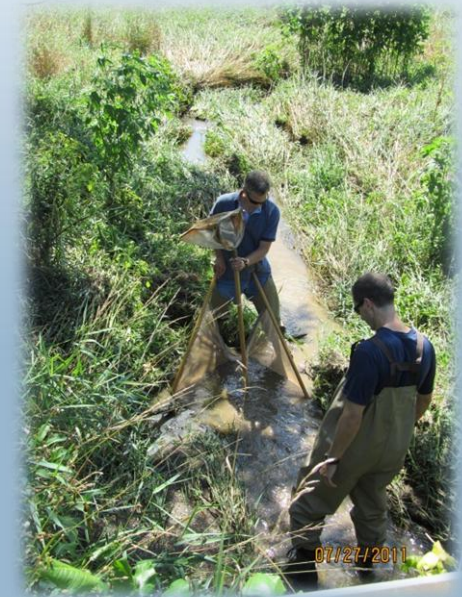
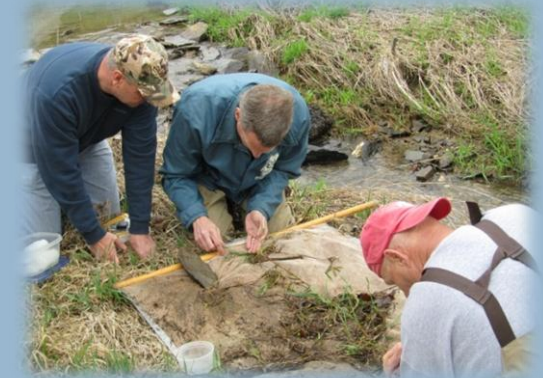
Schuylkill Action Network
2011 Macroinvertebrate Survey

A multi-disciplinary team conducted stream sampling on behalf of the Schuylkill Action Network's agriculture workshop in July 2011. The sampling team included representatives from the United States Environmental Protection Agency, Berks County Conservancy, Sport Stevens and McGee, the Partnership for the Delaware Estuary and Miller Environmental. Macroinvertebrate sampling observations noted progress in the health of tributaries in Madsen and Samsen Creeks near Virginville and Kutztown, Pennsylvania. The presence of mayflies, caddisflies, stoneflies, and cephids indicate that the work completed by the SAN along these tributaries is successfully contributing to the restoration of these important watersheds. Though the tributaries are not likely eligible for removal from Pennsylvania's list of impaired waters due to enhanced biological criteria requirements it is encouraging to witness the ongoing ecological and biological improvements showing that the streams are getting cleaner and healthier.

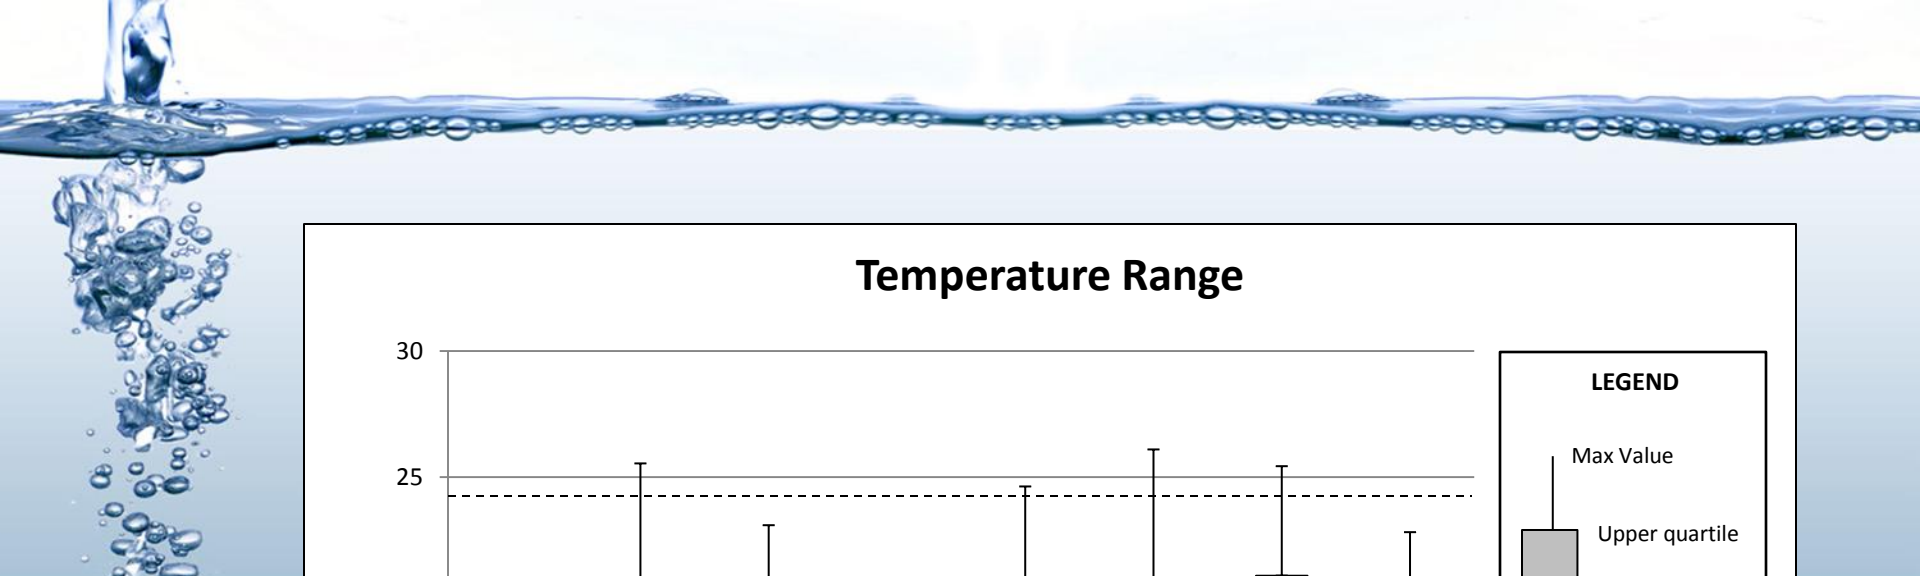
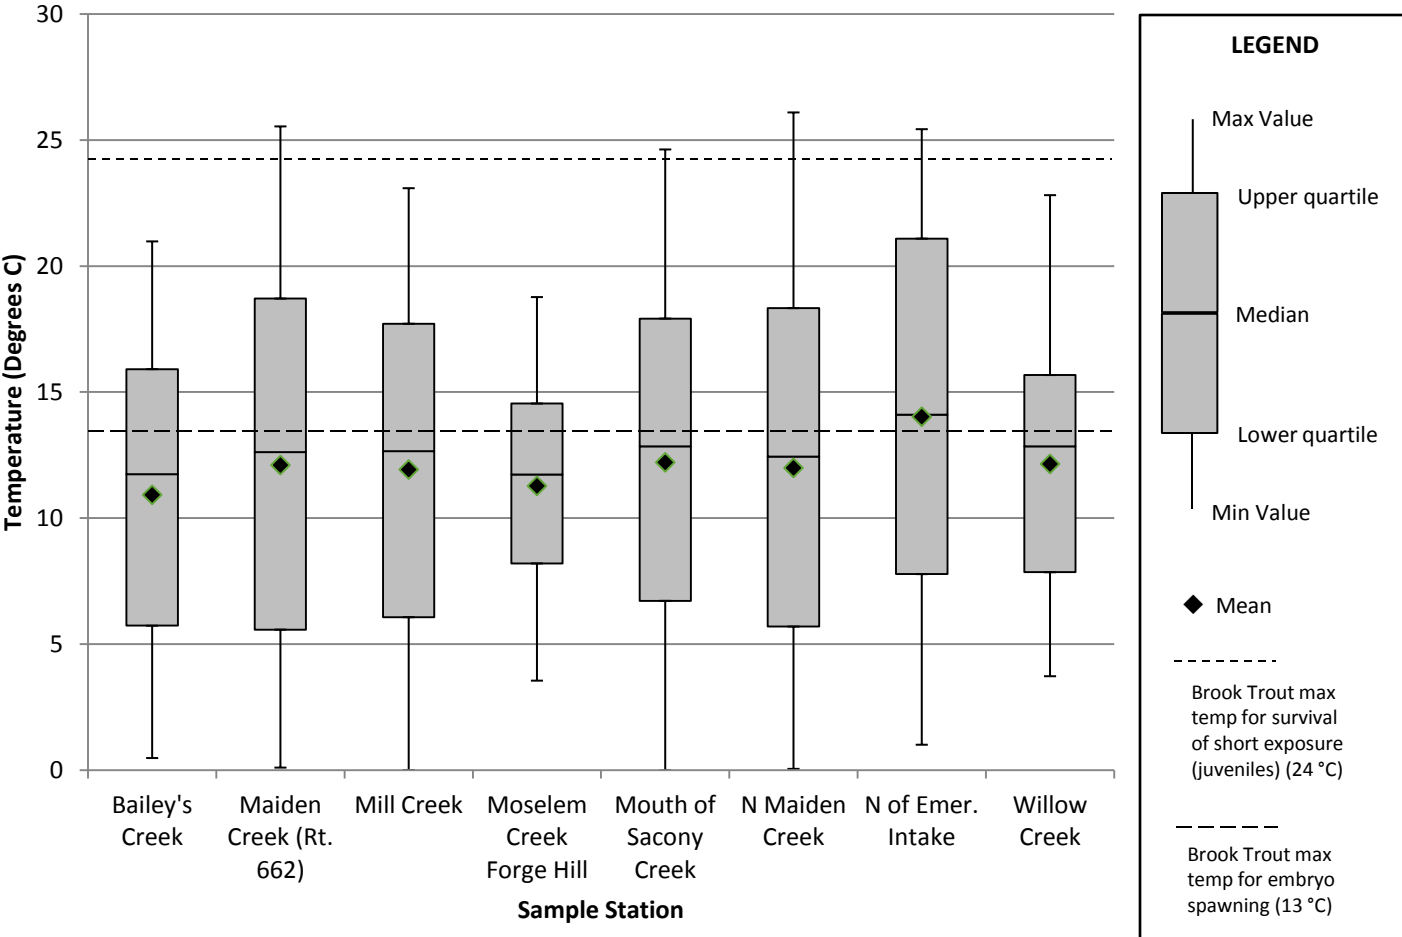
Temperature Range

Temperature

- Typically not elevated throughout watershed
- Seasonal fluctuations and ranges consistent with designated uses of streams

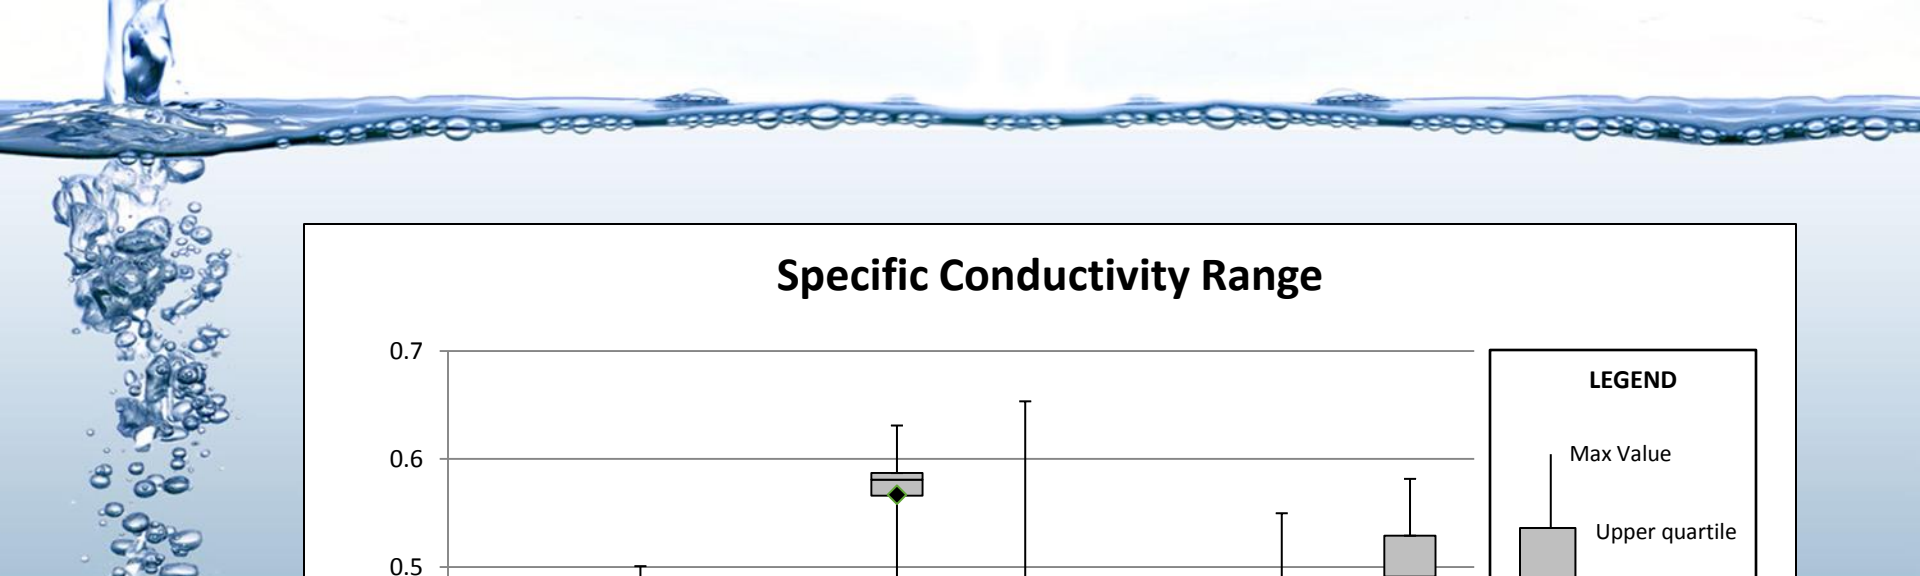
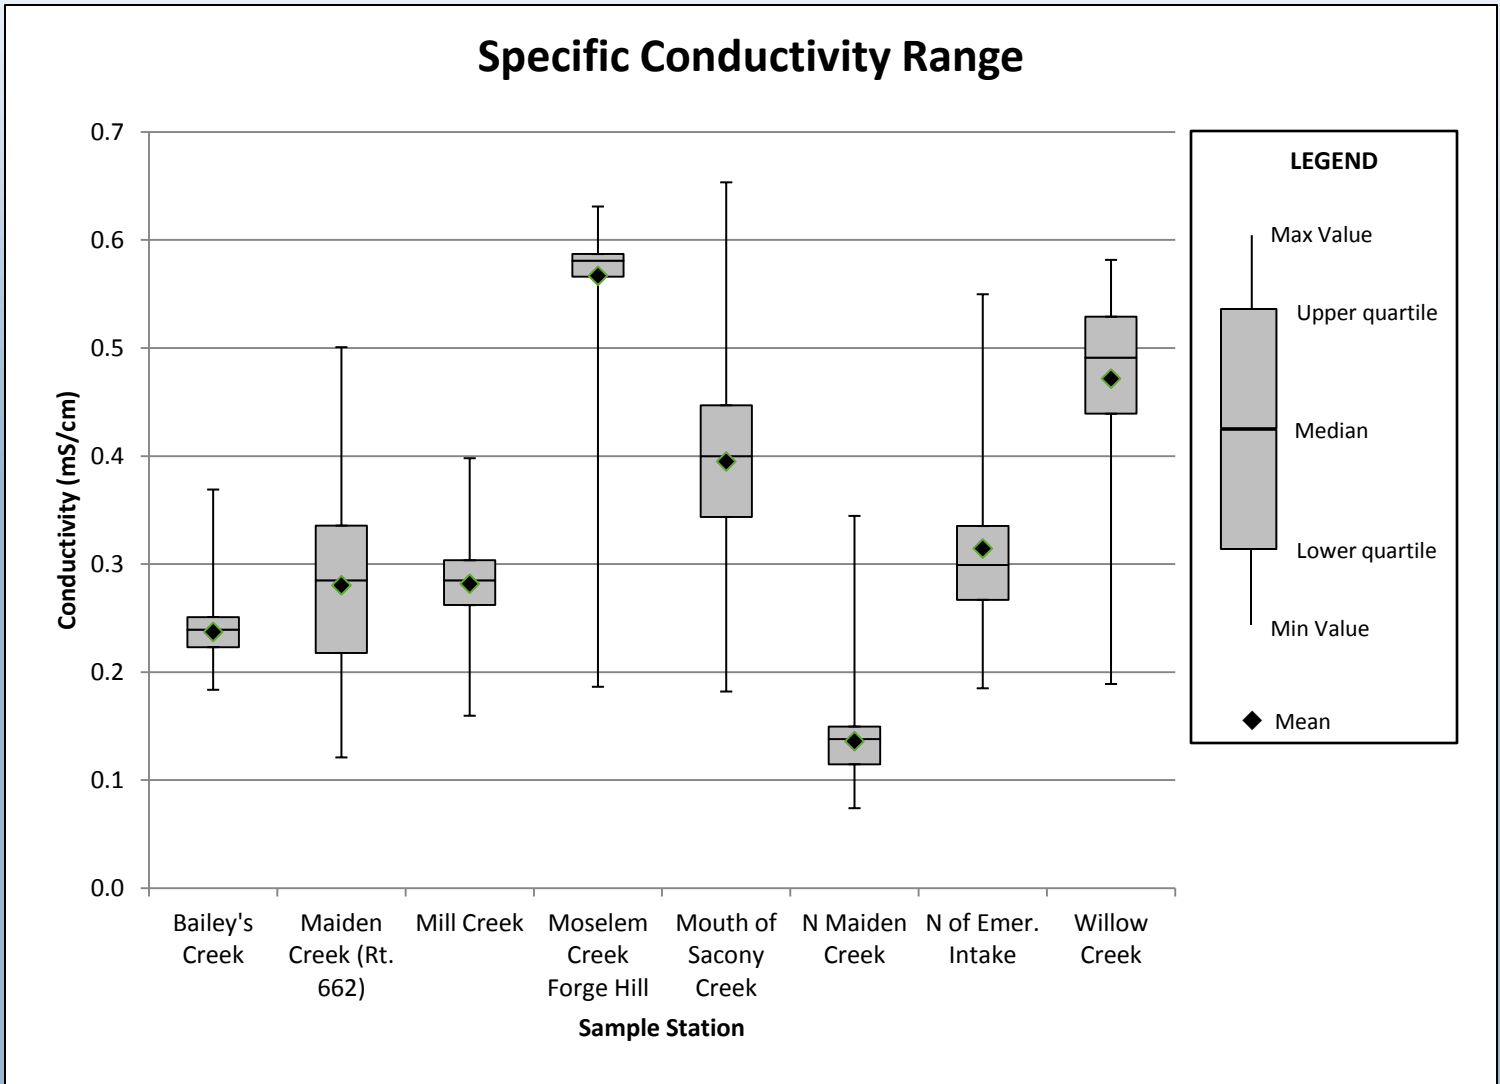
Specific Conductivity Range

Specific Conductivity

- Highest at Moselem Creek, Sacony Creek and Willow Creek
- These sites also have higher nitrate levels

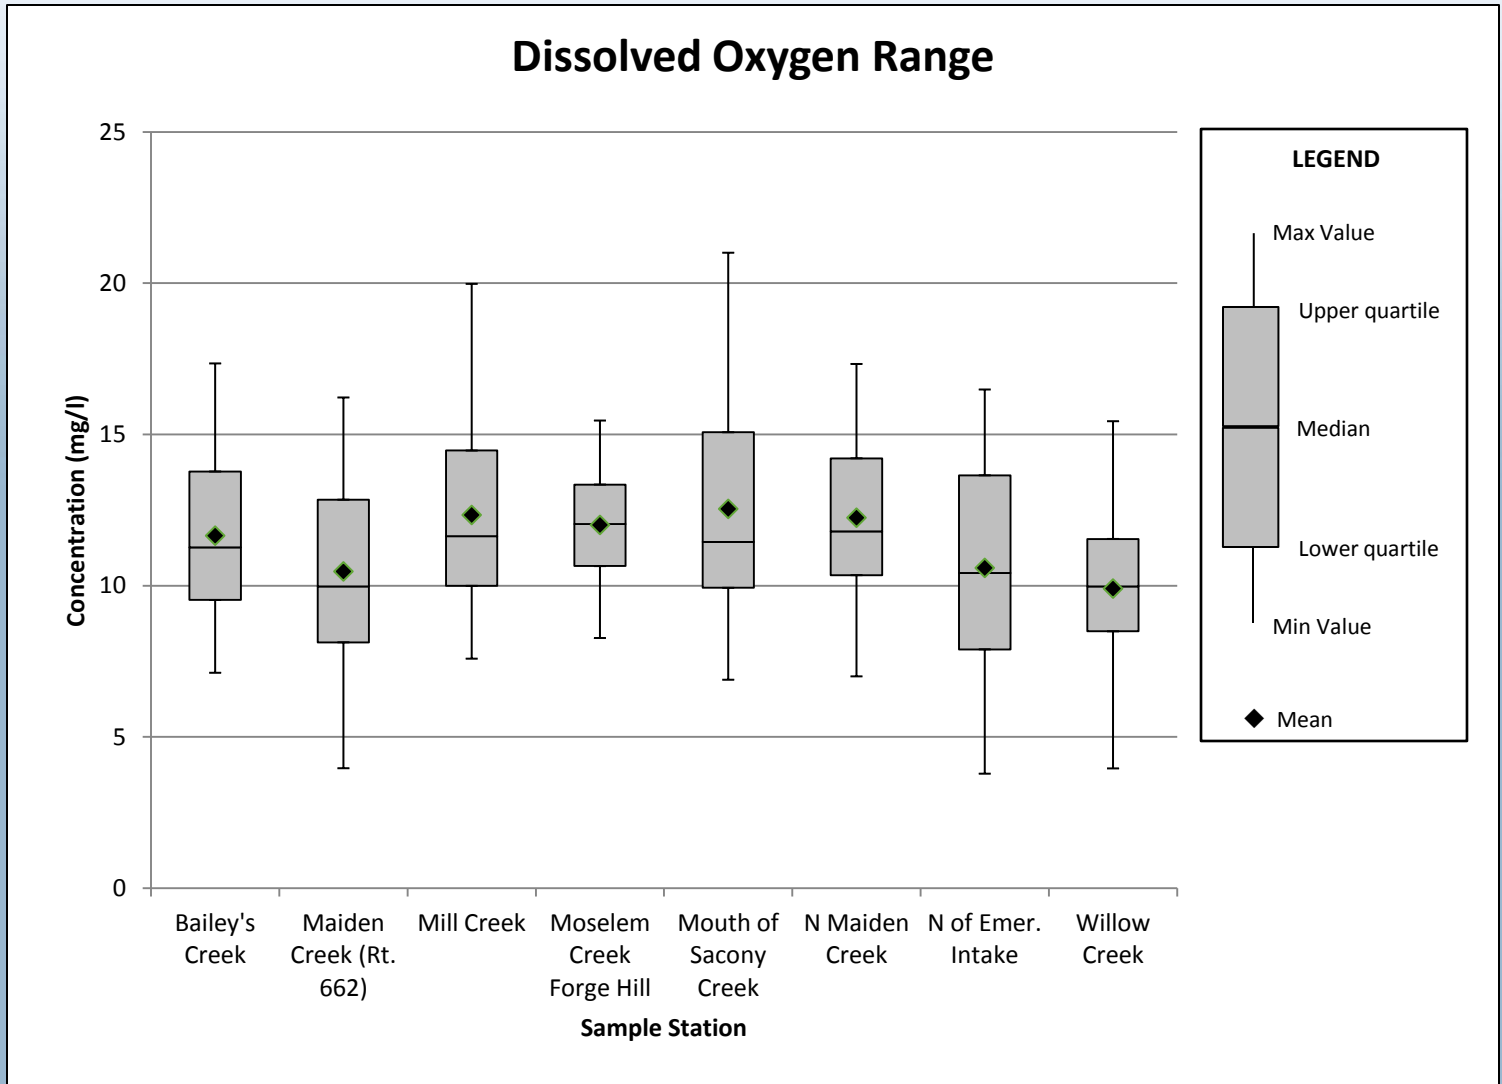
Dissolved Oxygen Range

Dissolved Oxygen (DO)

- Lowest DO concentrations:
 - Maiden Creek (@ Rt. 662)
 - Maiden Creek (North of Emergency Intake)
 - Willow Creek
- Saturated DO acceptable or better at most monitoring locations
- Saturated DO low in Willow Creek and Maiden Creek (at Route 662) during summer and early fall

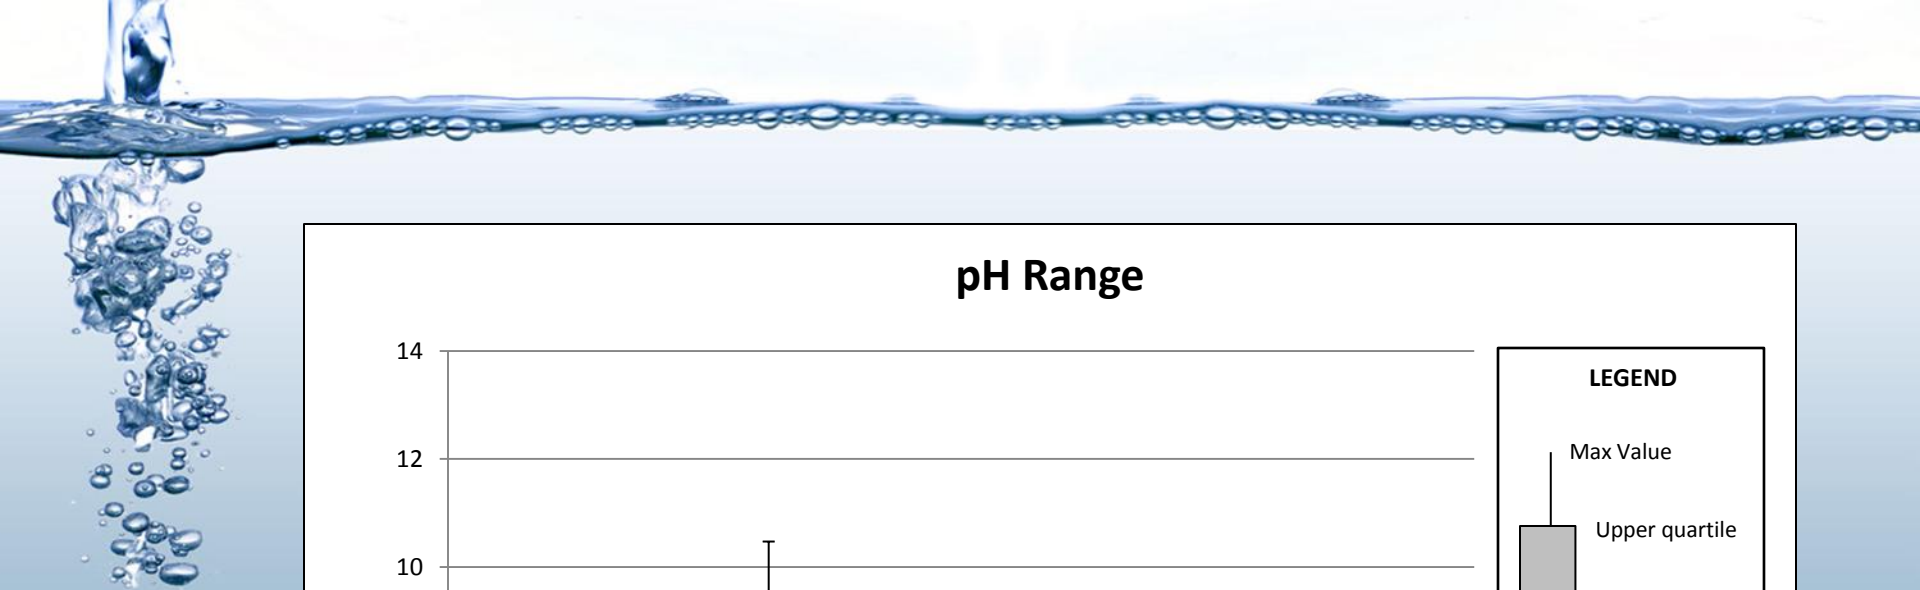
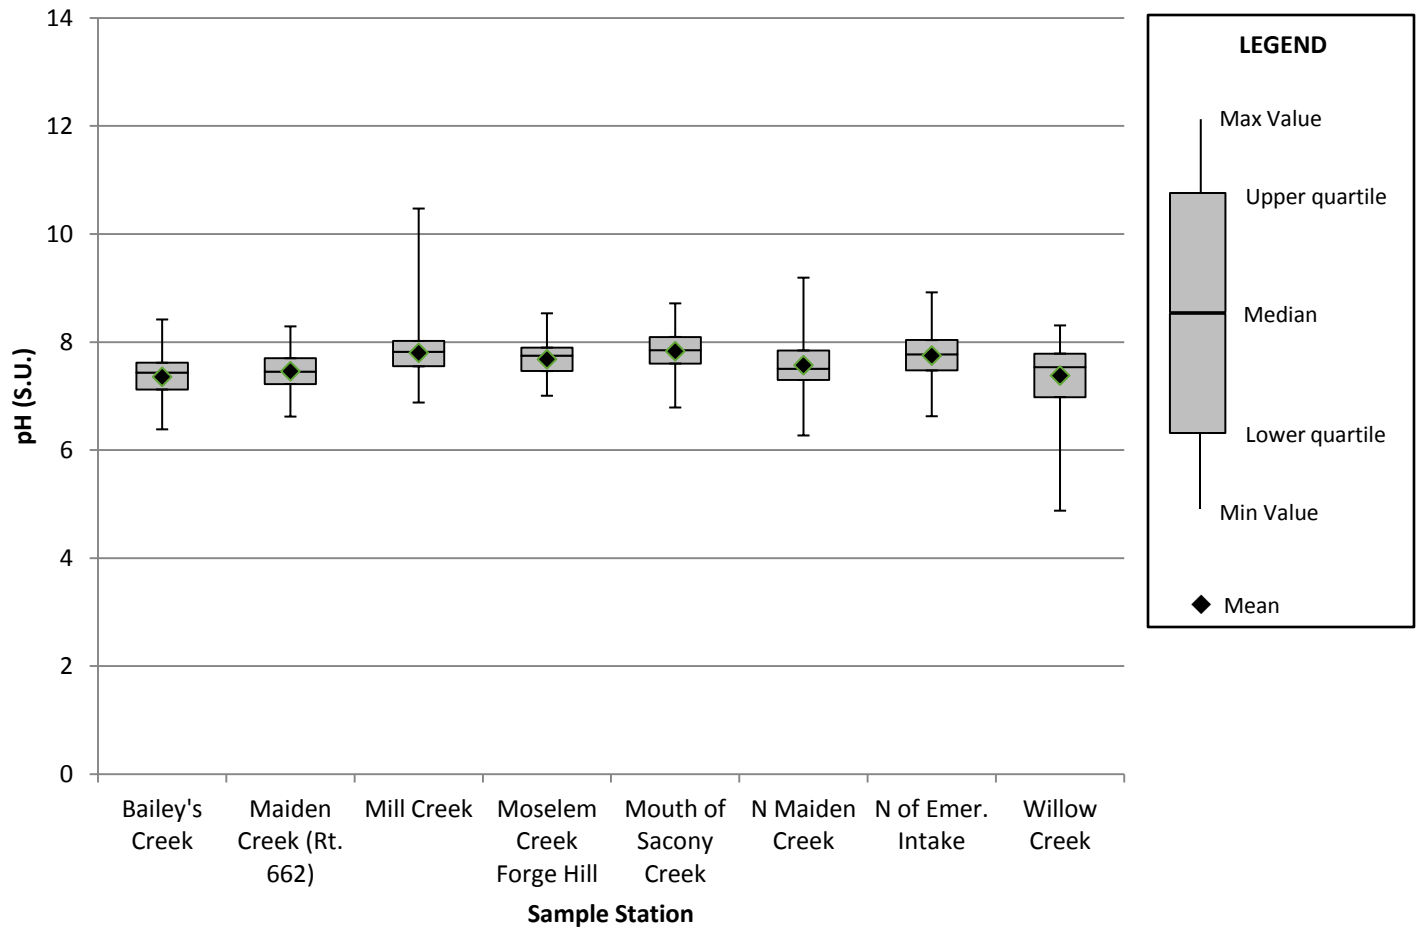
pH Range

pH

- Relatively consistent at each site and between sites
- Low pH (<5) observed in Willow Creek in March 2011
- High pH (>10) in Mill Creek attributed to meter malfunction

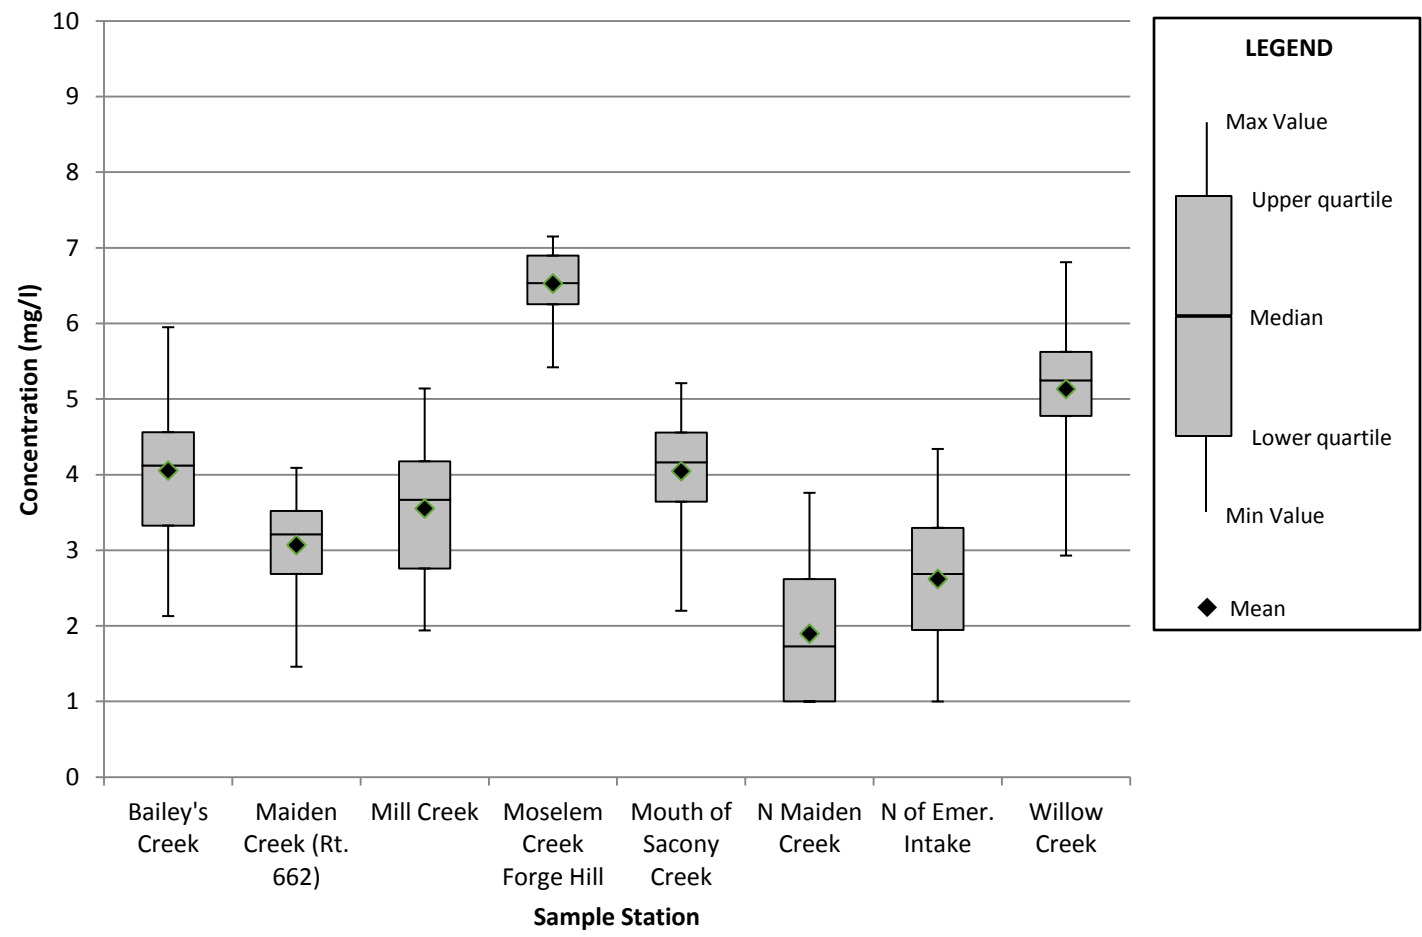
Nitrate Range

Nitrate

- All monitoring < 10 mg/L*
- Highest in Moselem Creek and Willow Creek

* PA DEP drinking water standard = 10 mg/L

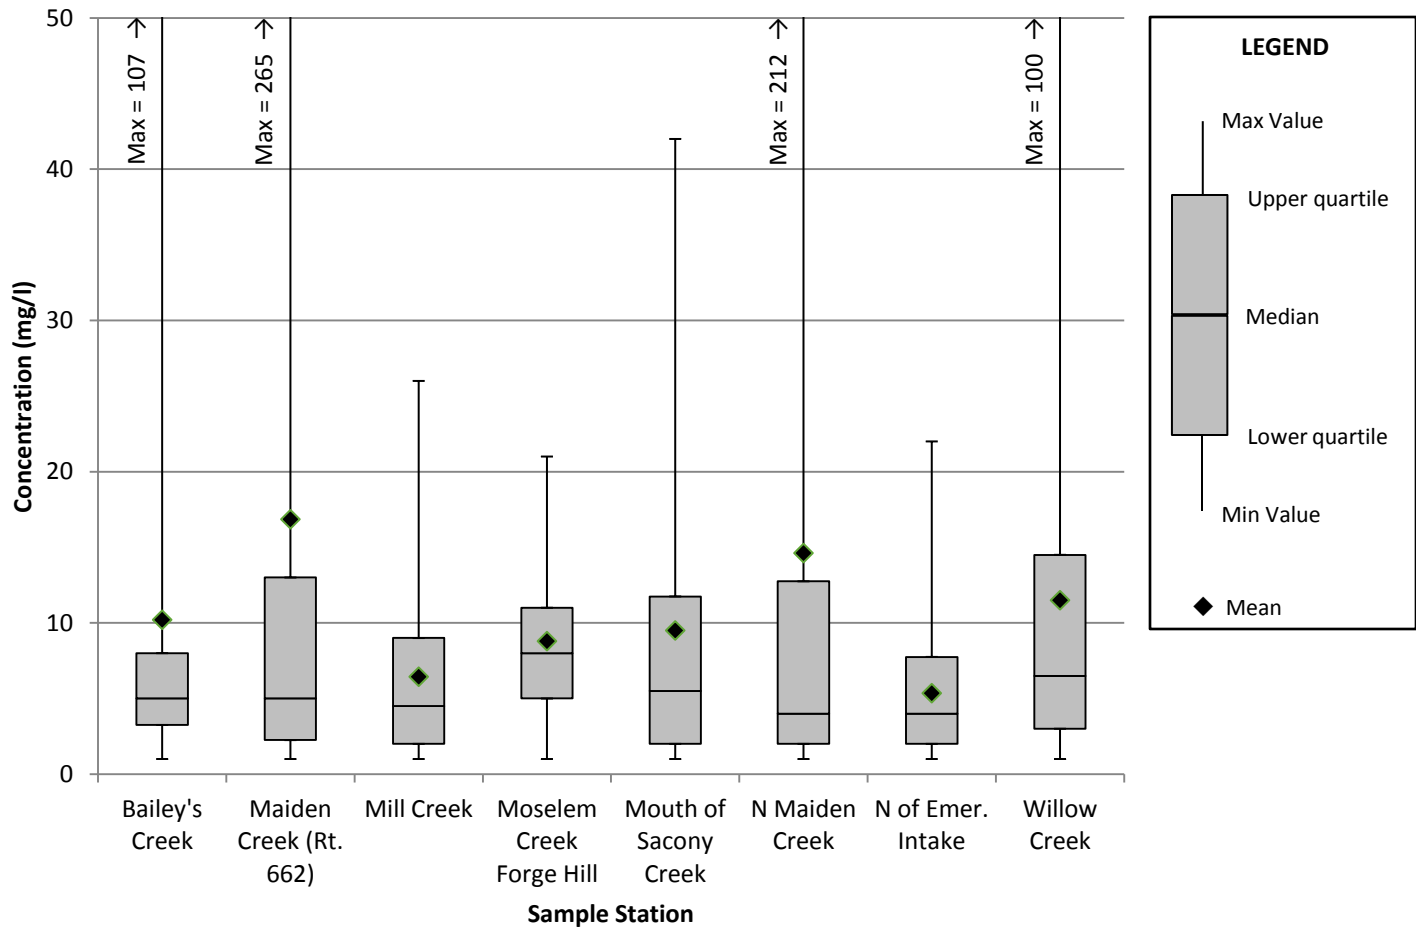
Total Suspended Solids Range

Total Suspended Solids (TSS)

- Concentration spikes associated with large storm events
 - North Maiden Creek
 - Maiden Creek (@ Rt. 662)
 - Bailey's Creek
 - Sacony Creek
- Northern part of watershed appears to be large source of TSS
- Sampling location added at mouth of Onteleunee Creek

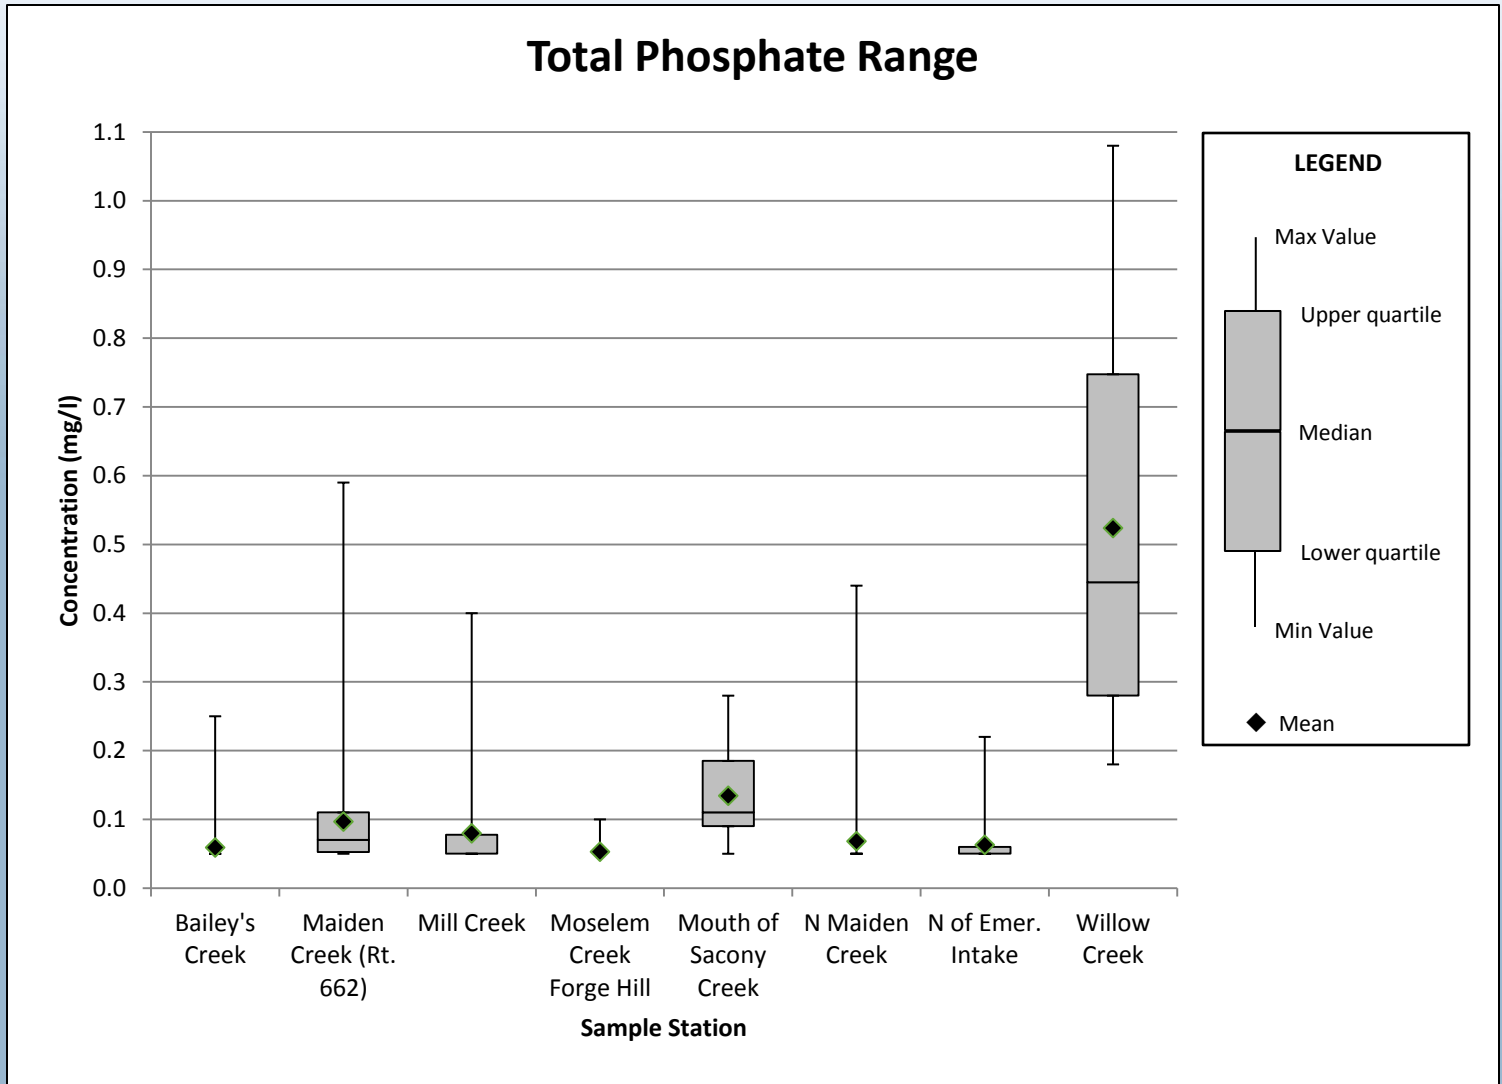
Total Phosphate Range

Phosphorus (P)

- Monitoring Total Phosphorus and Orthophosphate
- Low or nondetectable concentrations:
 - North of Maiden Creek
 - Mill Creek
 - Moselem Creek
 - Bailey's Creek
 - Maiden Creek (North of Emergency Intake)
- Moderate concentrations:
 - Sacony Creek
 - Maiden Creek (@ Rt. 662)
- Elevated concentrations in Willow Creek
- Concentration spikes may be related to large storm events
- Sampling location added in Sacony Creek downstream of Kutztown

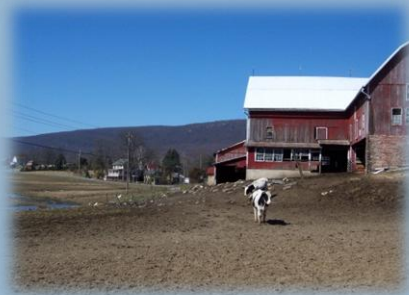
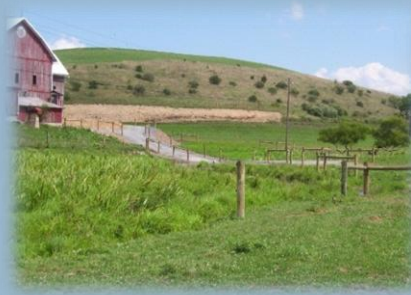
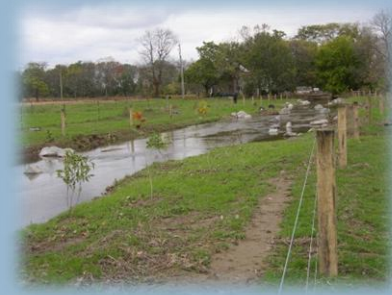
Agriculture Restoration Projects

- Exotic species removal on restoration sites
- Contribute funding for development of farm conservation planning and implementation

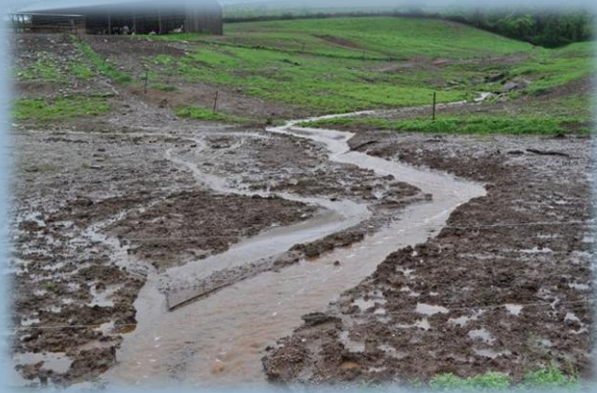
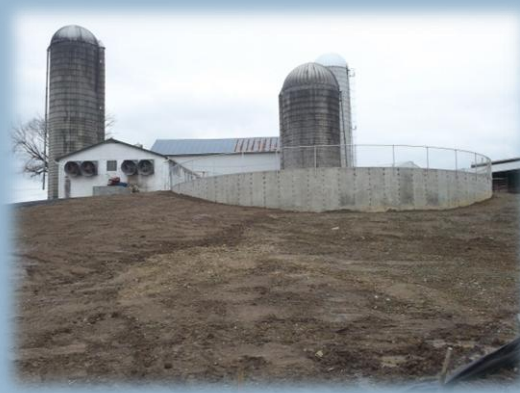
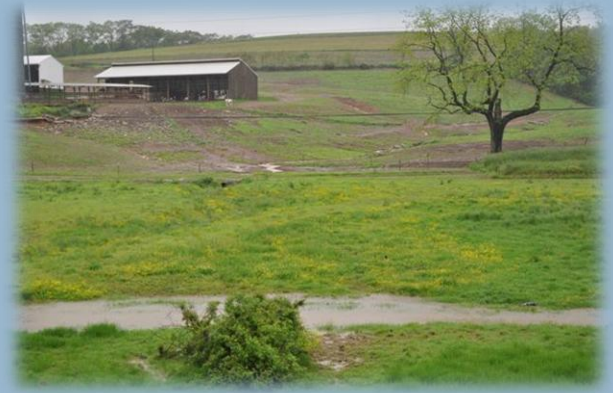
AGRICULTURAL RESTORATION

- Sacony Creek
- Farm with swine operations
