# Lower Crabby Creek Restoration

Learning the Art and the Science

This slide presentation is the first part of an on-going account of the restoration of Crabby Creek, a small cold water feeder stream to Little Valley Creek, just north of Paoli, Pennsylvania, in suburban Philadelphia. The stream is part of the Valley Creek Watershed that includes Valley Forge National Historical Park. Crabby, a well wooded brown trout nursery stream, suffers the ravages of storm water run-off from the impervious surfaces of the development in its headwaters. By 2008 the erosion of about 3500 cubic feet of streambed had undercut a sanitary sewer line that carries a million gallons of waste per day, creating a potential environmental disaster.

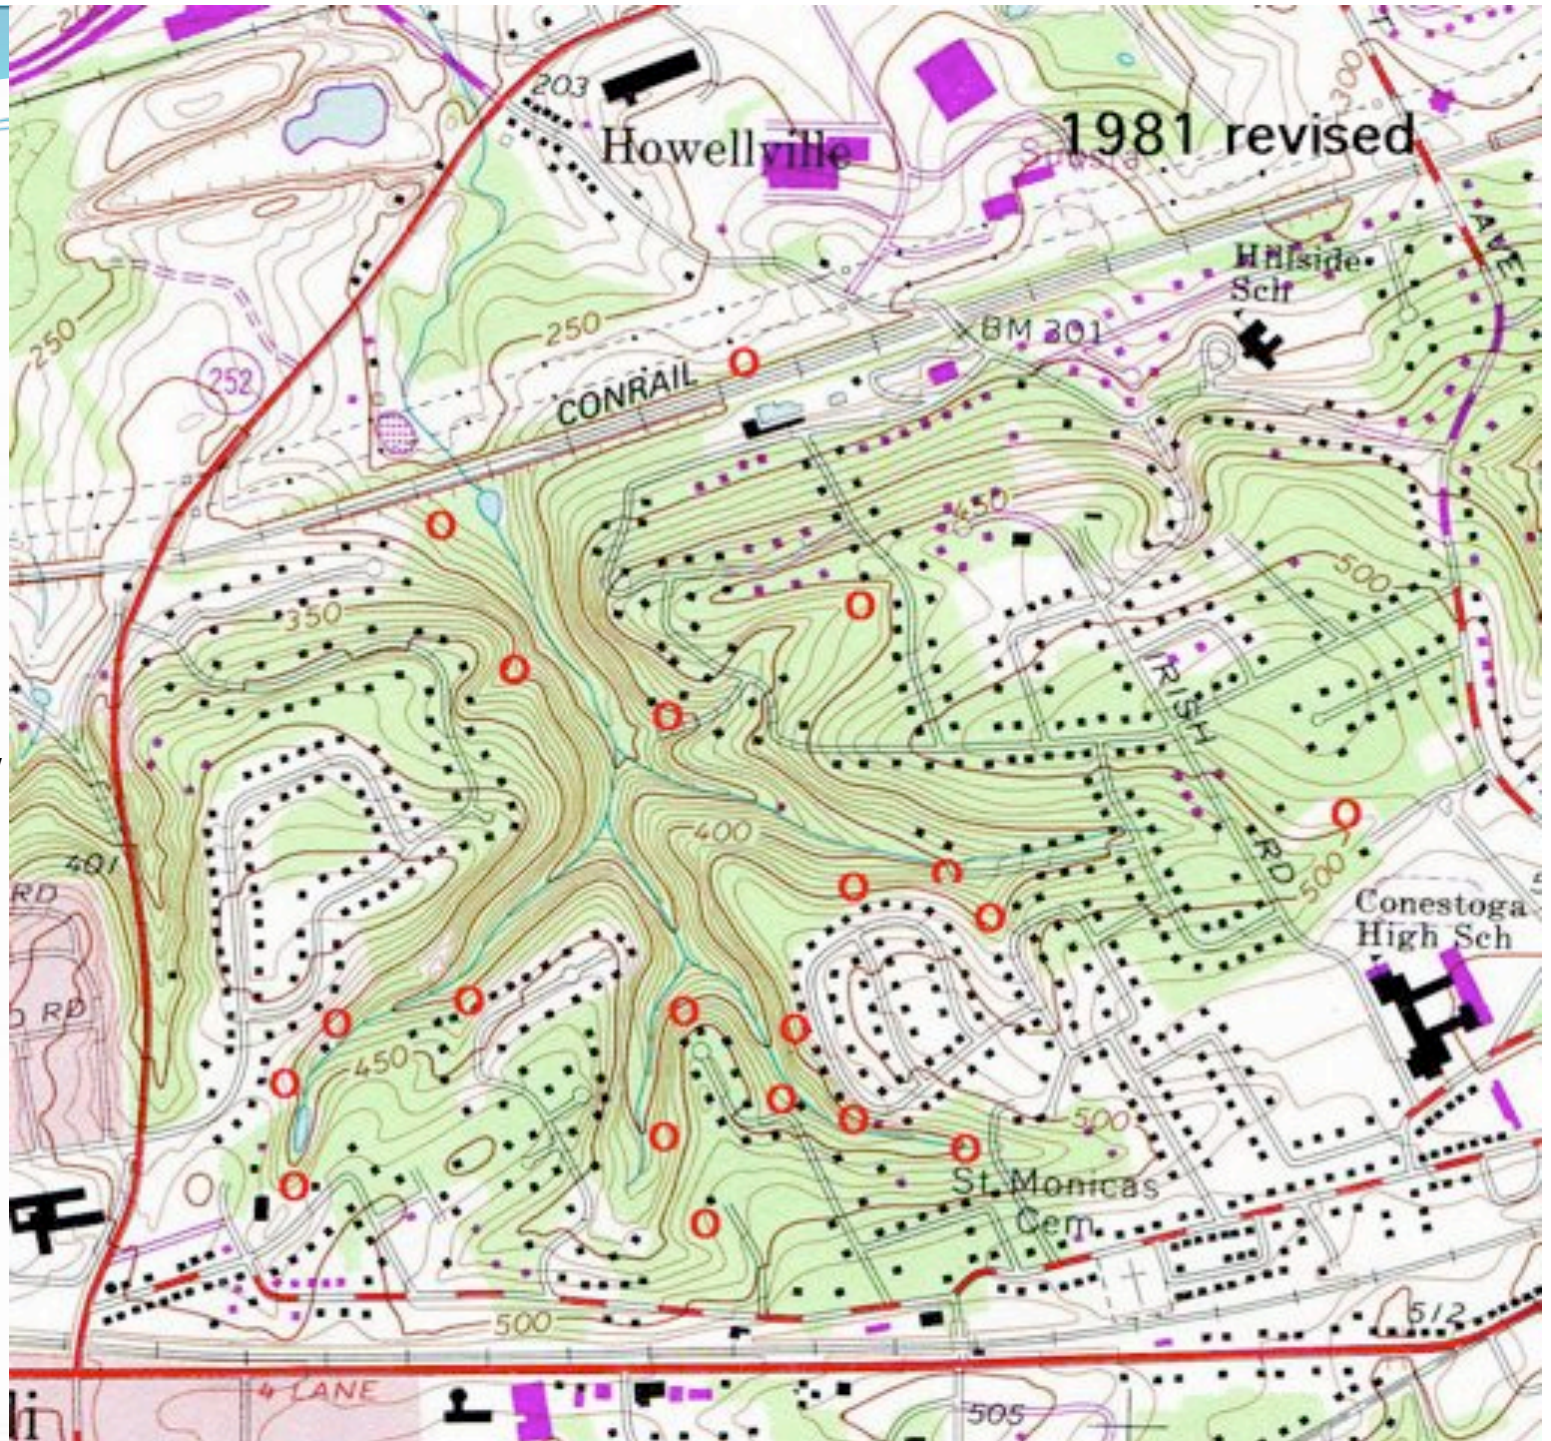
# 20 stormwater outfalls

All of the impervious surfaces- roads, driveways, roofs, and lawns are piped directly to the stream at stormwater outfalls below street inlets

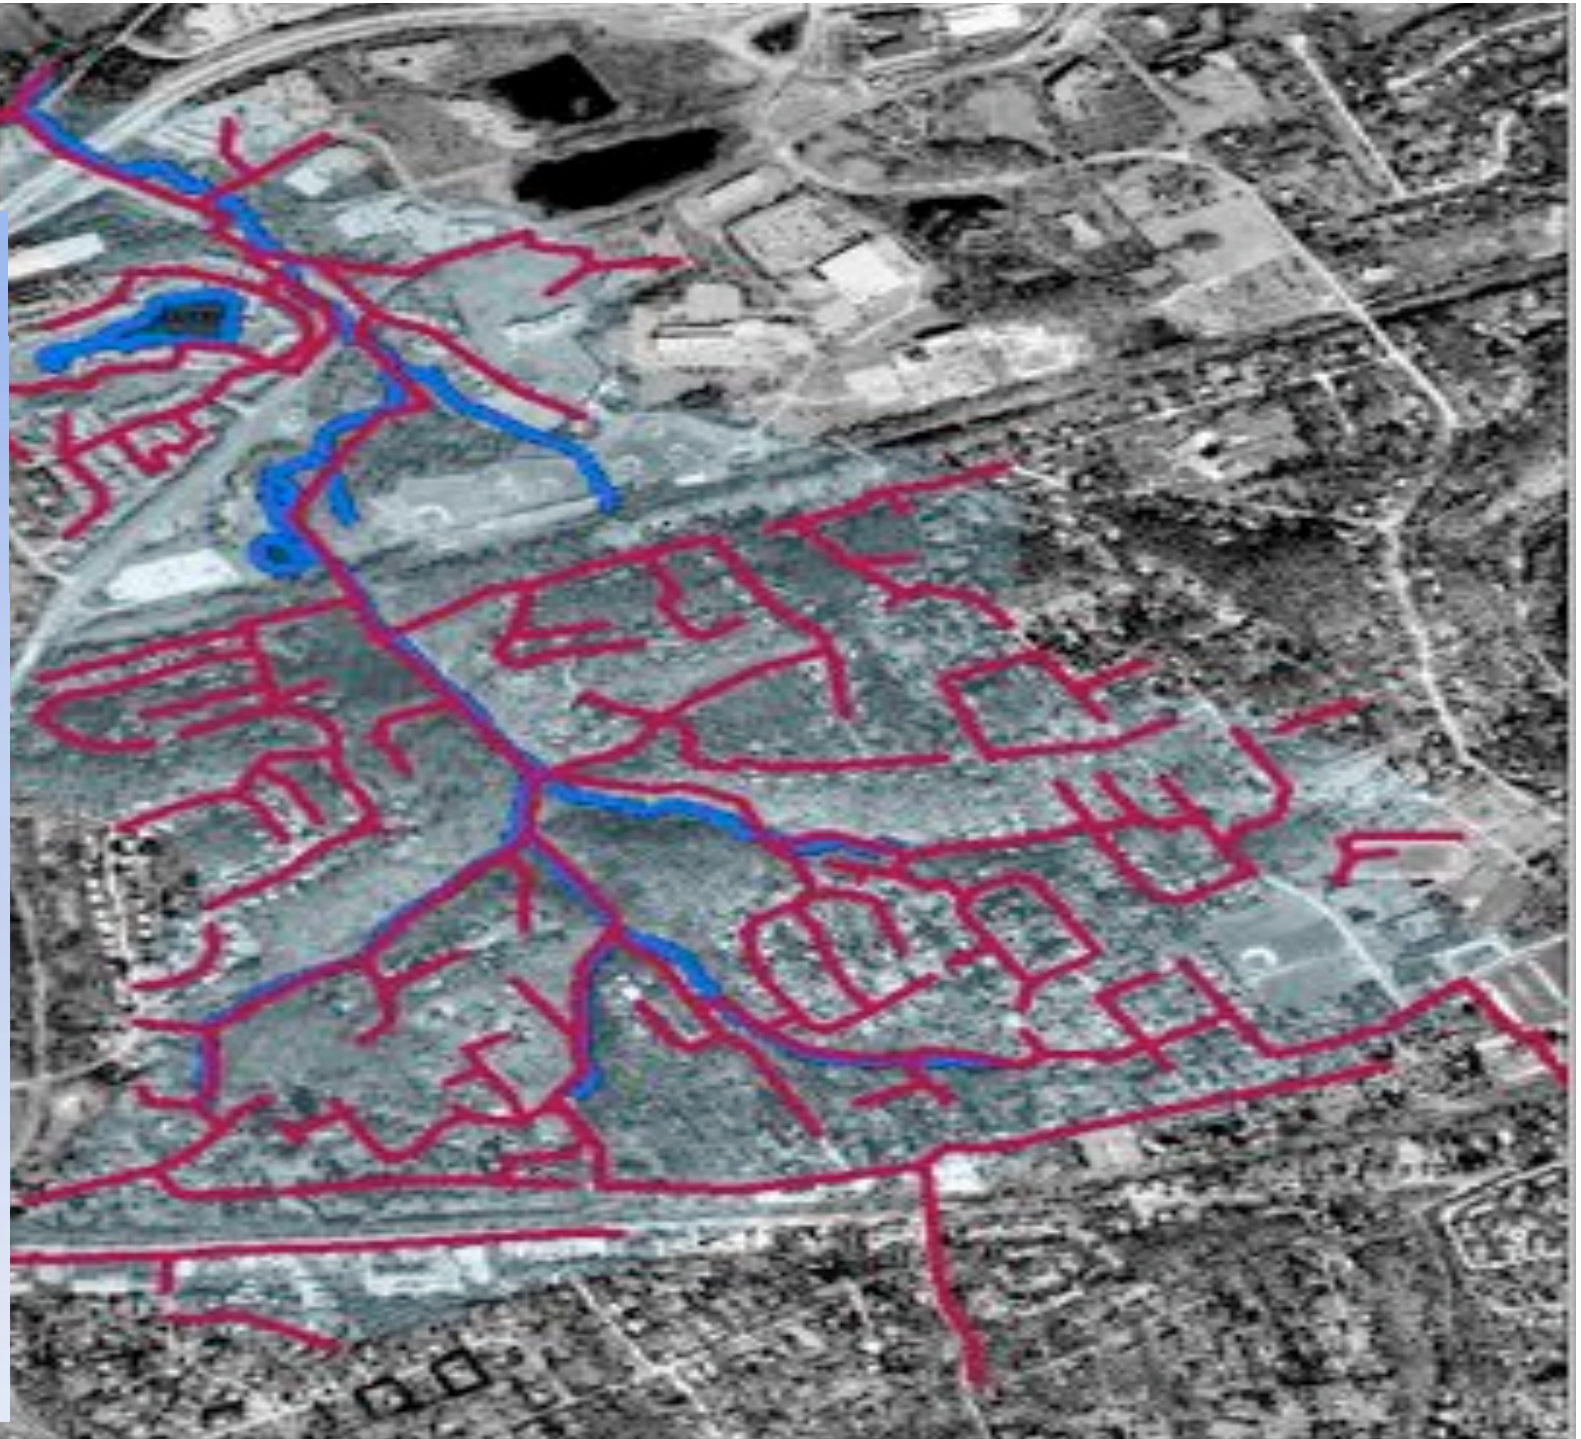
**Sewer lines  
Shown in  
Red**

Installed in mid 1970's, these sanitary sewer lines straightened the stream, cut off its access to flood plain, and created an abundant supply of easily eroded sediment from the backfill along the stream banks, as shown on the next slide.

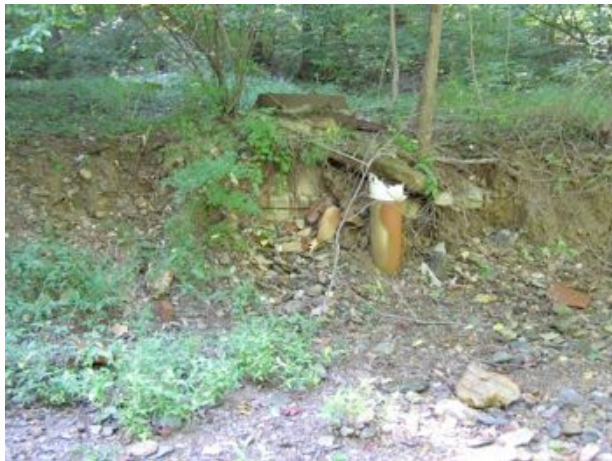
↑  
Erosion of sewer line fill  
in stretch upstream  
from tunnel under railroad

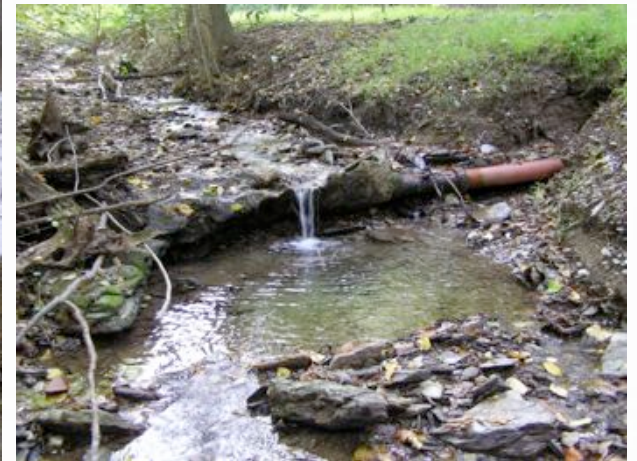
↑  
Erosion even in  
occurs along the sewers  
the upper headwaters

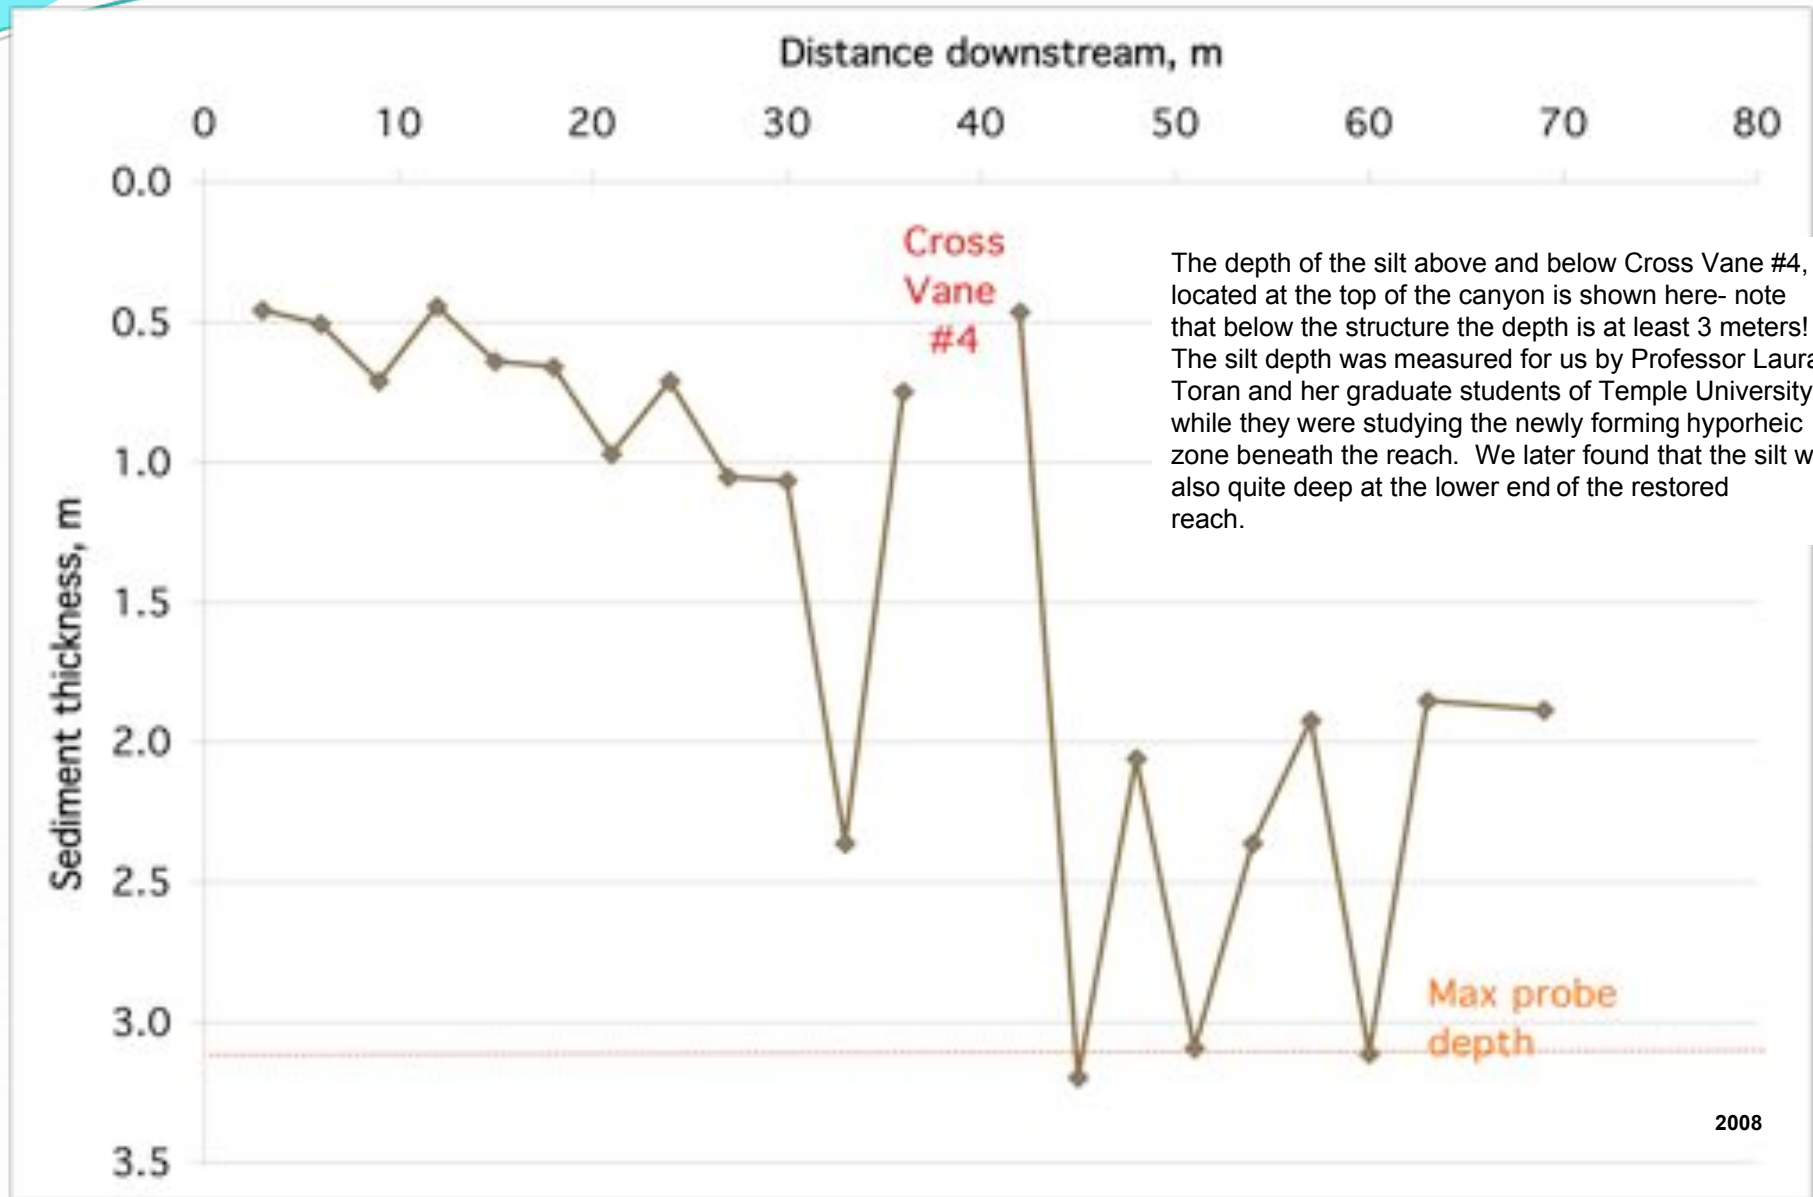
# Tile Probe Measurement of Sediment Depth above and Below CV#4

The depth of the silt above and below Cross Vane #4, located at the top of the canyon is shown here- note that below the structure the depth is at least 3 meters! The silt depth was measured for us by Professor Laura Toran and her graduate students of Temple University while they were studying the newly forming hyporheic zone beneath the reach. We later found that the silt was also quite deep at the lower end of the restored reach.

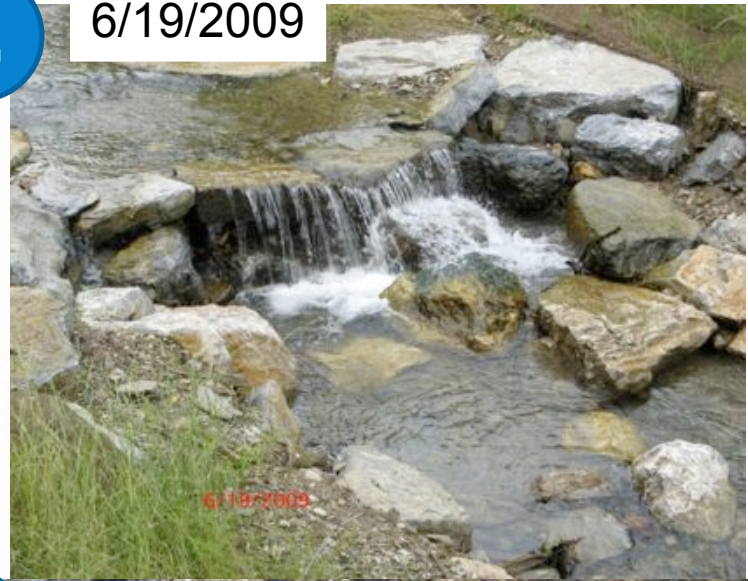
2

On the next slide in Photo #1, Cross Vane 9a (a **double** throated vane ) is shown intact on April, 2009. This was one of the structures that had been washed out in September of 2008, and rebuilt with deeper footers, but without any underlying or backing geo-textile. By 6/19 the lowest throat had washed out and by 7/29 the center throat followed. The level of the water below the backbone dropped substantially, and high water continued to move rock as shown in photo #4.

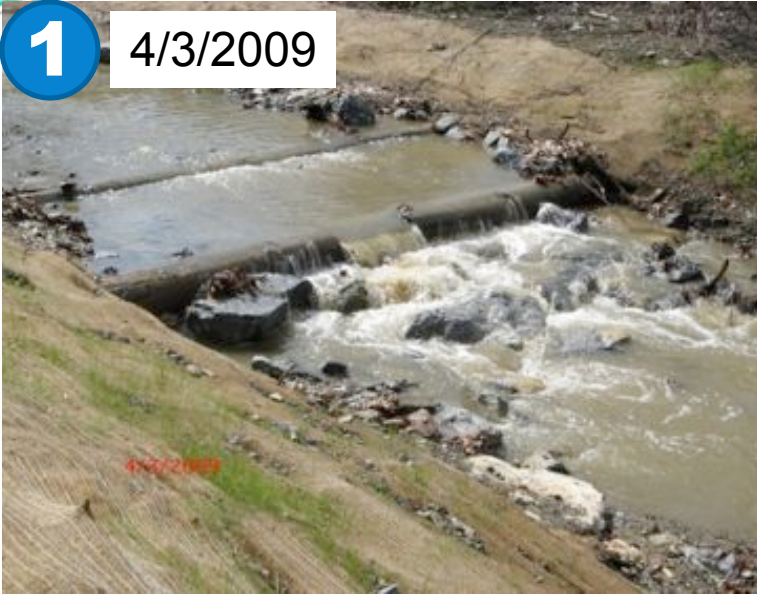
1

The last log bump on the restored reach, positioned near the top of the final 6% drop, shown in Photo #1 on the next slide, was functioning as of 4/3/2009. Note the heavy bedsill that had been lain on the stream bottom below the log. However, by 6/19 some of the boulders at the foot of the log had washed out and water had begun moving under the the log. By 10/28 the log had been completely undercut and was no longer functioning as a grade control. Several things were wrong with our log bumps. First, the diameter of the logs used were less than the proposed average depth of the stream. Usually, where logs are used in this fashion, they are stacked two deep and pinned with rebar. Second, they should be backed with geotextile to hold the upstream fines in place. It is also important that the log (s) be deep enough into the streambed to that they are continually wet, otherwise the wood will rot prematurely.
