## MEMORANDUM

**SUBJECT:** VALLEY RUN RESTORATION OPPORTUNITIES DURING UNIVERSITY CONSTRUCTION

**DATE:** MAY 11, 2016

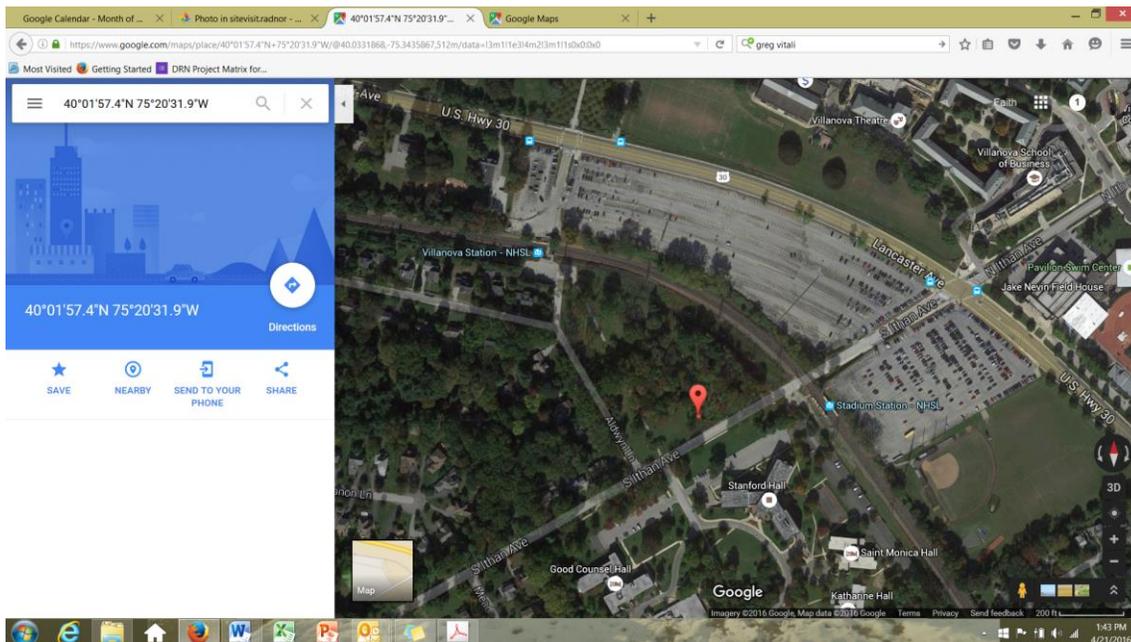
Map 1. Red pin represents the lower end of the forested tributary located within “the Triangle” that flows under South Ithan Road. Outlet A (explained later in the letter) flows under the Septa ROW through pipes and directly into this forested protected tributary in “the Triangle”

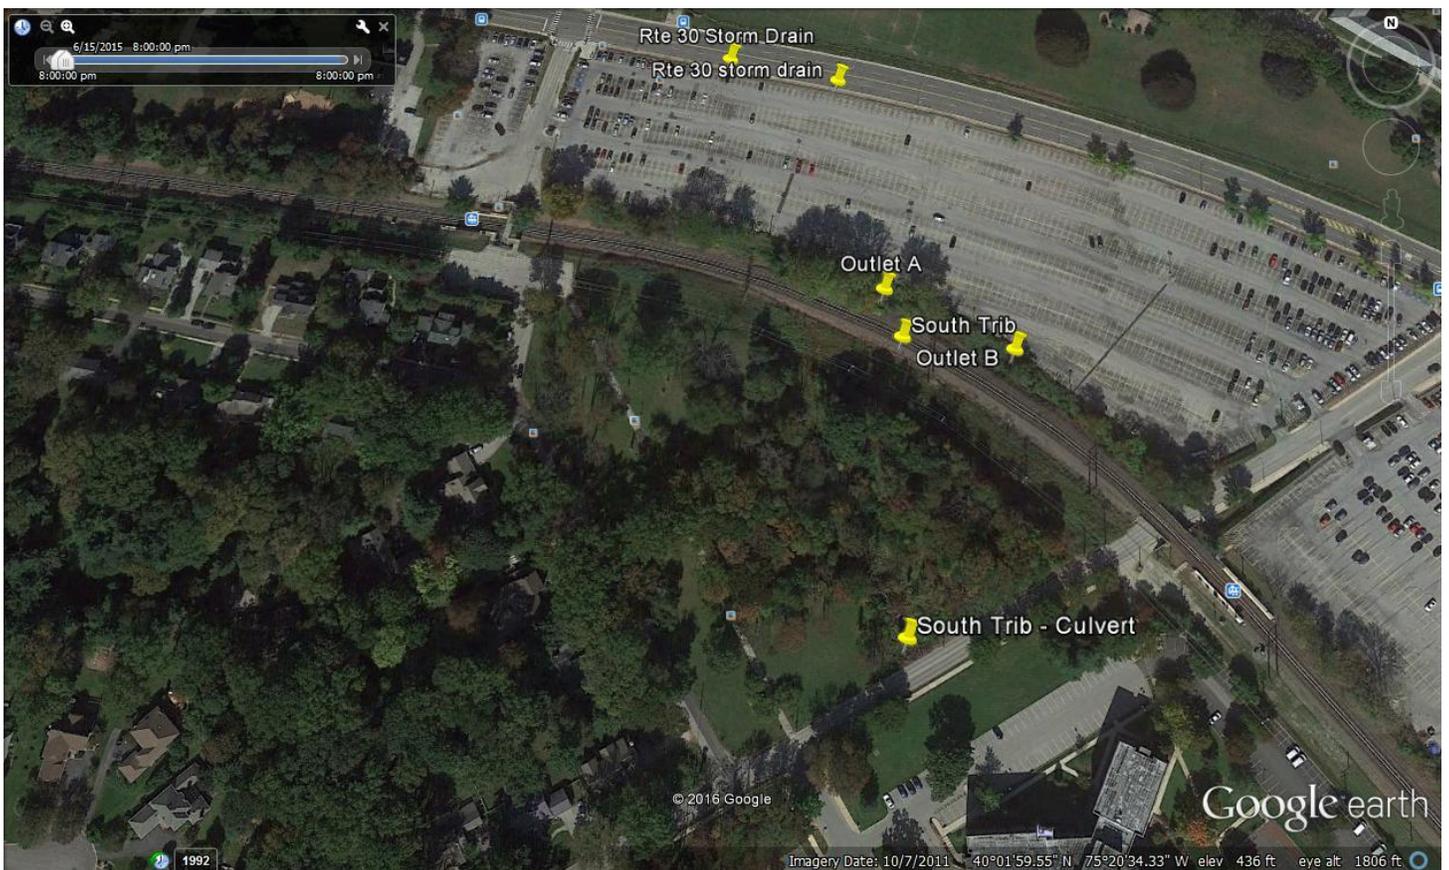
Map 2. Outlet A originating from under the parking lot flows under the Septa ROW via pipes and directly into the forested tributary located in “the Triangle”. Outlet B, likely another headwater spring or tributary, originates from under the parking lot and then flows along the base of the Septa ROW in a easterly direction to South Ithan Avenue.

DRN documented Outlet A has a junction from a pipe that we believe runs under the Villanova parking and then flows under the Septa ROW flowing directly into the forested tributary in “the Triangle”.

Outlet B, which also appears to collect and flow under the parking lot is located east of Outlet A and had a very low baseflow running adjacent and in an eastward direction along the the Septa ROW to South Ithan Ave. This above ground tributary is dominated by *Phragmites*, has evidence of trash and debris dumping within it, has very little riffle habitat, is eutrophic, and is confined between the Septa ROW and parking lot – conditions are poor. However, there was evidence of limited stream benthic life on the few cobble sized rocks that were examined along it. This tributary with erosion noted along the banks also has severe inputs from stormwater likely flowing off Rte 30 and the parking lot – see the location of highway storm drain grate maps on map below. Outlet B is likely another headwater spring/tributary that originates from under the parking lot.

In light of these observations of historic headwater streams that are connected to the Valley Run, we are requesting that DEP and Villanova determine the extent of the original buried stream under the parking lot as part of the planned design and review process. At a minimum, baseflow should be maintained to the existing tributary south of the Septa ROW, and erosive velocities managed. Conditions should also be improved along the ROW where habitat was observed to improve conditions for these headwaters to Valley Run to better protect important macroinvertebrates colonized there that help improve water quality.

With renovations of the parking lot being planned, we strongly encourage Villanova to explore the daylighting and restoration of this headwater stream within the footprint of the Villanova parking lot which would have tremendous benefit to the watershed and which also may prove more cost effective than the maintenance of a very old culvert and replacement by a new culvert. American Rivers provides an excellent overview on daylighting that is available at this link: <http://www.americanrivers.org/wp-content/uploads/2014/04/daylighting-streams-report-2.pdf>.
